EXECUTIVE SUMMARY

Churchill Engineering, Inc (CEI) inspected the bridge located on Bartlett Road spanning the Beaver Dam Brook within the Town of Plymouth, Massachusetts on February 19, 2010. A previous Structures Inspection Field Report was completed on April, 12 1999 by Beta Group, Inc. A copy of the previous report was made available Churchill Engineering, Inc. prior to conducting the inspection and is included within this report. This structure also impounds water from the outlet of Fresh Pond by way of flash boards between the southern end of the East and West Abutments and a center pier. The dam is known as Fresh Pond Dam and is registered with the US Army Corps of Engineers as 7-12-239-26 and the Massachusetts Office of Dam Safety as MA01029.

The Town of Plymouth Massachusetts has retained Churchill Engineering, Inc. to perform a visual inspection and develop a conditions assessment report for the bridge which carries Bartlett Road over the Beaver Dam Brook (Outlet from Fresh Pond) in Plymouth, Massachusetts.

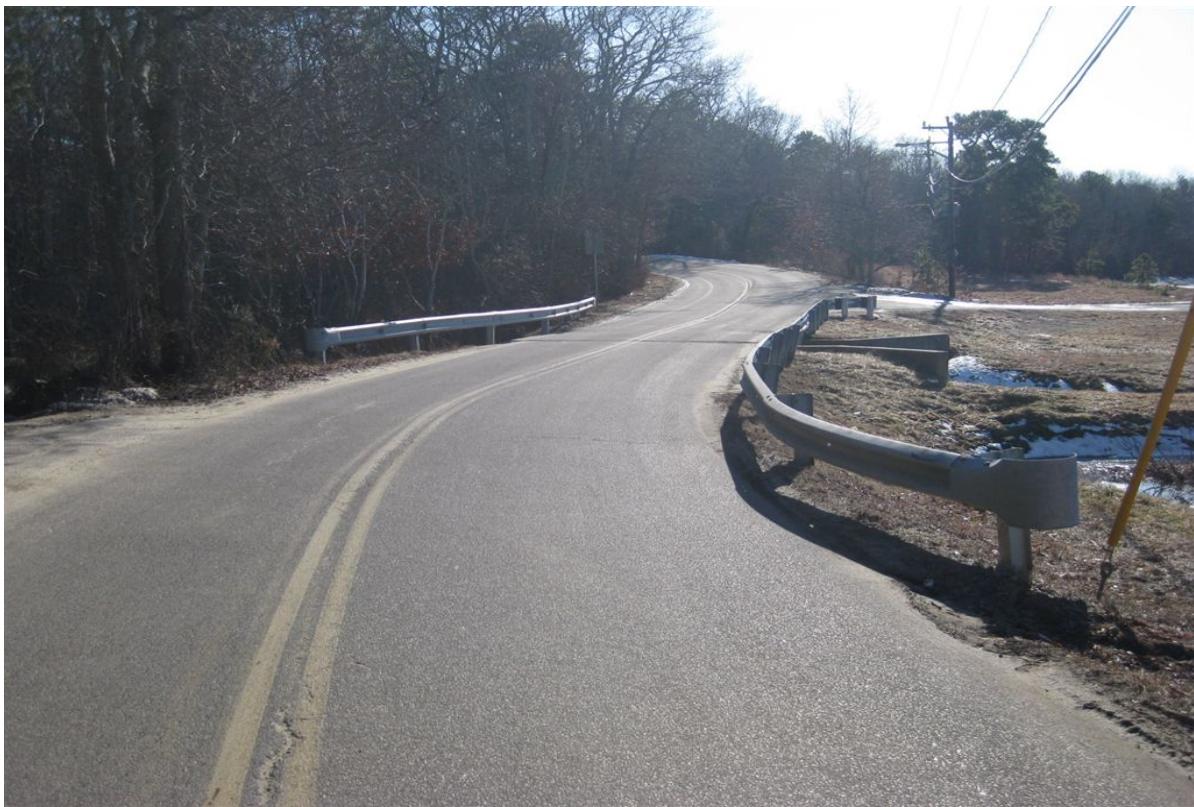
Figure 3. East Approach

The approaches to the bridge were considered in poor condition. Roadway alignment of both approaches is located along a curve with a bridge width of 18' for two lanes of traffic. The east approach pavement exhibited minor alligator cracking with roadway settlement of 1 – 2 “ at the East abutment. The West approach pavement exhibits similar cracking. However, an approximate 2' wide x 3' long section of pavement has settled 2 – 3” and the Northern edge of the West abutment. Speculation as to the causes of this settlement is offered above. Settlement of the remainder of the West approach diminishes towards the centerline and then increases to up to 1 inch from the center line towards the south elevation.

- Repair of the settled pavement of both approaches is recommended.
- CEI recommends continued monitoring of the settlement at the Northern limits of the West abutment to determine if movement is ongoing.

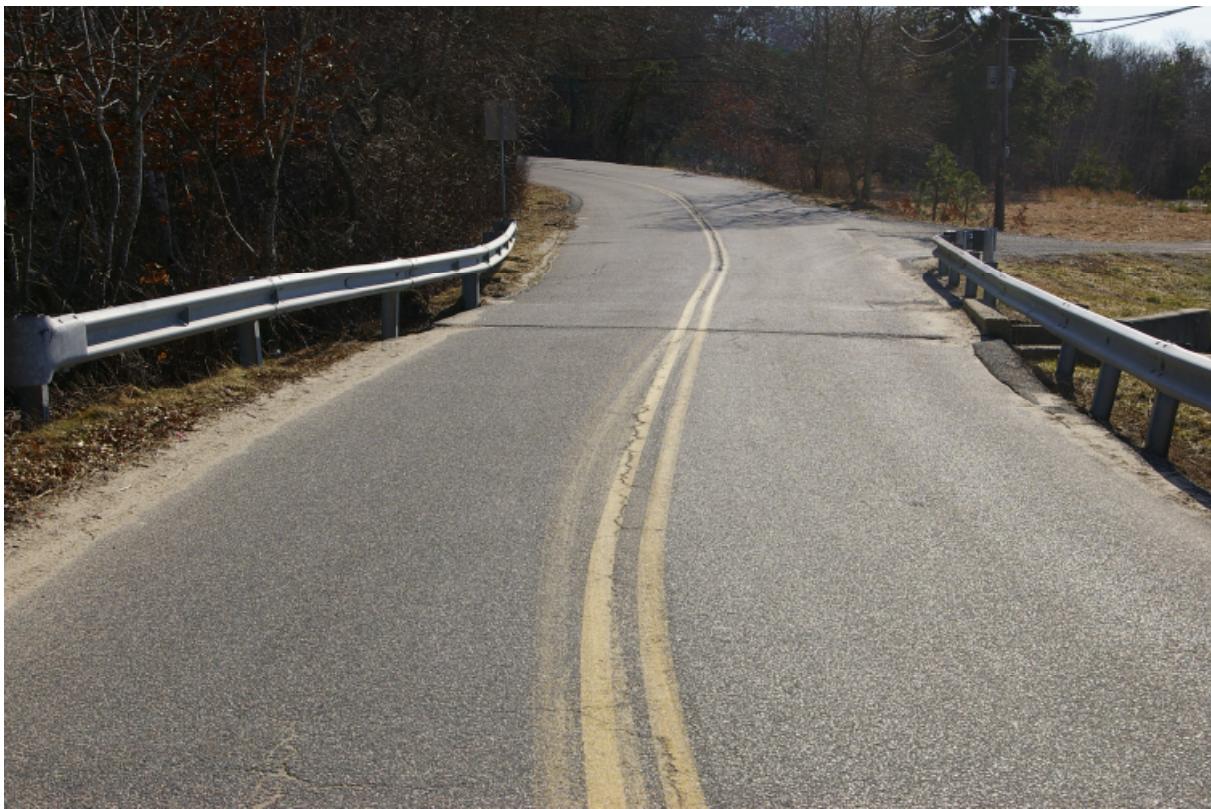
Figure 5. Bridge Deck

The superstructure is a concrete deck supported on concrete encased steel stringers / girders considered in satisfactory condition. The underside of the deck exhibits minor cracking throughout with spalling of concrete limited to the encasement of the stringers / girders. Some oxidation of the exposed stringer/ girder flanges was observed although no section loss was noted. The wearing surface upon the deck is map cracked but otherwise in satisfactory to fair condition.

The deck slab and supporting girders / stringers were considered in satisfactory condition. Some spalling of the concrete encasement of the girders / stringers revealed surface oxidation on the exposed surfaces. However, section loss at these locations was not noted. Sounding of the remaining encasement yielded some hollow spots along to bottom of the flanges concentrated were cracking was observed. Otherwise the encasement was considered sound. The underside of the deck exhibits minor cracking throughout with spalling of concrete limited to the encasement of the flanges of the girders / stringers. Sounding of the underside of the deck between the girders / stringers did not yield hollow spots, voids, delaminations or other signs of distress. The wearing surface upon the deck was map cracked but otherwise found to be in satisfactory to fair condition.

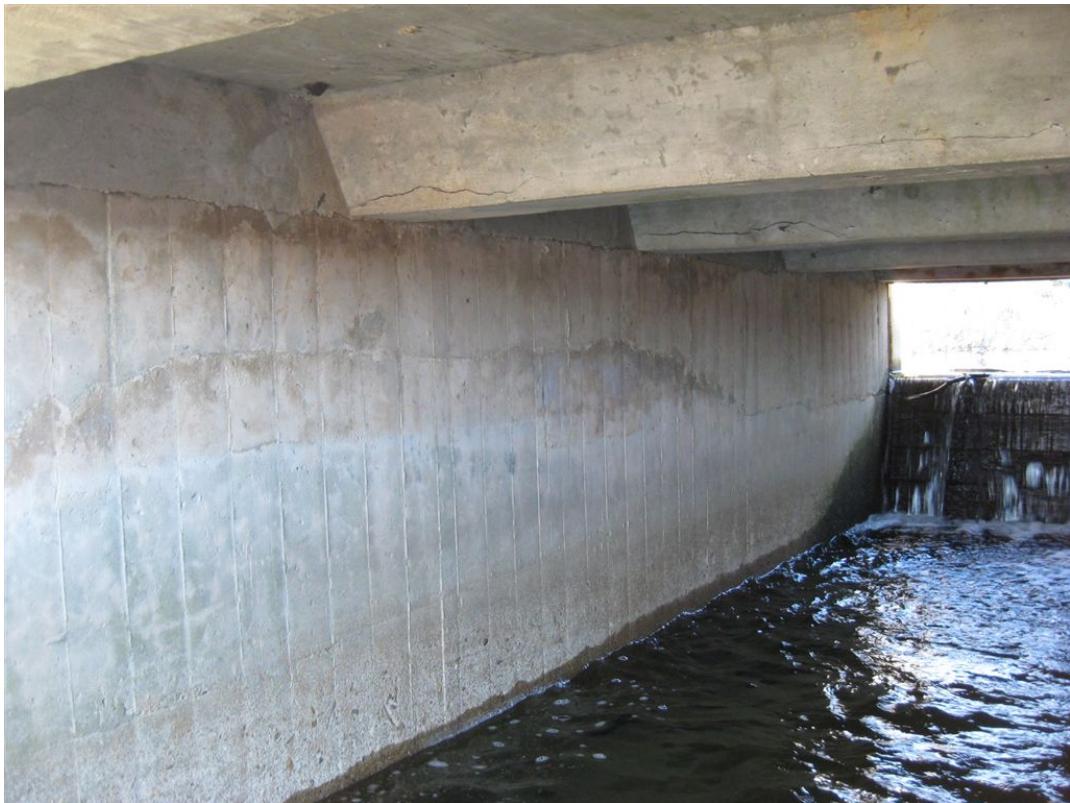
Figure 7. East Breast Wall

The substructure consists of concrete breast and wing walls also considered in satisfactory condition. Both North and South Breast walls exhibited minor scaled regions approximately 24" in height along the waterline. A cold joint in the cast in place concrete was observed along the East breast wall. The wing walls on the southern elevation and a center pier form the structure impounding the Outlet from Fresh Pond. These walls were found to be in satisfactory / fair condition. The Northeast and Northwest wing walls appear to have been constructed at a date later than the rest of the structure. A review of the previous inspection report yields that these walls have been installed after the last inspection of April 12, 1999. These walls are considered to be in good condition.

The substructure was found to be in satisfactory condition. Minor scaling within 2 feet of the waterline was observed at both the East and West breast walls. A cold joint was observed along the East breast wall with some minor hairline cracking and honeycombing noted in both breast walls. Some additional scaling and minor spalling was observed in the south end of the West breast wall at the support location of the flash boards. Hence, both breast wall were considered in satisfactory condition. The majority of the Southeast and Southwest wing walls could not be observed due the impoundment and the resulting accumulation of silt. The exposed portion of the walls were considered to fair condition. However, misalignment of a number of flash boards supported at the center pier were noted. It is suggested the Town authority responsible for the maintenance of the dam be advised corrective action may be necessary. The Northeast and Northwest wing walls appear to have been constructed relatively recently. A review of the previous inspection report of April 12, 1999 indicated these walls were constructed of dry laid rubble masonry and were in poor condition. The current walls appear to be constructed of reinforced concrete constructed after April 12, 1999 and are considered in good condition. However, some settlement in the pavement at the Northwest wing wall and the West approach indicate lateral movement or migration of fines within the supporting soil may be occurring. However, the settlement may also have been the result of poor compaction of the retained soil at the time of construction of the Northwest wing wall.

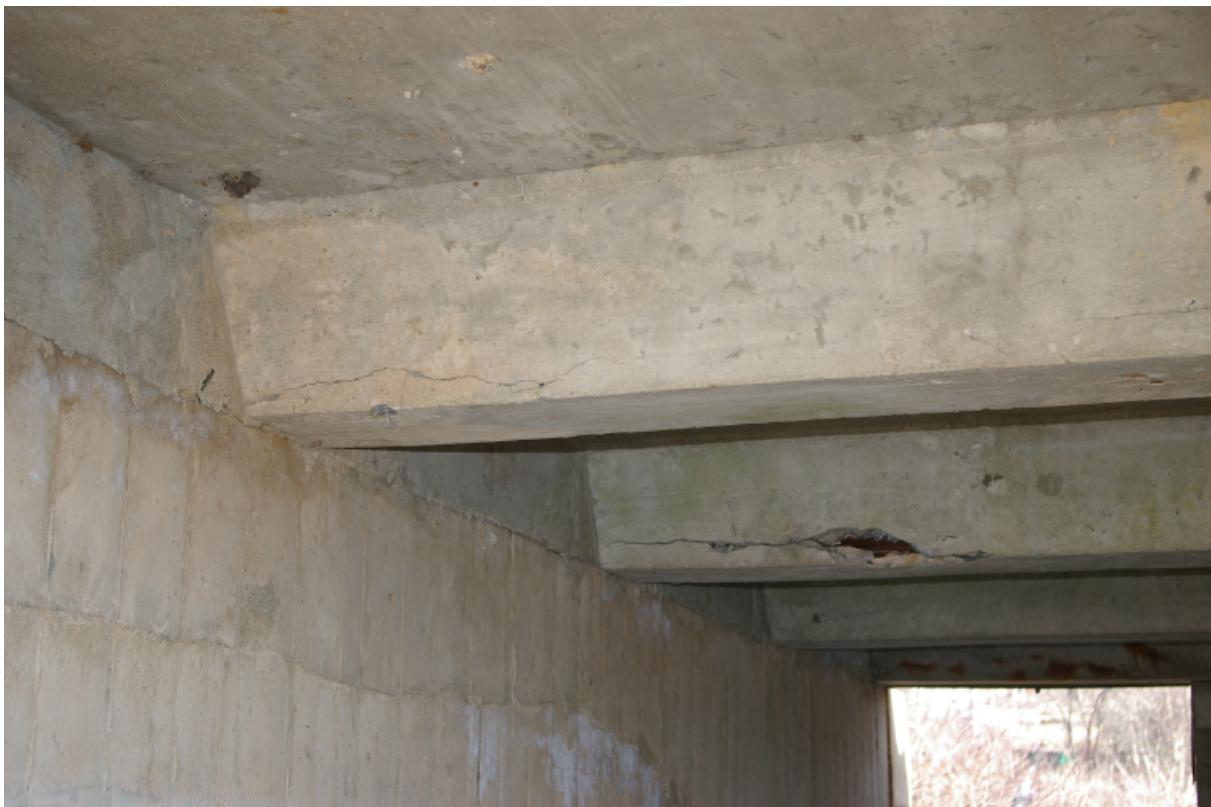
Figure 11. Delamination and Cracking Concrete Encasement

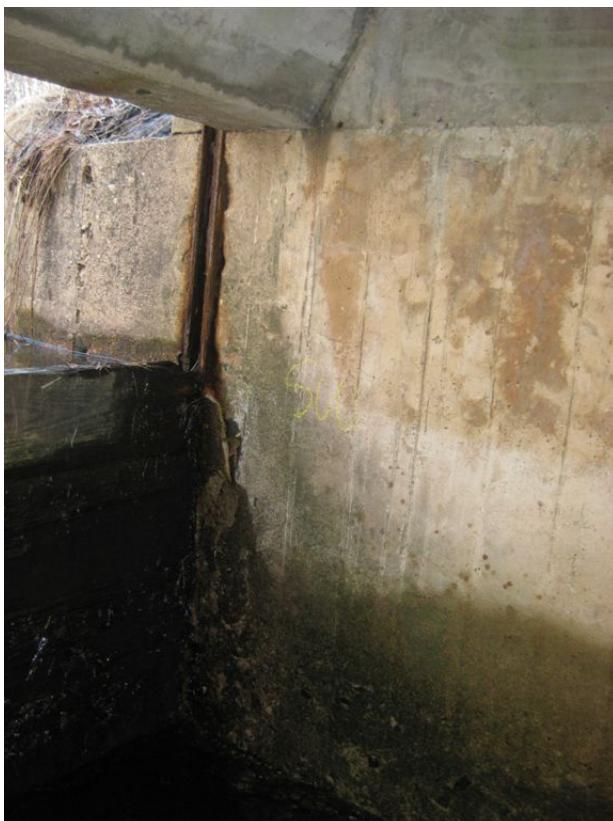
Figure 12. Scaling and Spalling West Breast Wall South End
Bartlett Road over Beaver Dam Brook
Plymouth, MA

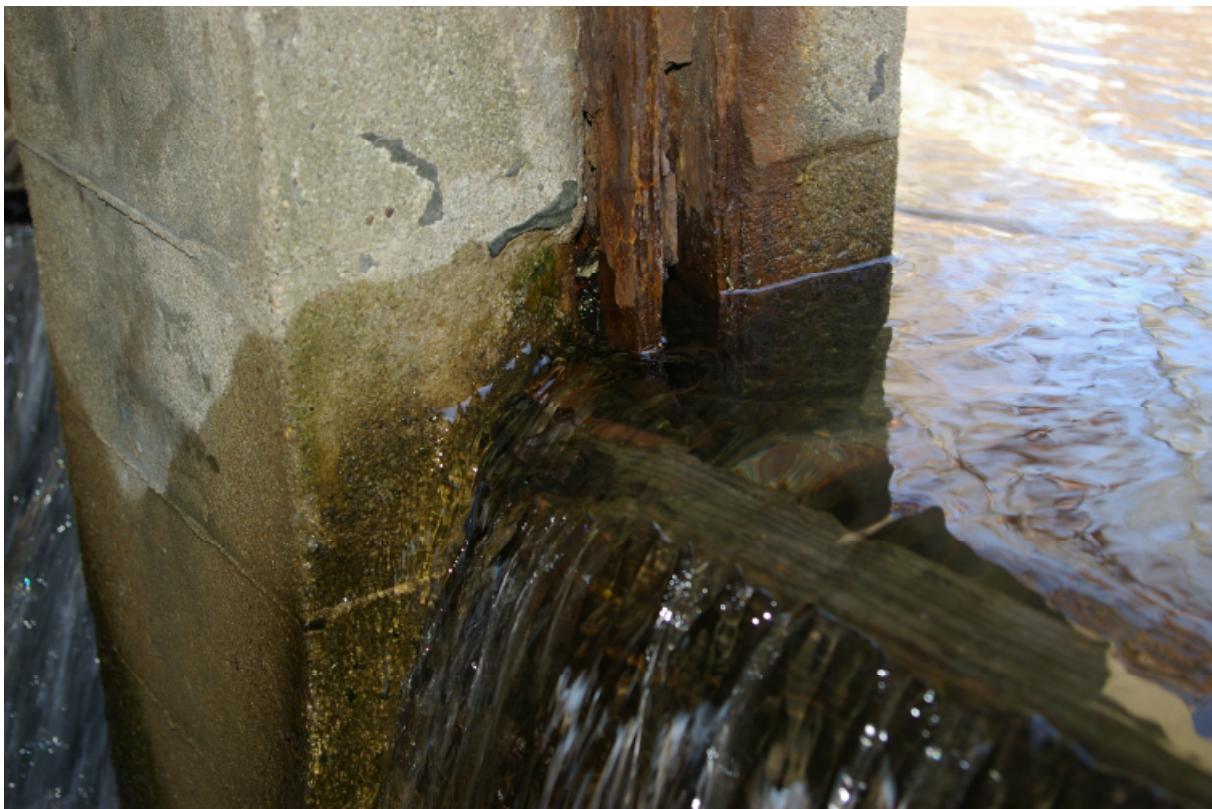
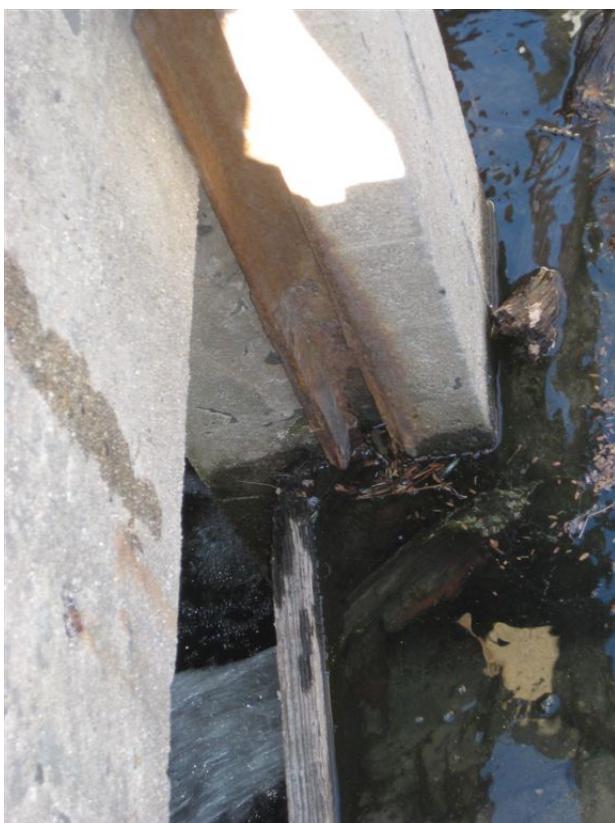
Although not included in the scope of work, misalignment of the flash boards impounding water along the south elevation was noted. We understand this dam is owned by the Town and as a result the department responsible for the dam should be advised that corrective action may be required.

Figure 13. Misaligned Flash Boards

Figure 14. Misaligned Flash Boards

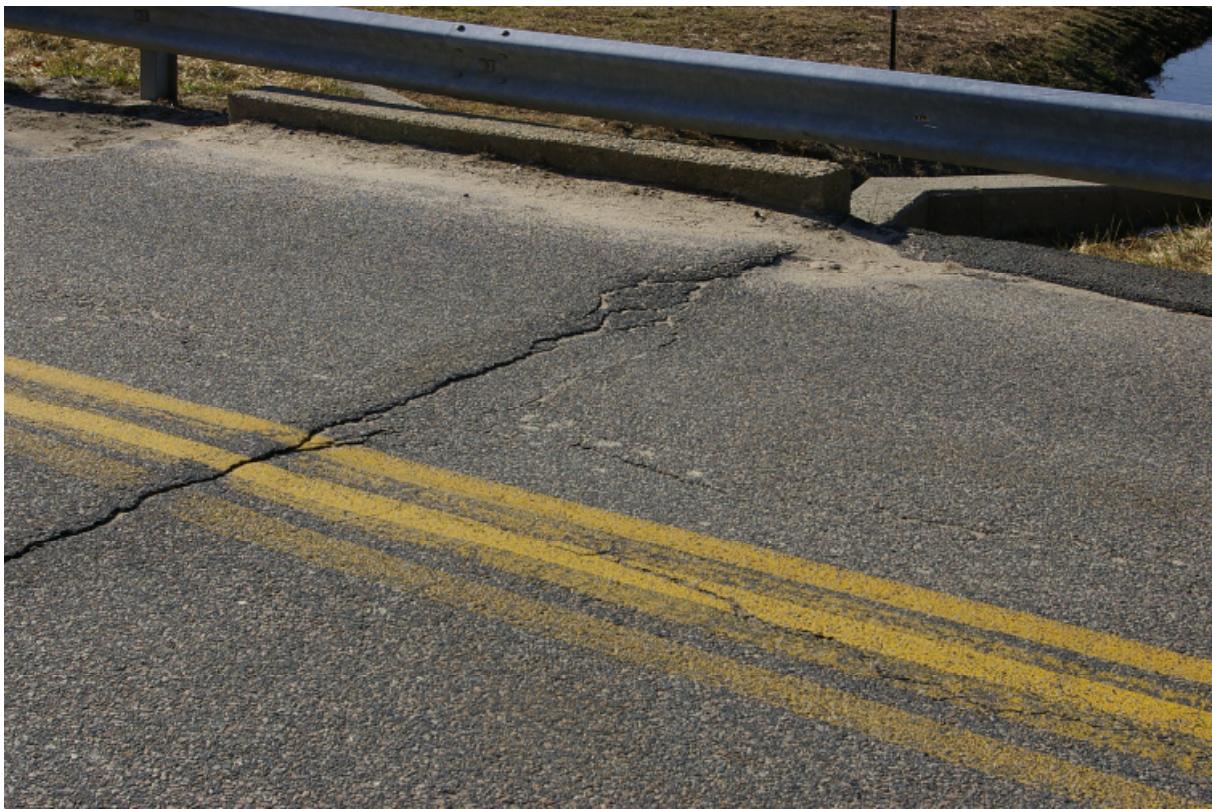
Figure 17. Settlement East Approach

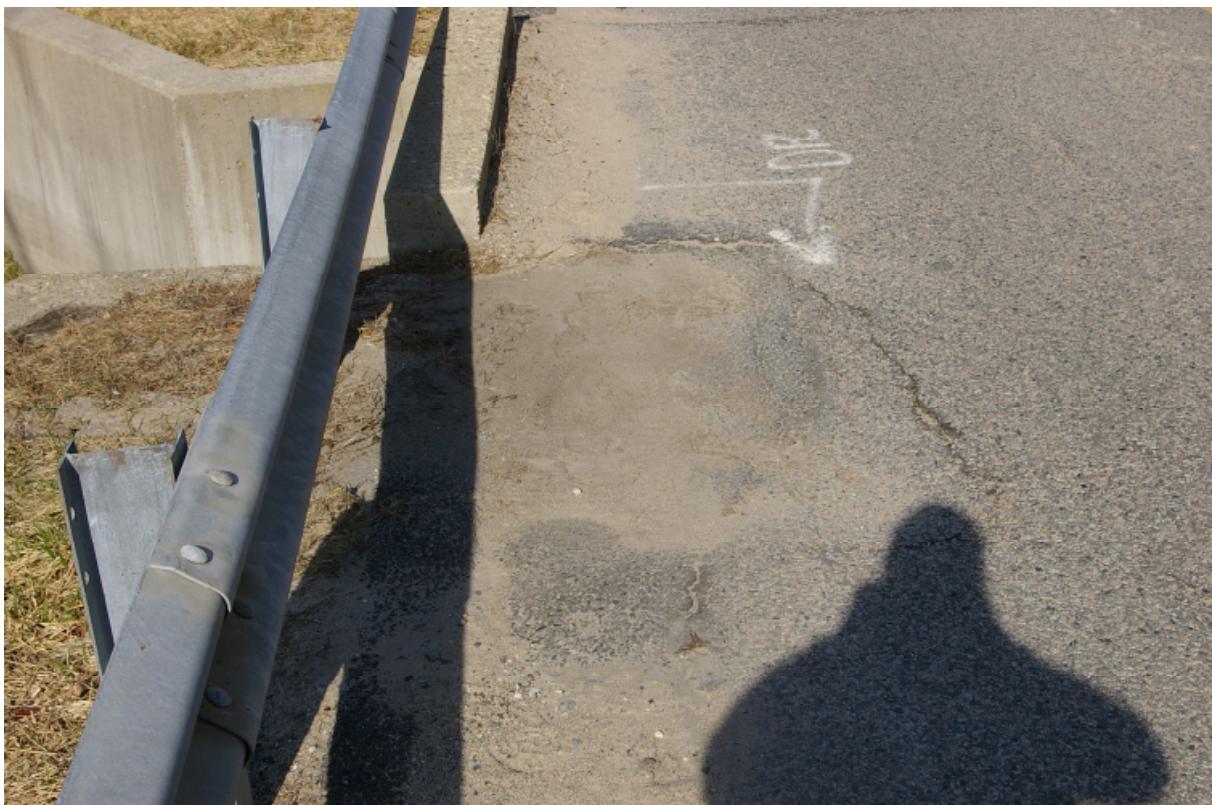
Figure 18. Settlement West Approach

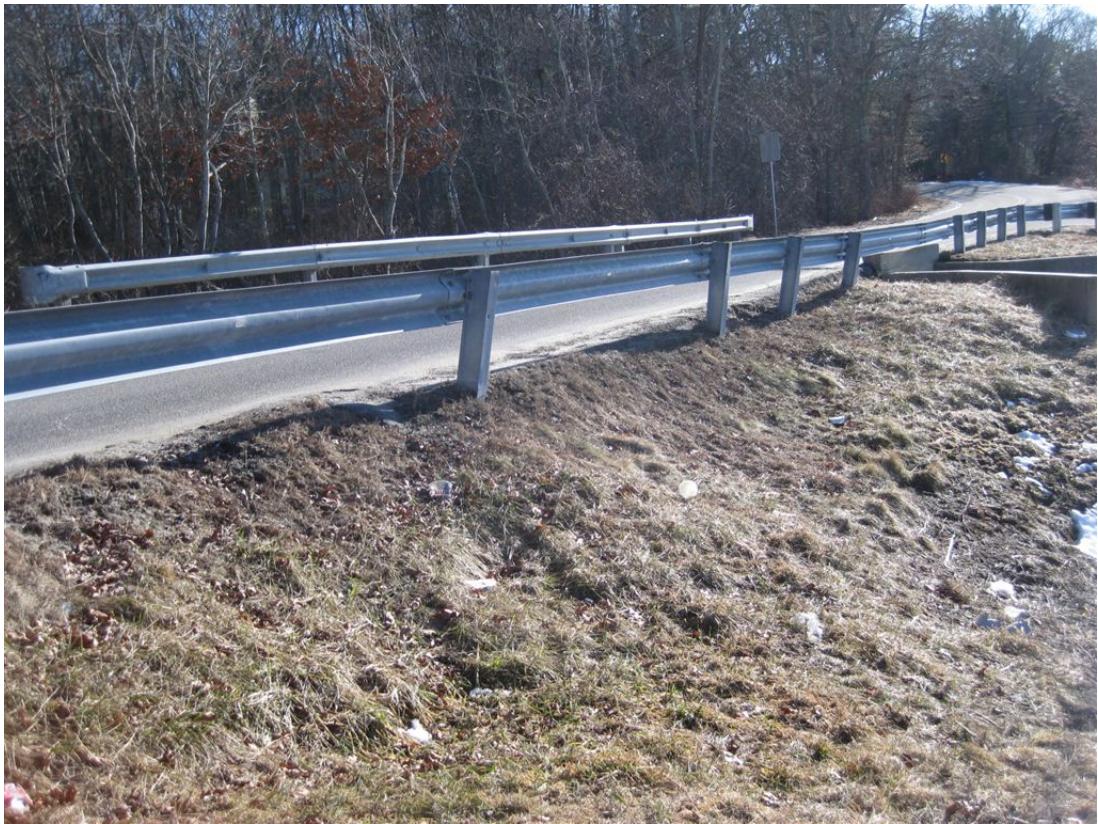
The bridge railing is provided by steel guard rail section unsupported along the approximate 8' length of the structure. The current support condition of the bridge rail is not considered to provide adequate protection for vehicular traffic. Approach guardrails and end treatments are present although the guard rail posts appear out of plumb or otherwise misaligned. Hence, they not considered to comply with current standards or provide adequate protection to vehicular traffic on the bridge.

Figure 19. Unsupported Bridge Rail

- The bridge rail should be evaluated for conformance with current AASHTO standards. CEI recommends a revised bridge rail design be developed and secured to the superstructure. The approach guard rail should be reviewed for compatibility with the revised bridge rail.
- If the current approach guard rail is determined to be compatible with the revised bridge rail, then the damage to the guard rail on the Northern side of the East Approach should be repaired.
- Due to the limited width of the Bridge, approximately 18 feet, regulatory / warning signage is recommended. Signage should be placed along both approaches in accordance with current standards.

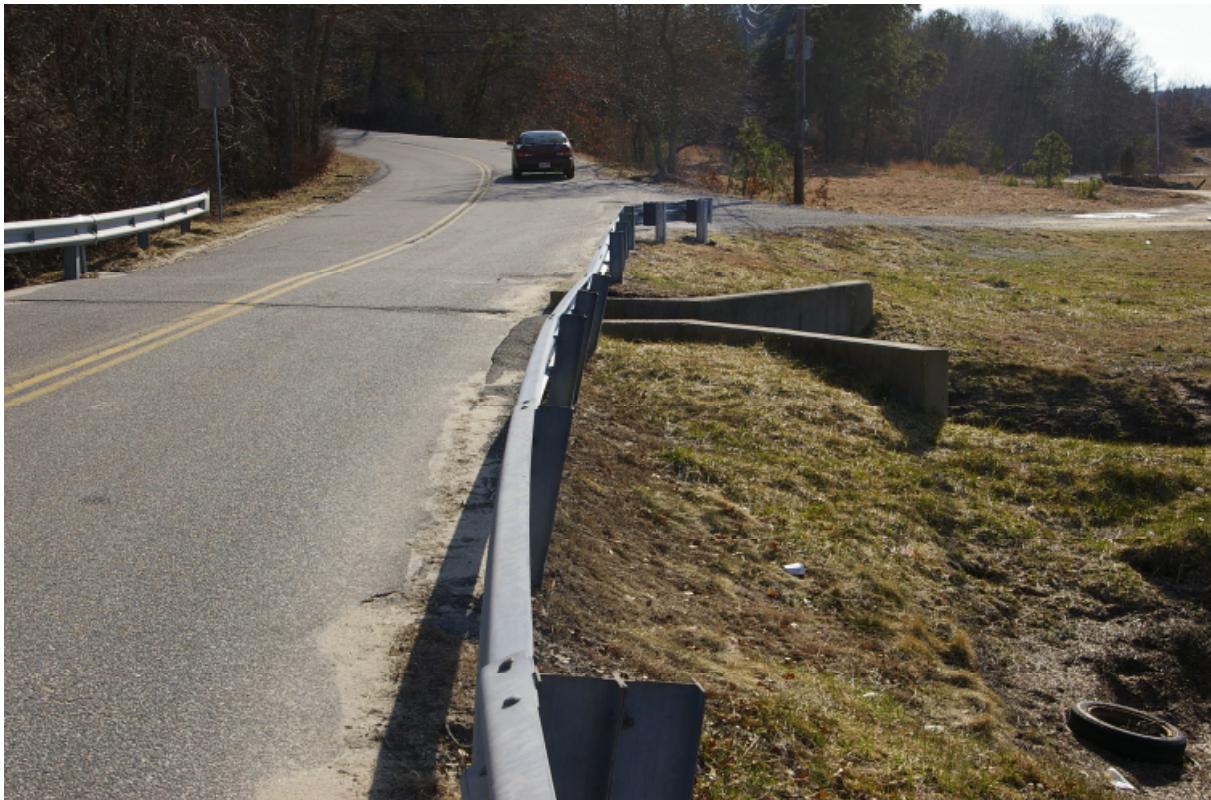
Figure 20. Misaligned Bridge Rail
