Plymouth Foundry

Safe Harbor Marinas
Plymouth, Massachusetts

Exterior Conditions and Treatment Recommendations

September 8, 2022

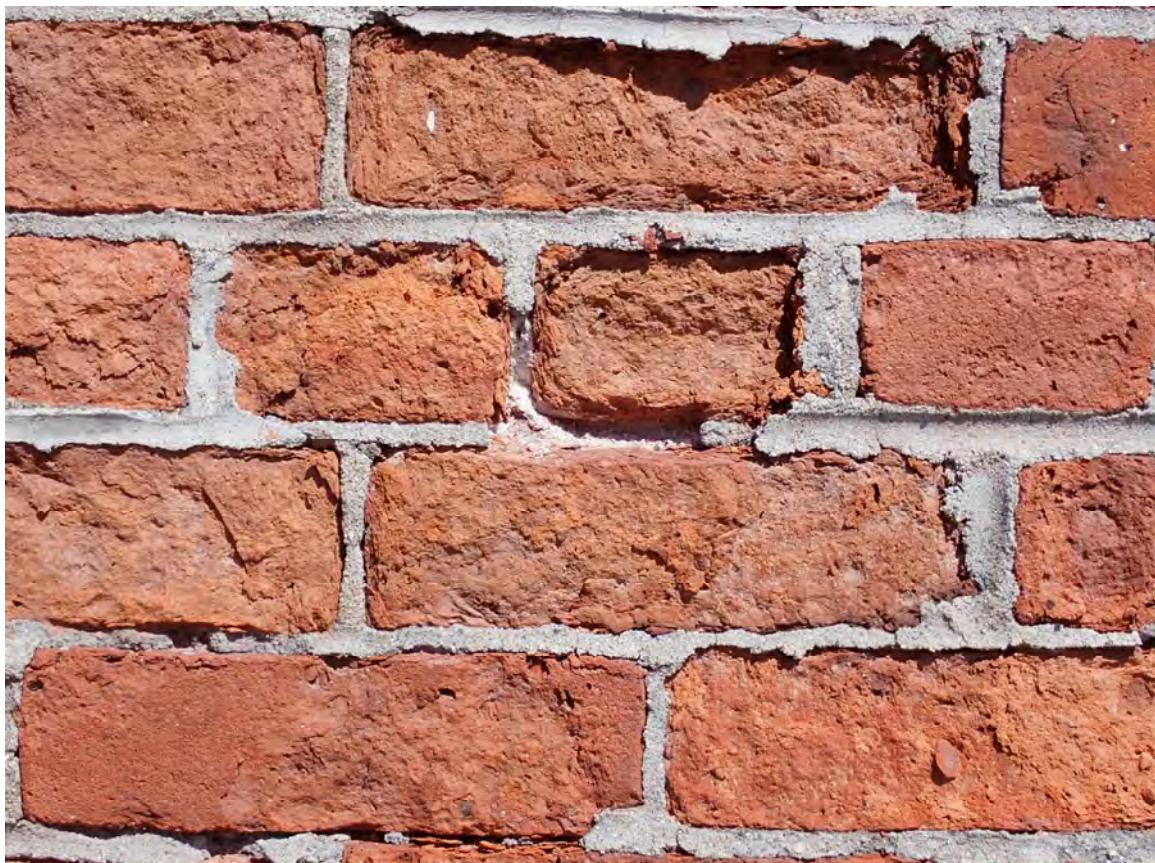
Figure 1: South elevation, west end. Brick laid in English bond with red brick. Spalled brick caused by repointing mortar that is too hard and not compatible with the soft brick.

- Replace cracked, spalled, or missing brick with salvaged or new brick (assume 120SF)
- Replace poorly matched replacement brick with new brick (assume 43SF).

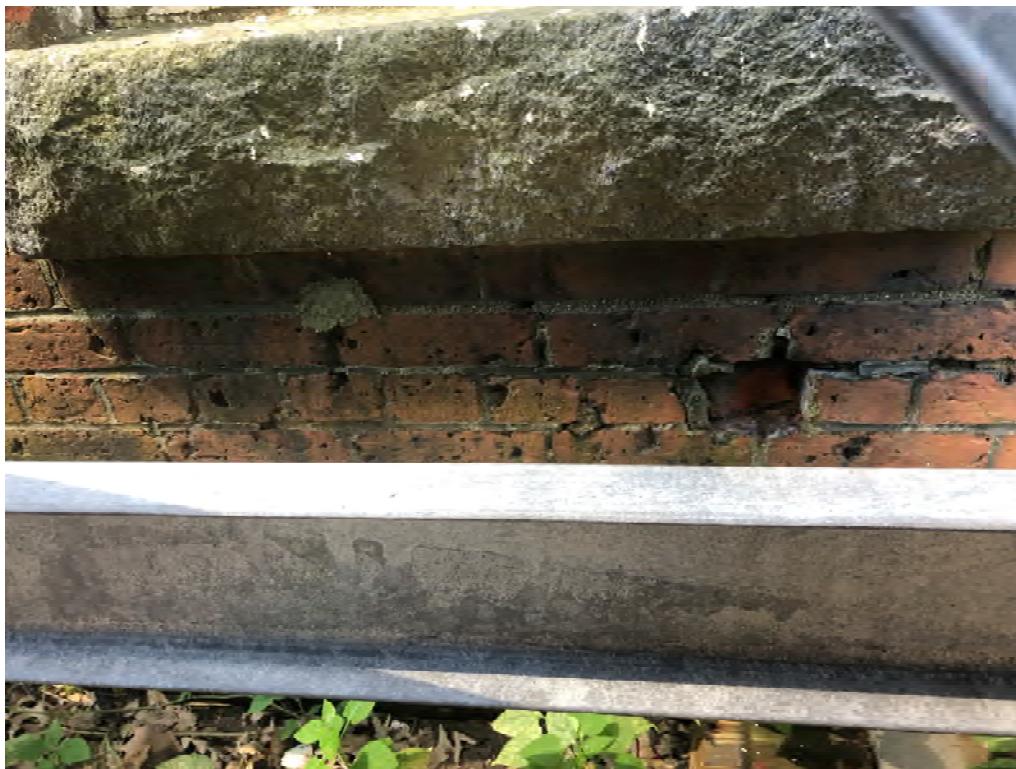
Figure 2: North elevation, damaged/missing brick.

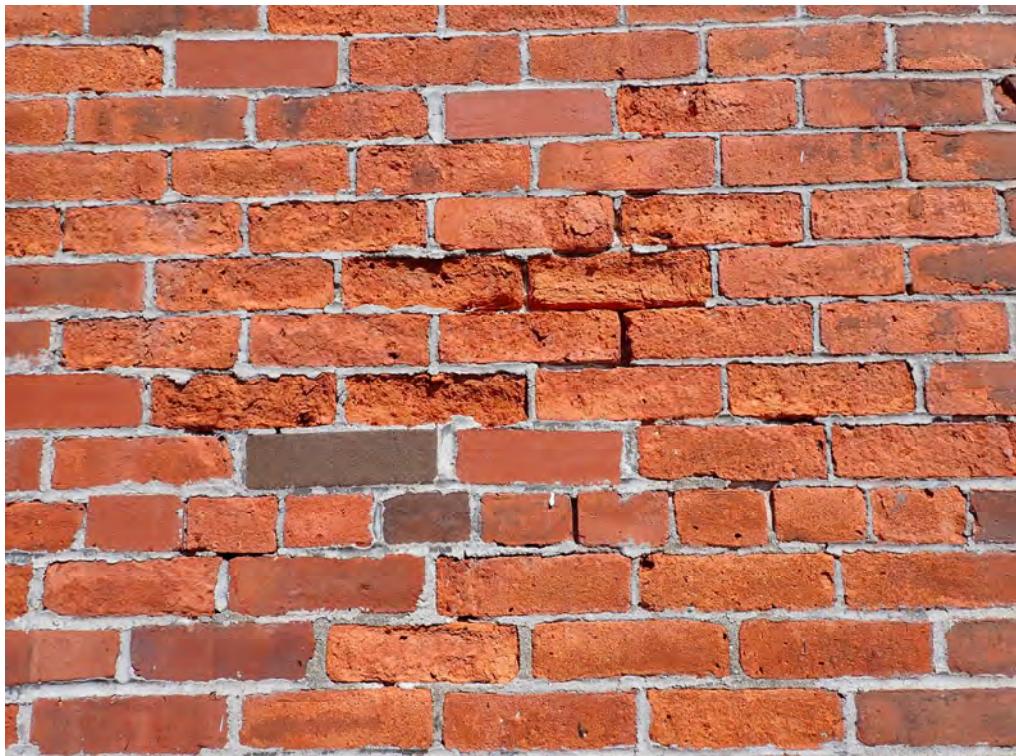
Figure 3: South elevation, west end. Brick laid in English bond with red brick. Note both spalled brick and poorly matched replacement brick.

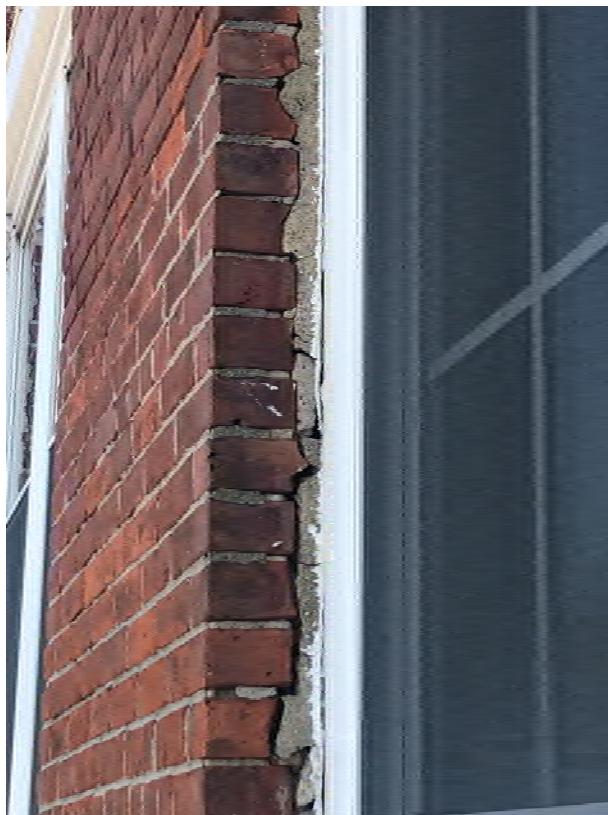
Figure 4: West elevation (front); slight movement of wall at jamb, allowing for water to enter into the wall.

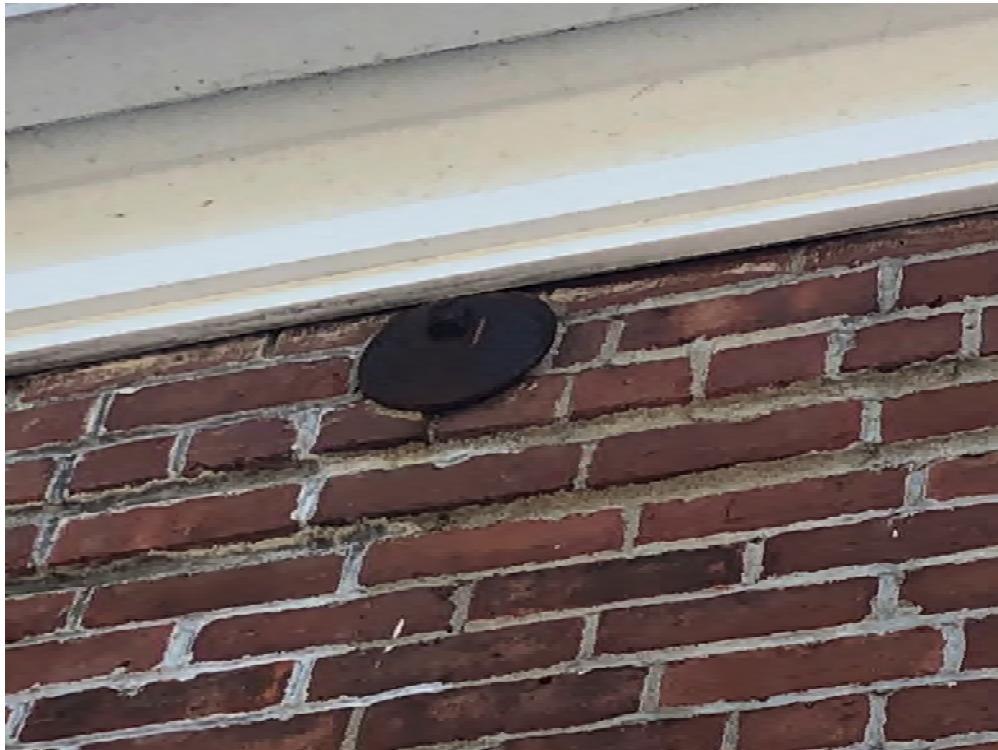
Figure 5: Tie rod at west elevation.

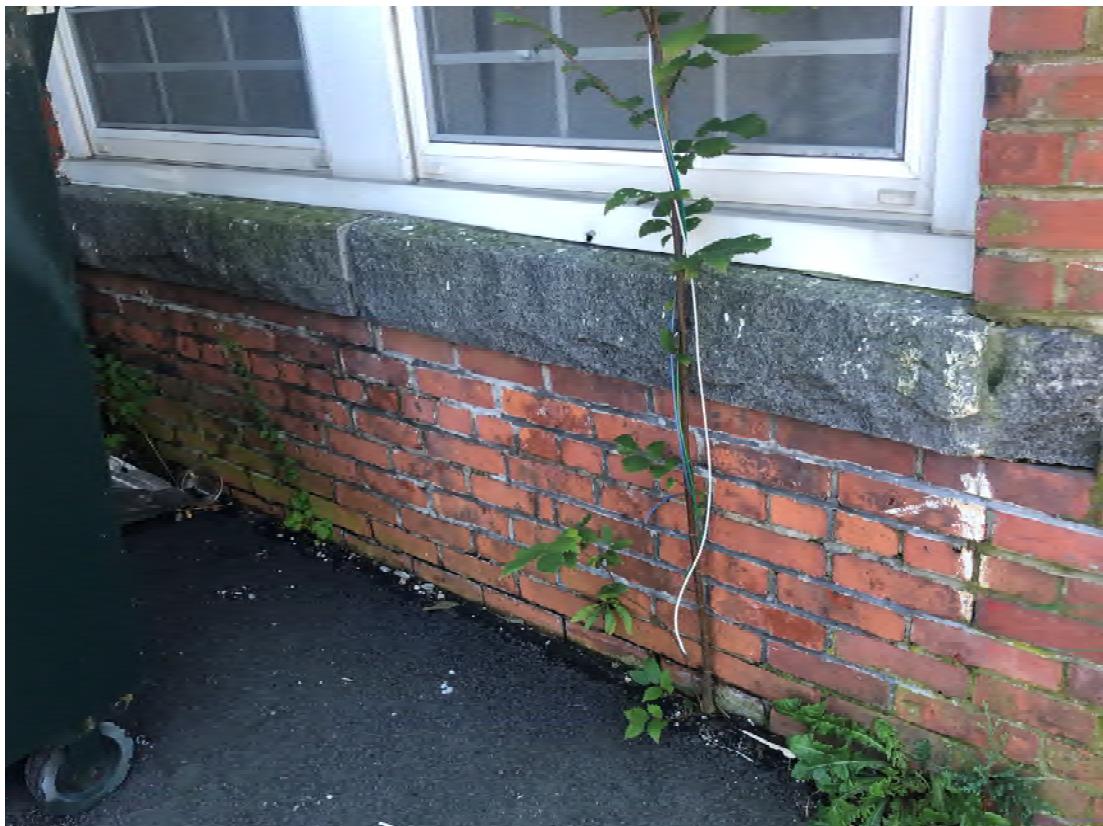
Figure 6: Granite retaining wall, east elevation.

- Repair spalled granite with granite dutchmen (2 locations)

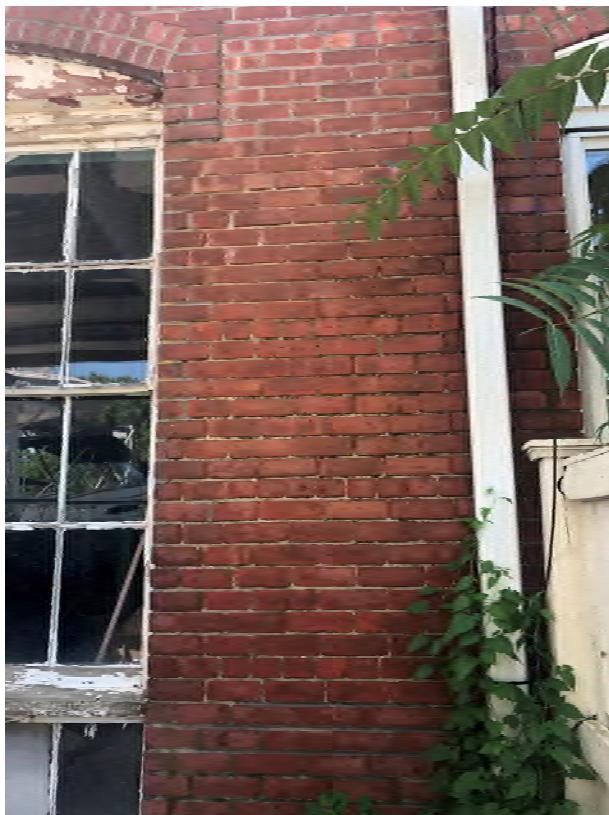
Figure 7: North elevation, typical deteriorated mortar joints.

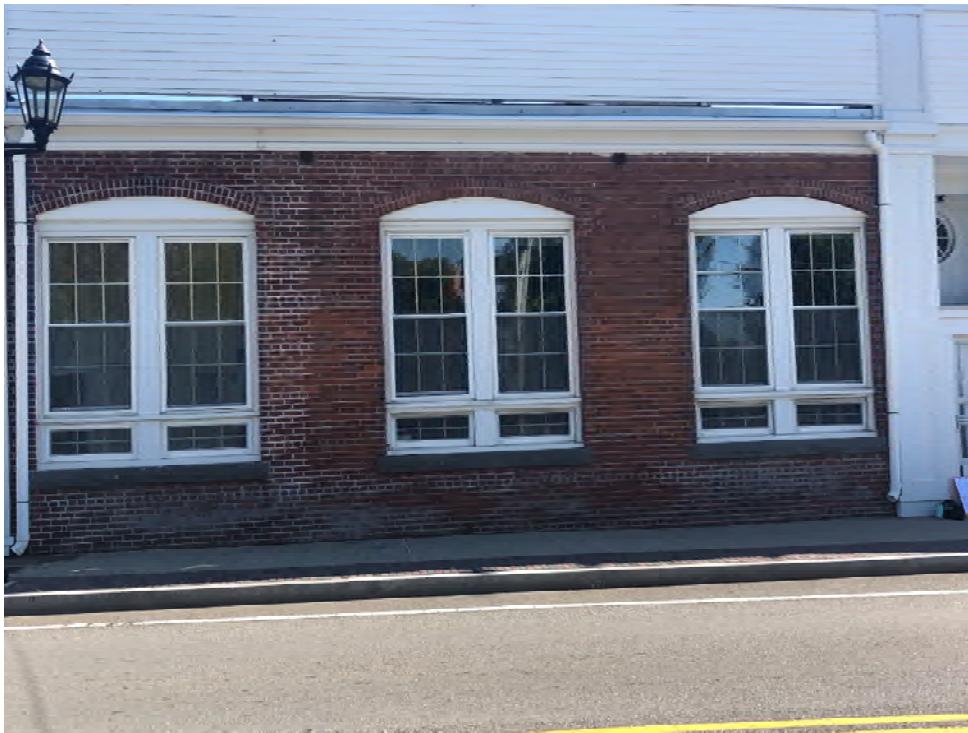
Figure 8. West elevation; poorly color matched and installed repointing mortar.

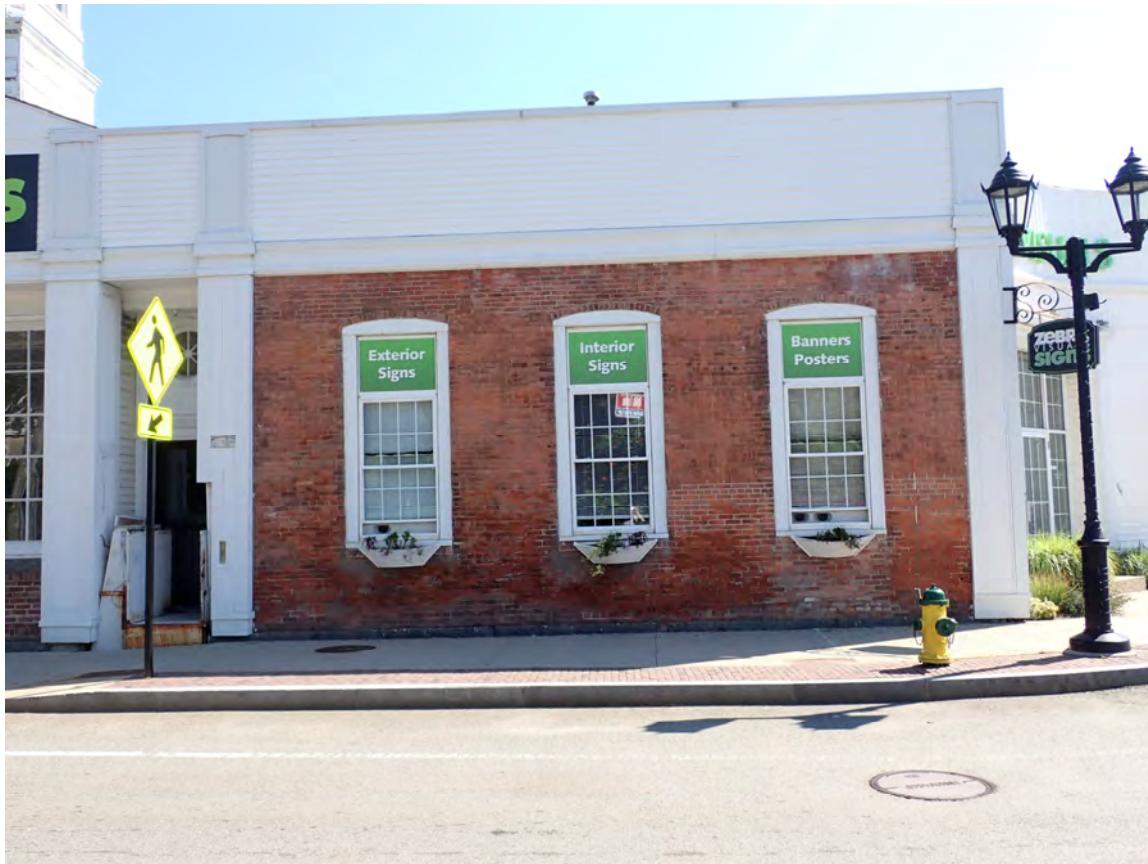
Figure 9. West elevation; poorly color matched and installed repointing mortar.

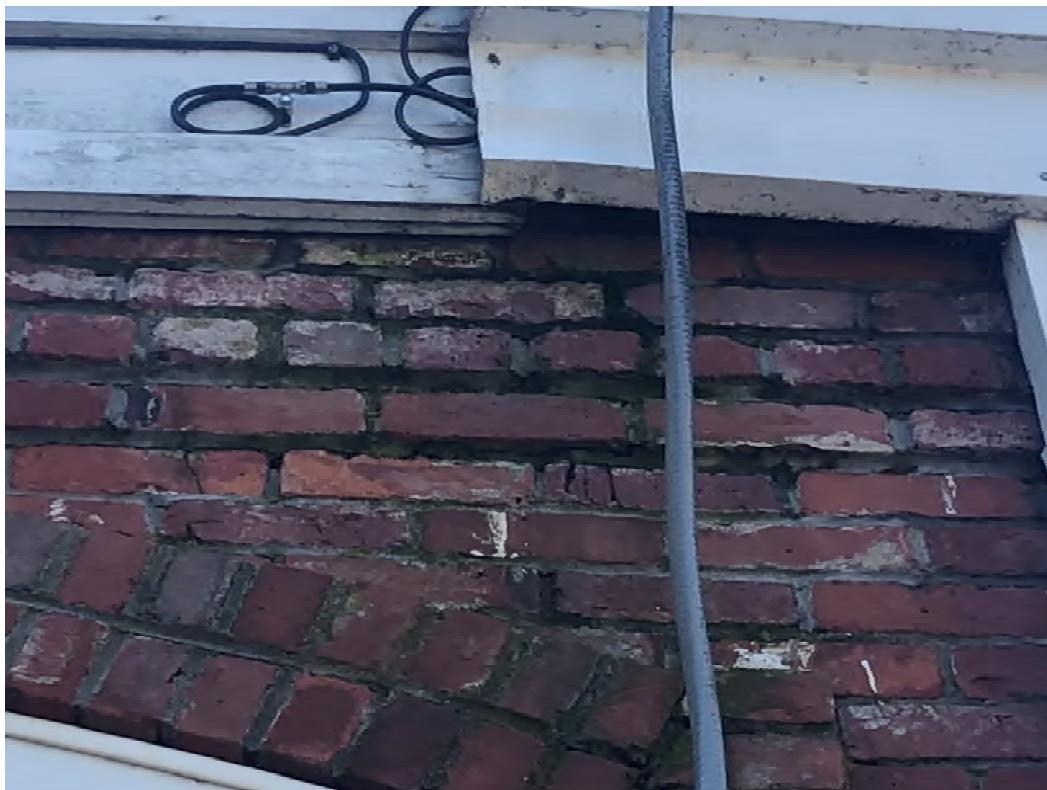
Figure 10: North elevation, heavy biological growth, particularly at mortar joints.

- Clean masonry 100% to remove general soiling, biological soiling, metallic staining, and all sealant residue at masonry openings (assume 1,080SF).
- Remove 100% of unused anchors, conduit, lighting, etc. from masonry and patch holes with composite patching material.
- Replace 100% of sealants at all masonry openings.

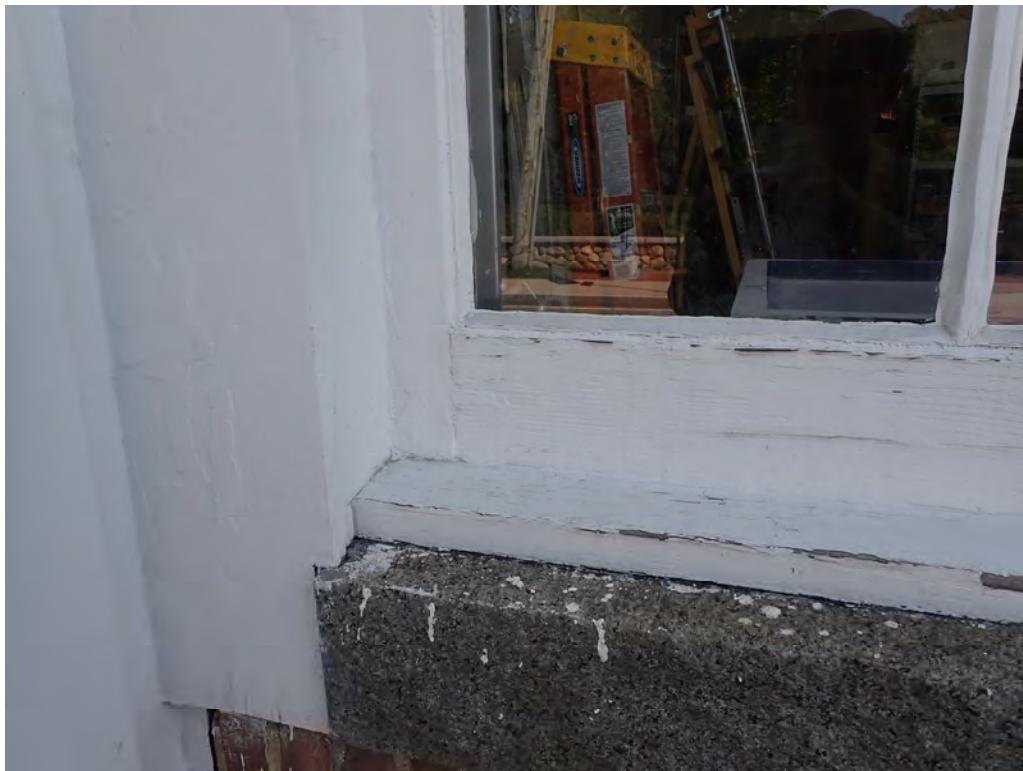
Figure 11: West elevation, paint drips on granite sill.

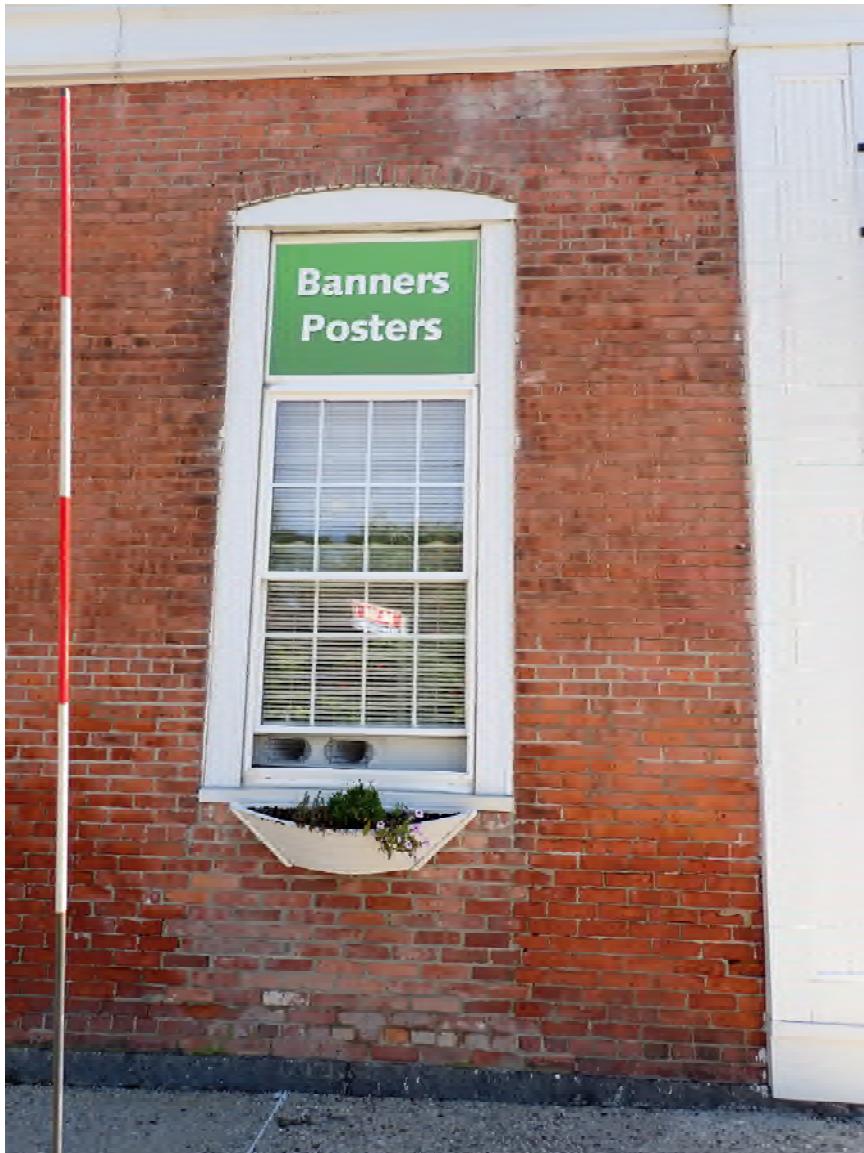
Figure 12: West elevation, paint haze and efflorescence on brick.

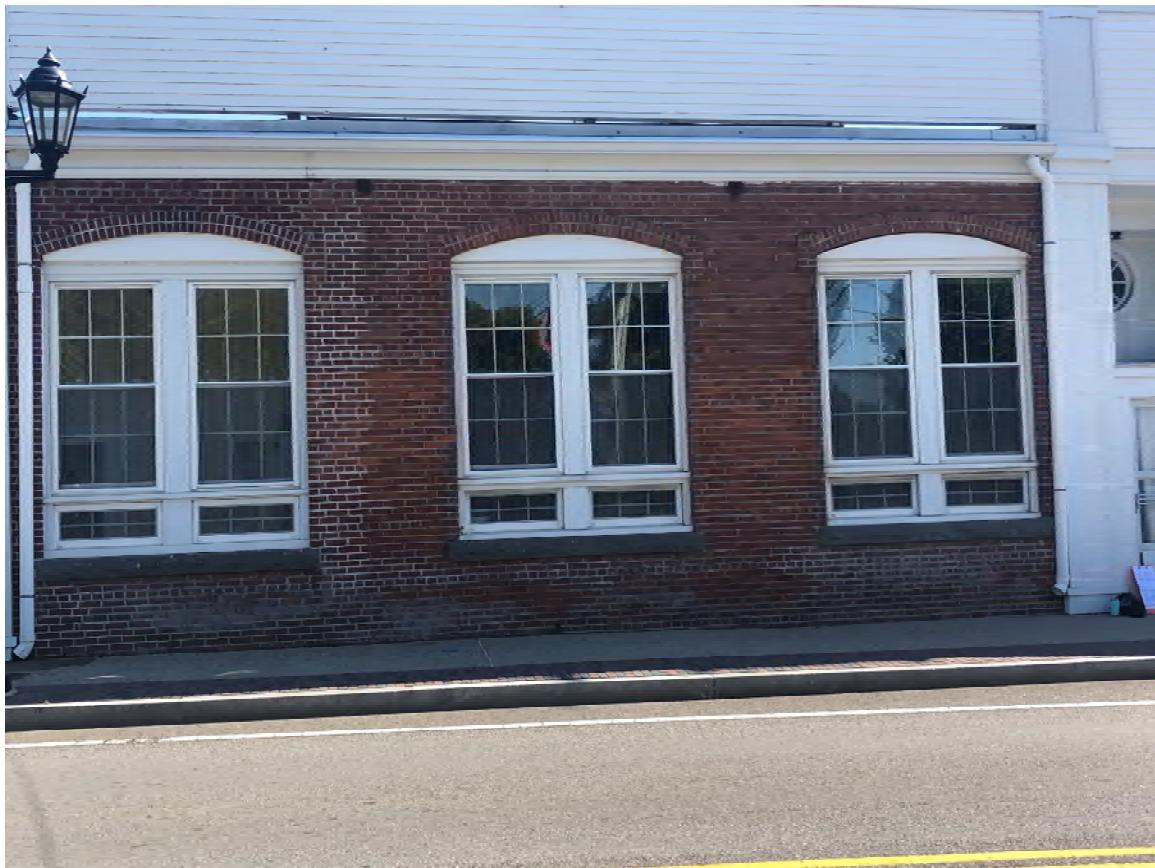
Figure 13: West elevation, north end; replacement windows set in masonry openings.

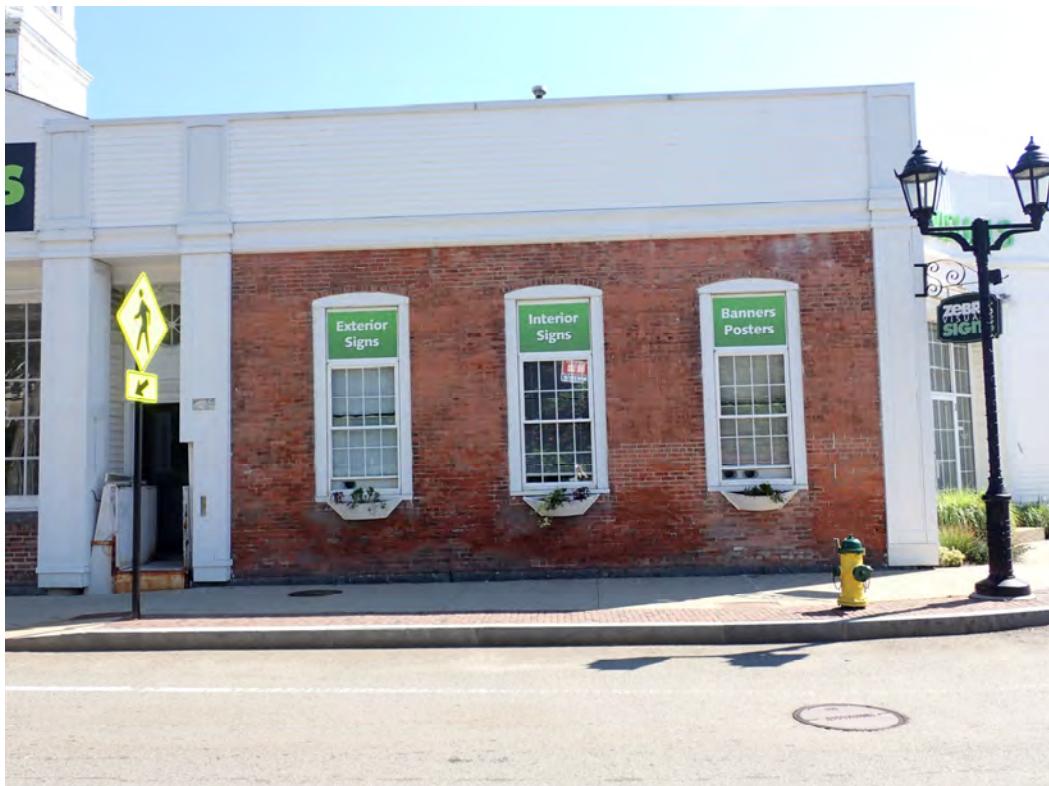
Figure 14: West elevation, south end; replacement windows set in masonry openings.

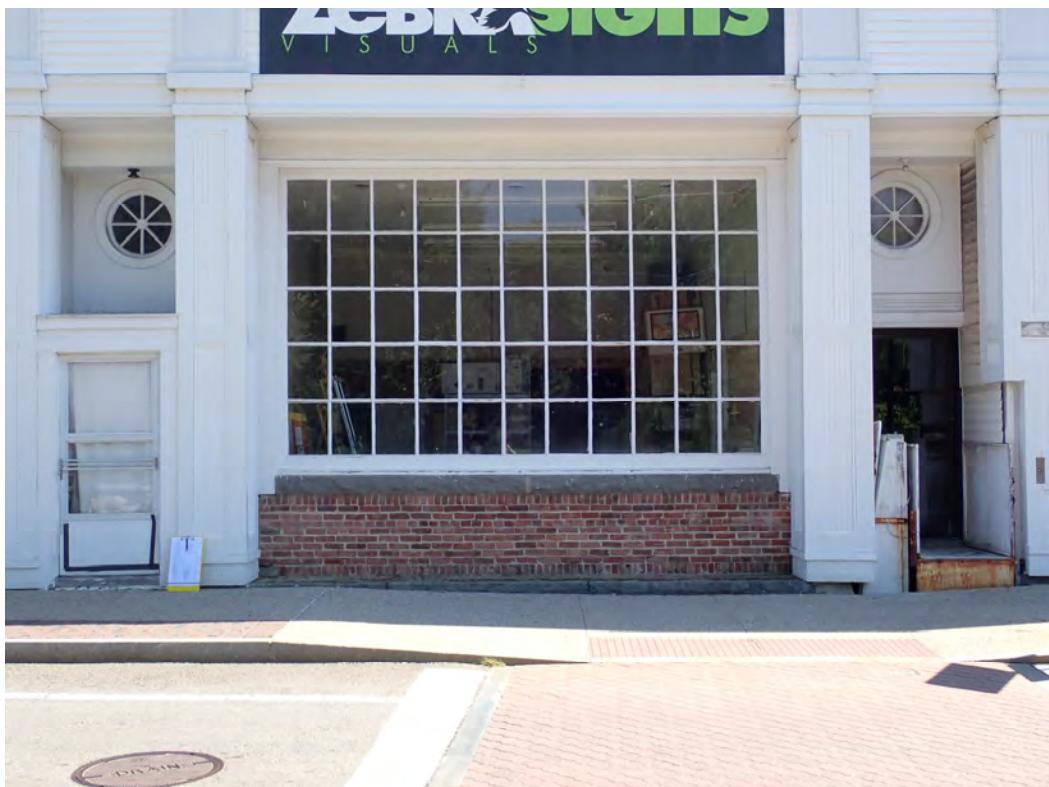
Figure 15: Wood windows dating to 1940's, including central bay window and side circular windows.

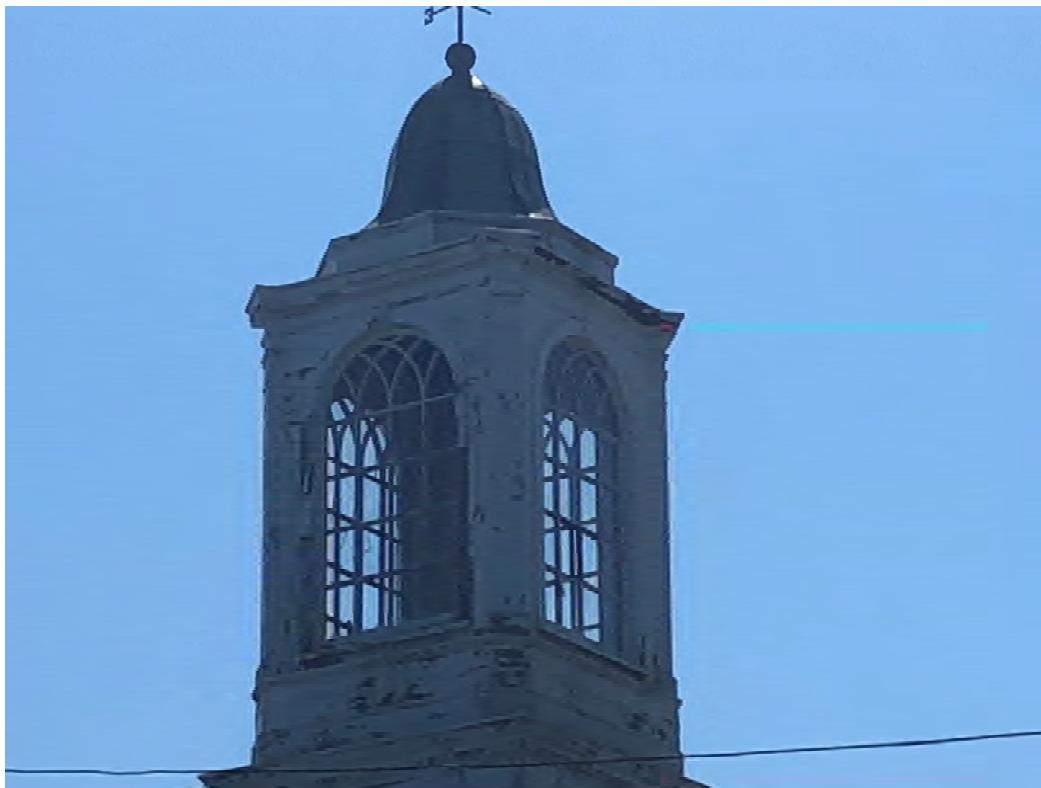
Figure 16: Original 1940's arched wood windows in the cupola.

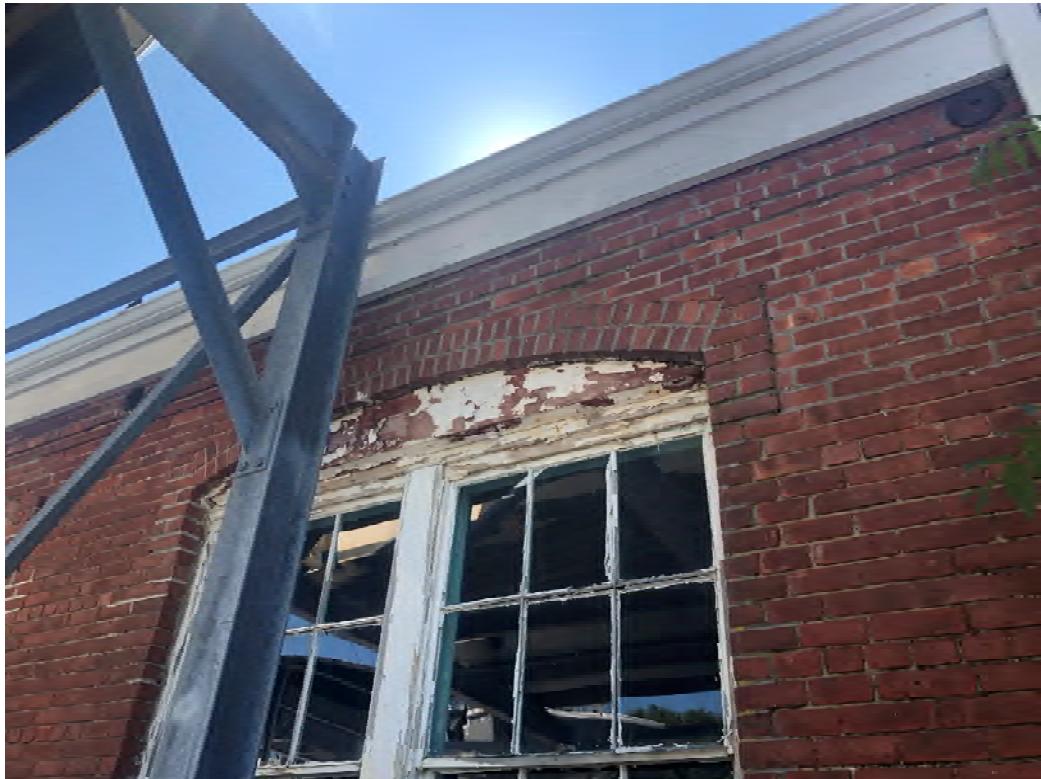
Figure 17: 2nd window bay of north elevation, original wood window that may predate 1940's work.

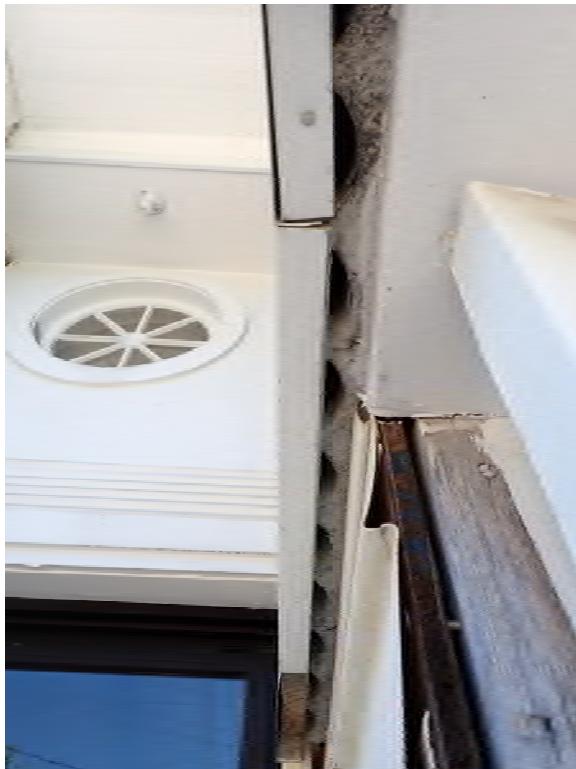
Most of the decorative wood trim elements that date to the 1940's modifications as the Shiretown Ford car dealership are largely covered by aluminum siding. It is possible that much of the trim work is intact beneath the siding. This is evident where some of the underlying original wood trim is visible under the siding or remains exposed (Figures 19,20). The 1940's wood trim included fluted pilasters, cornices, paneling and a paneled wood pediment at the roof. The concave corners of the building were simply wood paneled with a large garage door opening presumably for car entry. These details are noted in a 1940's photograph (Figure 21). The aluminum siding should be removed, existing wood details be restored, and those that are missing or deteriorated beyond repair replicated in new wood.

Figure 19: West elevation, evidence of original wood fluted pilaster beneath aluminum siding.

- Restore cupola wood cladding and trim, assuming 20% replacement of wood elements
- Remove 100% existing aluminum siding and trim
- Assess underlying original wood siding and trim; restore 75% of wood elements; replicate and install 25% new wood elements where missing or damaged

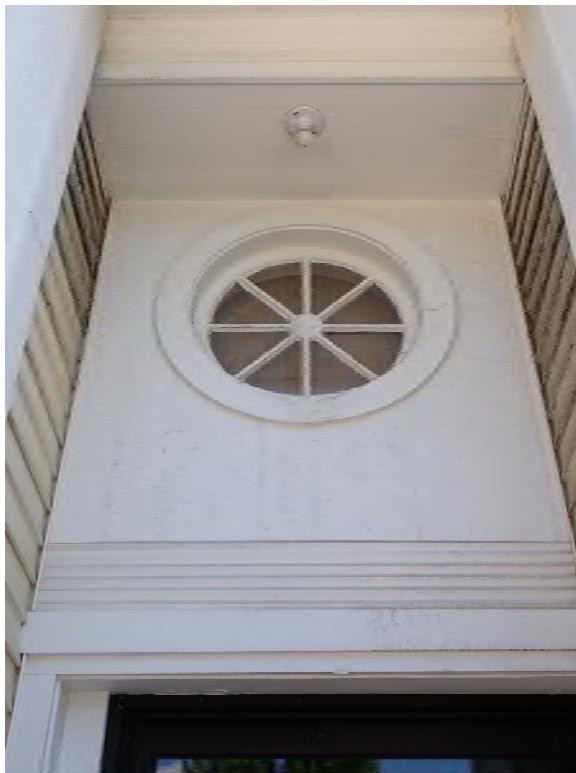
Figure 20: West elevation, 1940's window and surrounding wood paneling intact.

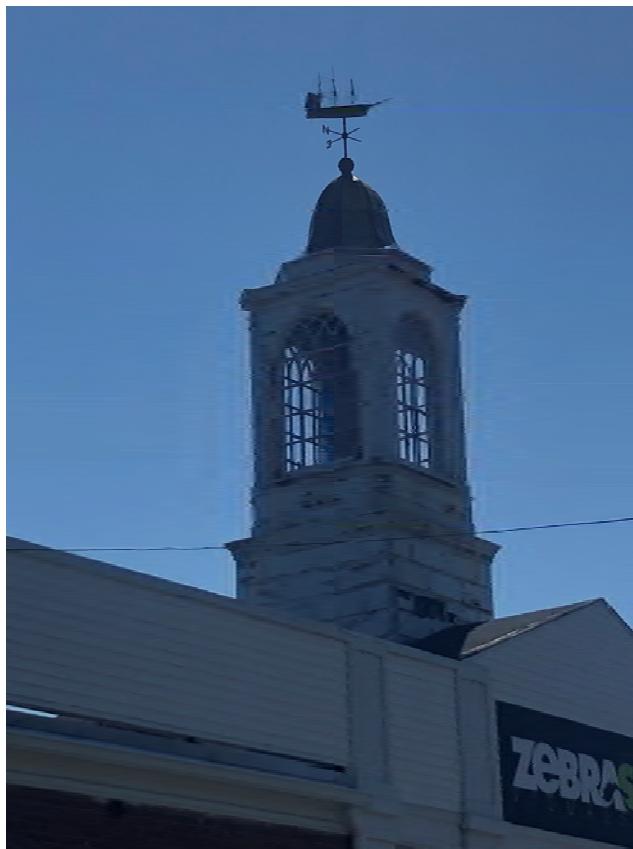
The wood cupola was erected as part of the 1940's work and has not been modified. It is in fair to good condition, suffering primarily from weathering and peeling paint. There are a limited number of wood elements that will require replacement. The bell shaped copper roof is deteriorating and has expended its useful life and should be replaced (Figure 22).

Figure 22: 1940's cupola, primarily intact but quite weathered.

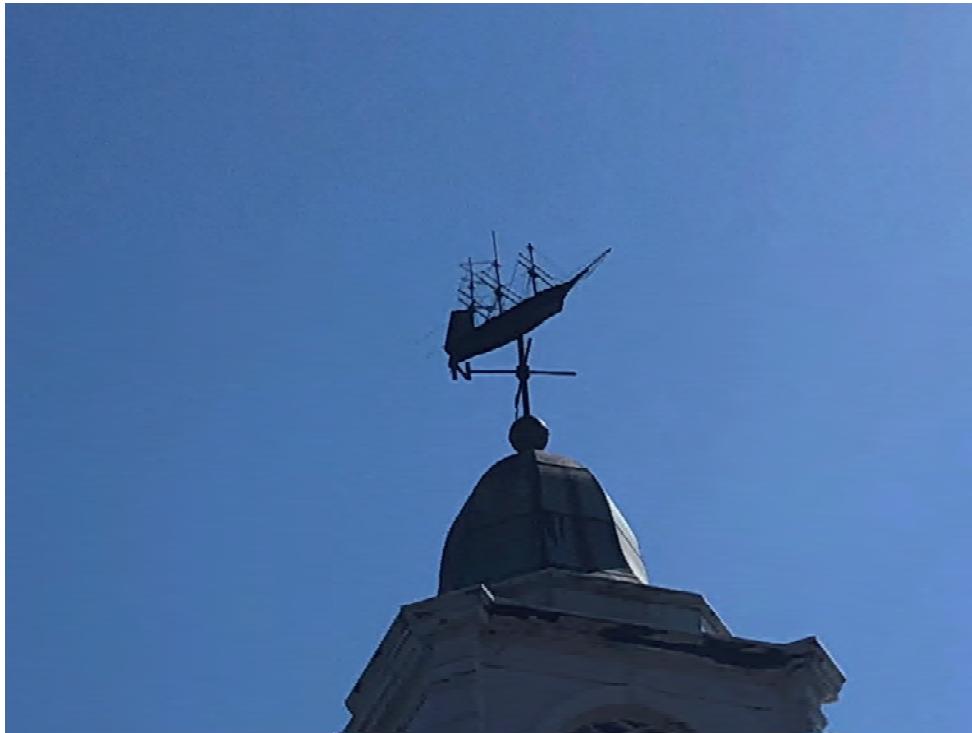
The weathervane is in generally good condition, however it is missing the "S" and "W" directional letters. The ship that tops the weathervane is quite detailed and its components appear to be intact. There does seem to be evidence that at least the hull of the ship had been gilded. The weathervane should be removed, restored including replacement of missing parts, and regilded (Figure 23).

Figure 23: Original weathervane, missing directionals "S" and "W".

- Remove, restore and reinstall cupola weathervane, including regilding of ship and fabrication of "S" and "W" directional letters.
