Town of Plymouth, MA
Department of Public Works
Environmental Management Division

Nutrient Management Data Report
Operational Monitoring Program
Data Report for 2011

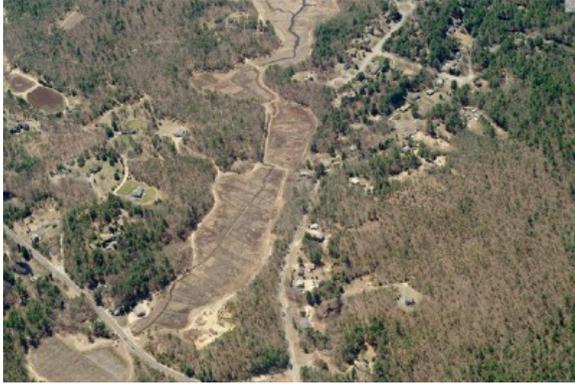
(Pre-restoration channel)

In October of 2010 the Town of Plymouth, with the assistance of State & Federal Project Partner Agencies, have completed river and wetland restoration activities in the headwaters of the Eel River, the small spring-fed system which drains into historic Plymouth Harbor. This State & Federal Listed Priority Project included dredging to construct a sinuous stream channel 1.7 miles in length to reestablish natural conditions and enhance river continuity, filling of former artificial side channels, reconstruction of a re-connected floodplain, removal of dikes and water control structures, replacement of undersized culverts at Long Pond Road and a driveway to enhance fish passage, extensive wetland plantings including 17,000 Atlantic white cedar (AWC) trees, and re-establishment of rare wetland communities. Sawmill Pond Dam site has been re-configured to allow fish passage, and a restored river channel and floodplain has been reconstructed in the existing impoundment.

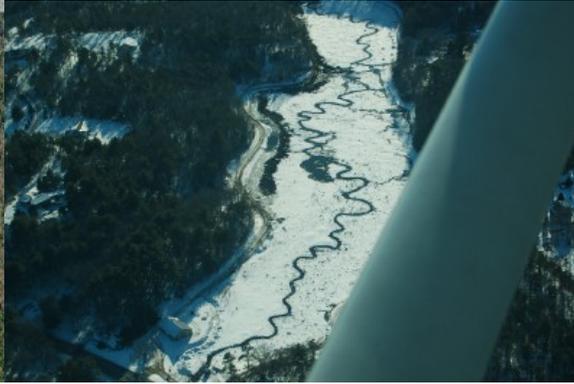
(Post-restoration channel)
