# Public Meeting

## Holmes Dam Stream Restoration

Town of Plymouth, Massachusetts | June 4, 2015

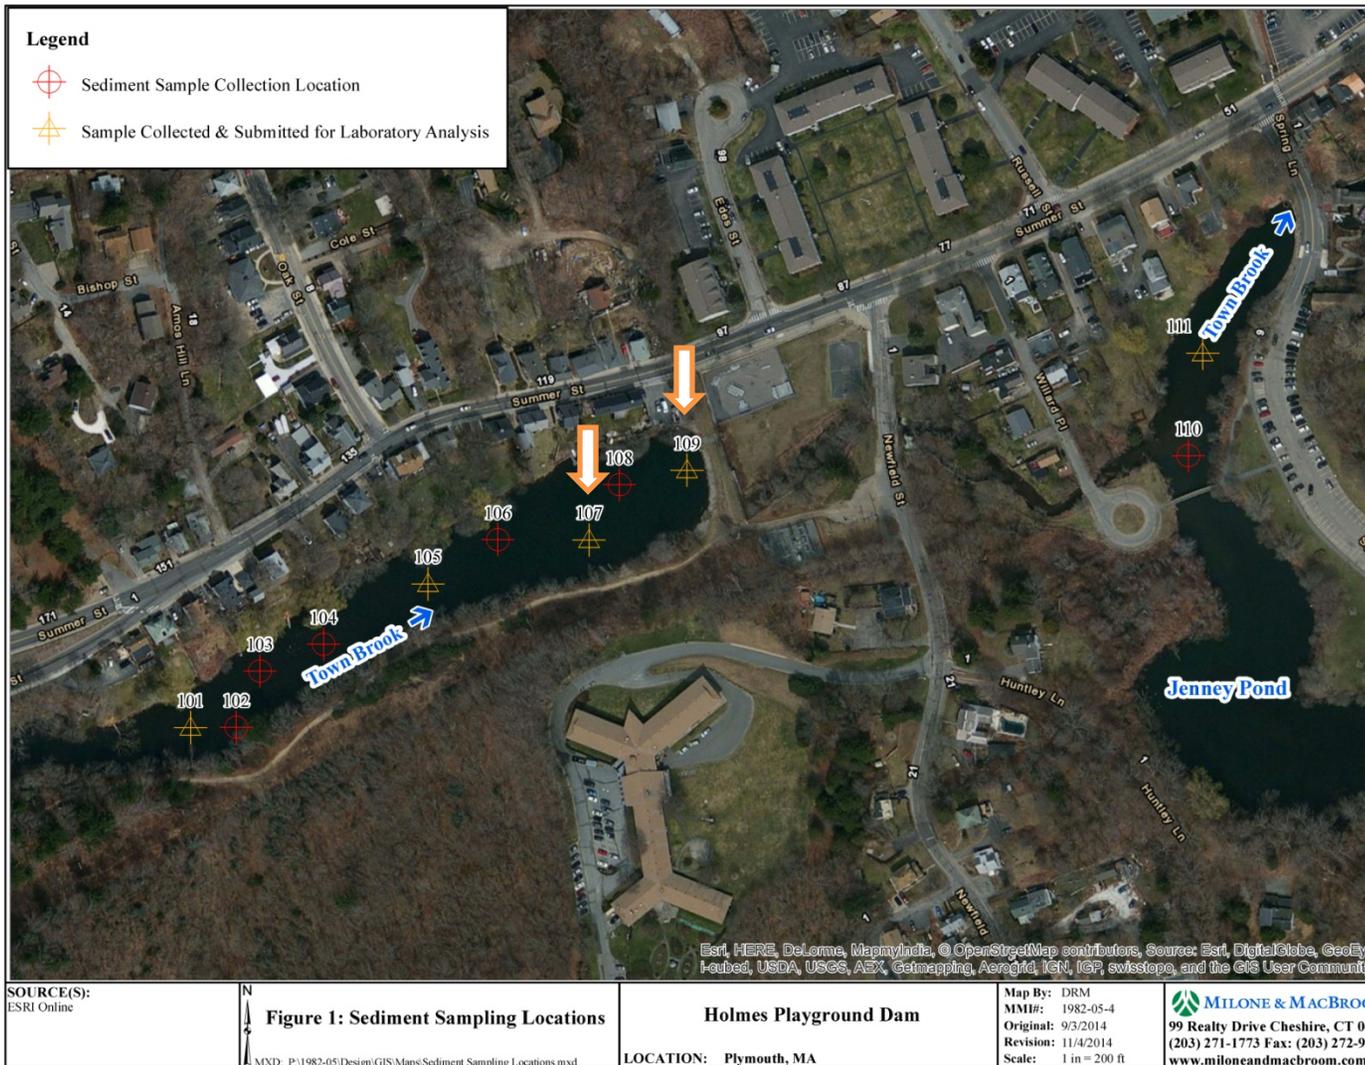
- Approximately 11,800 cubic yards of accumulated sediment in the impoundment
- 11 sediment samples collected, 5 analyzed
- Sediment contains relatively low level anthropogenic contaminants
- Sites 107 and 109 have elevated levels of contaminants, similar to upstream impoundments.

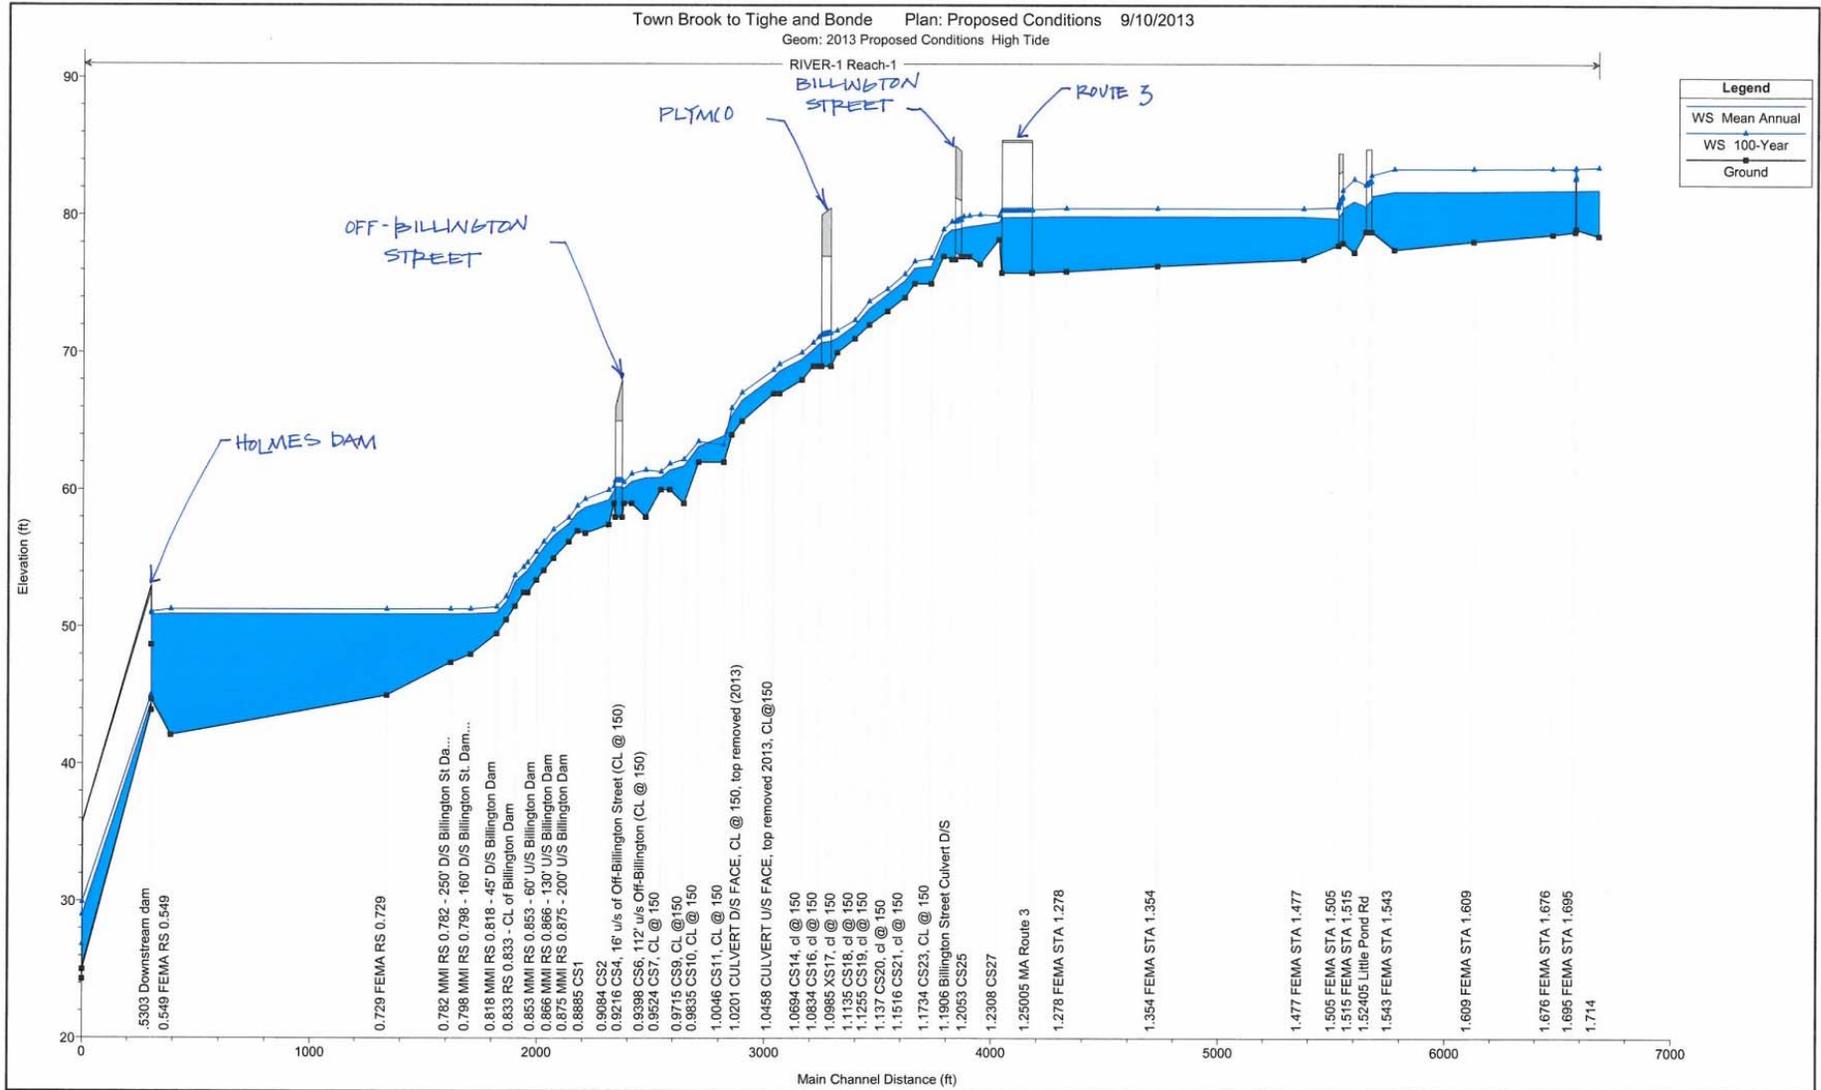
# Hydraulic Modeling

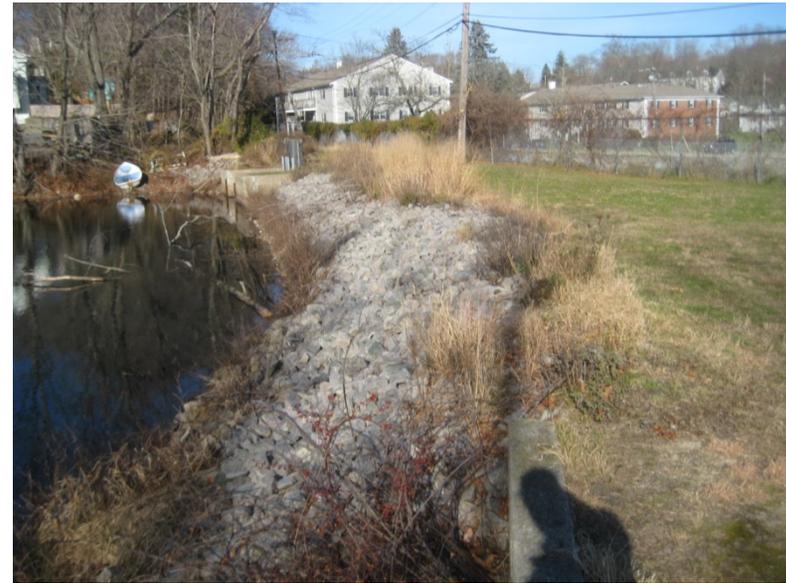
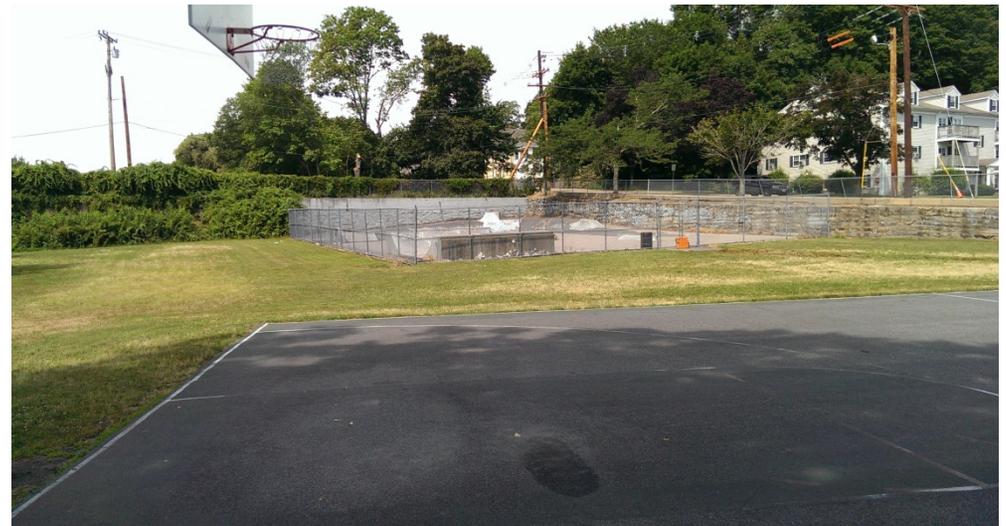
- Breach the dam through its center (approximately 110 feet of dam/spillway)
- Construct a  $\pm 24$ -foot wide channel in the location of the existing culvert
- Tie into the Newfield Street culvert
- Protect utility poles with a masonry wall or relocate
- Planting and instream features to create habitat
