Town of Plymouth, MA
Department of Marine & Environmental Affairs

Nutrient Management Data Report
Operational Monitoring Program
Data Report for 2015-2016

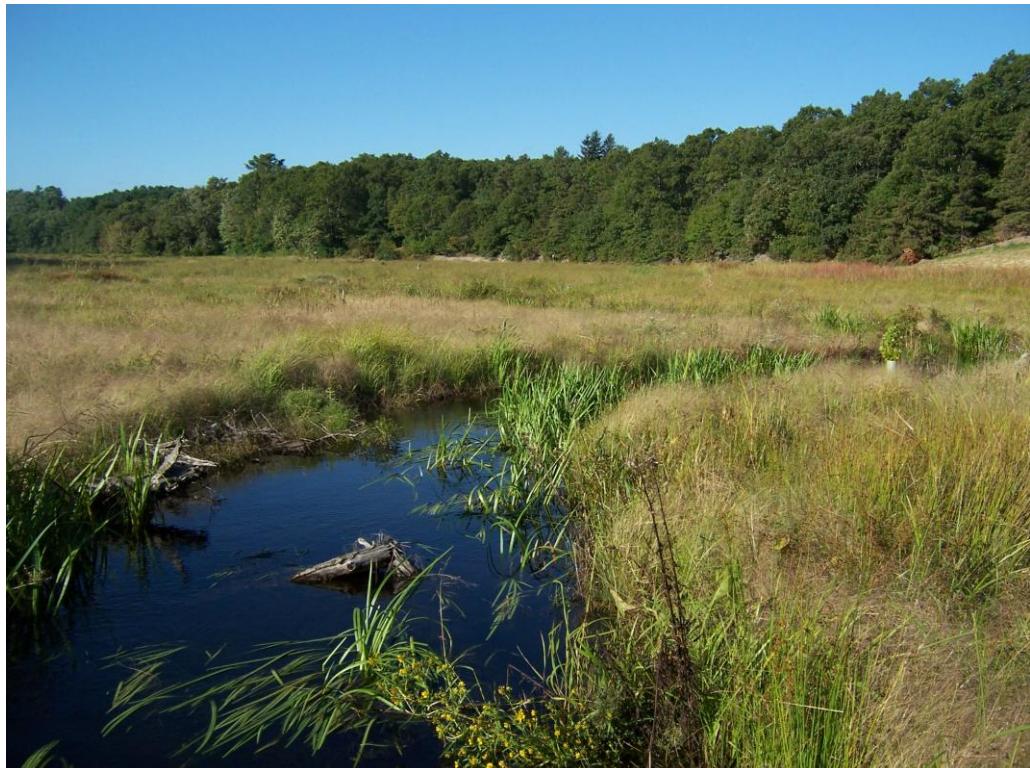
Portion of restored Eel River as part of the Eel River Headwaters Restoration Project.

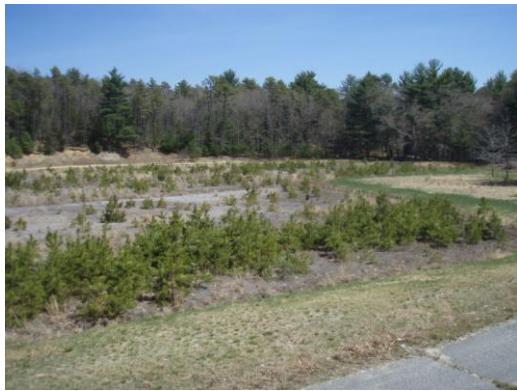
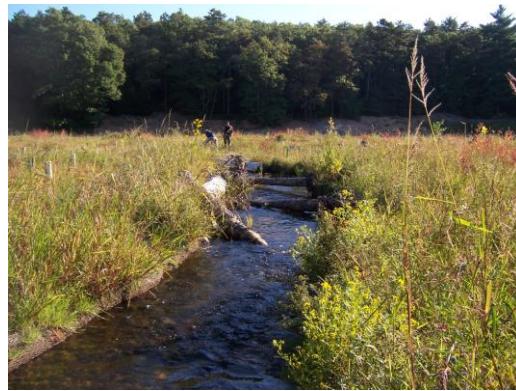
(Bog 1 pre-restoration)

(Bog 2 pre-restoration)

In October of 2010 the Town of Plymouth, with the assistance of State & Federal Project Partner Agencies, have completed river and wetland restoration activities in the headwaters of the Eel River, the small spring-fed system which drains into historic Plymouth Harbor. This State & Federal Listed Priority Project included dredging to construct a sinuous stream channel 1.7 miles in length to reestablish natural conditions and enhance river continuity, filling of former artificial side channels, reconstruction of a re-connected floodplain, removal of dikes and water control structures, replacement of undersized culverts at Long Pond Road and a driveway to enhance fish passage, extensive wetland plantings including 17,000 Atlantic white cedar (AWC) trees, and re-establishment of rare wetland communities. Sawmill Pond Dam site has been re-configured to allow fish passage, and a restored river channel and floodplain has been reconstructed in the existing impoundment.

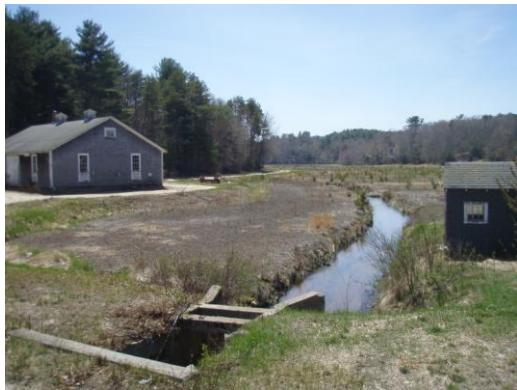
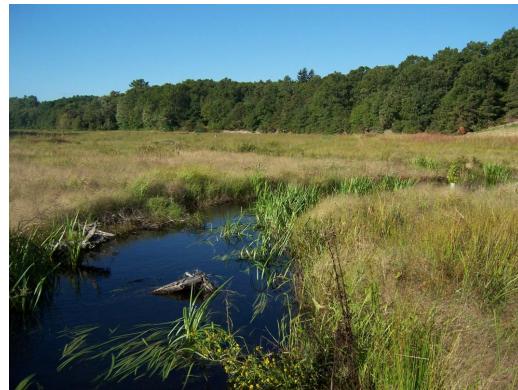
(Bog 1 post-restoration)

(Bog 2 post-restoration)

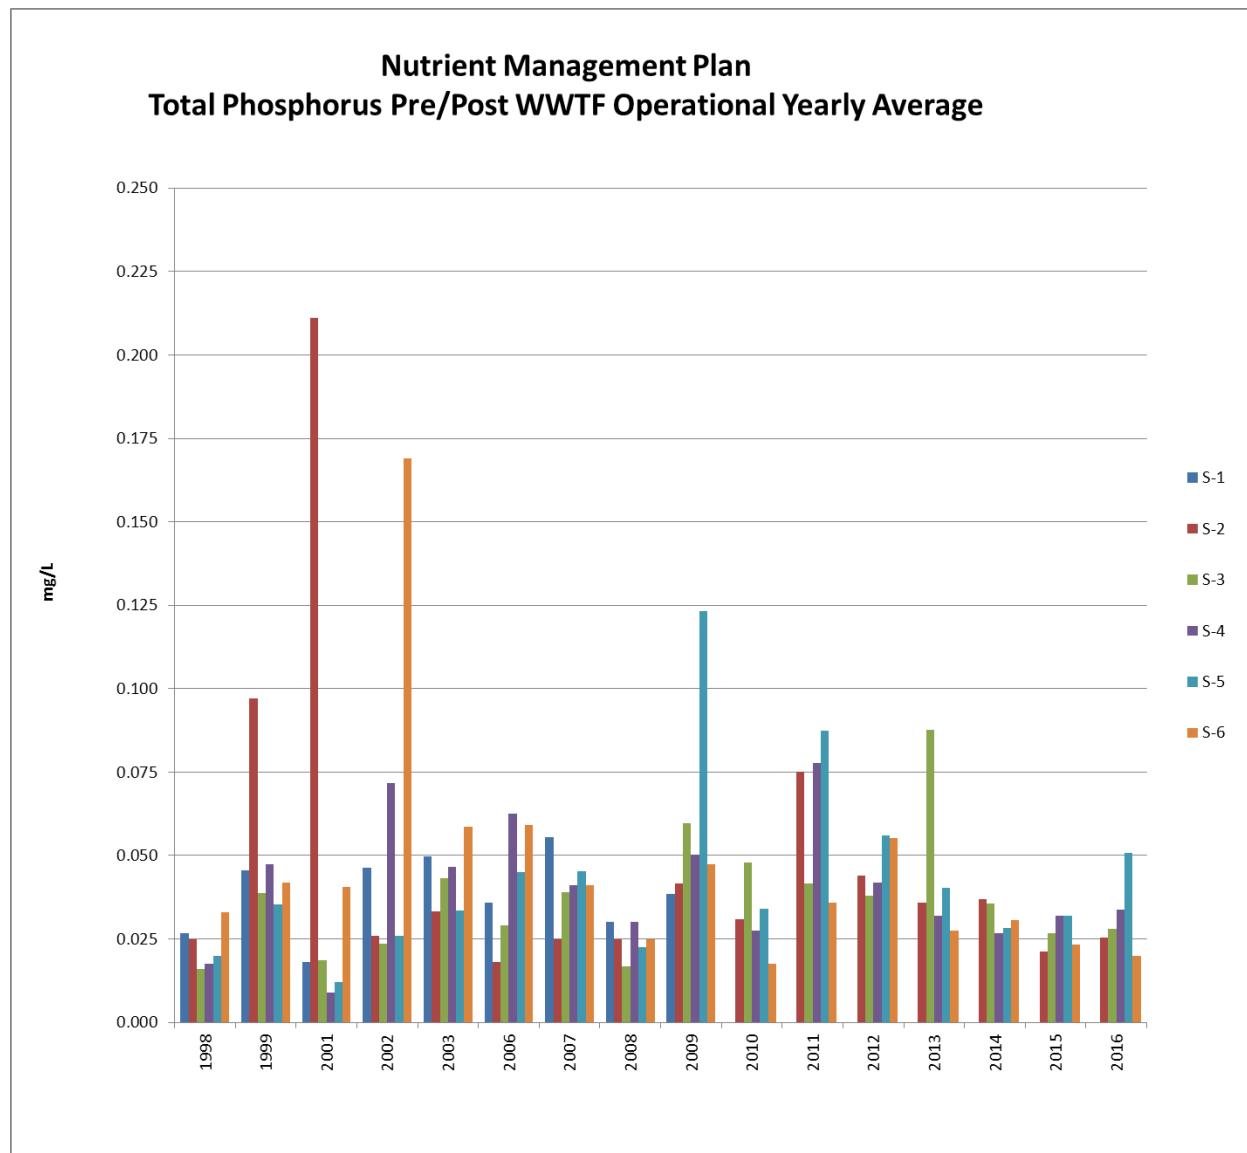
Figure 7

Below are two tables depicting the pre and post WWTF operational yearly averages for both total phosphorus and total nitrogen at surface water stations. All data was utilized for total nitrogen averages. Total phosphorus averages excluded values where the field blank had a high detection as noted in Section 2.2.3.
