Town of Plymouth, MA  
Department of Marine & Environmental Affairs

Nutrient Management Data Report  
Operational Monitoring Program  
Data Report for 2013-2014

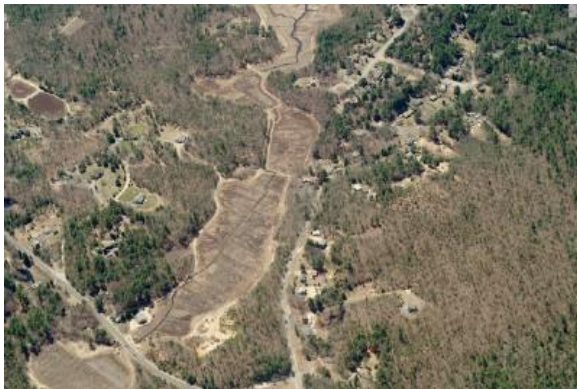
***(Pre-restoration channel)***

In October of 2010 the Town of Plymouth, with the assistance of State & Federal Project Partner Agencies, have completed river and wetland restoration activities in the headwaters of the Eel River, the small spring-fed system which drains into historic Plymouth Harbor. This State & Federal Listed Priority Project included dredging to construct a sinuous stream channel 1.7 miles in length to reestablish natural conditions and enhance river continuity, filling of former artificial side channels, reconstruction of a re-connected floodplain, removal of dikes and water control structures, replacement of undersized culverts at Long Pond Road and a driveway to enhance fish passage, extensive wetland plantings including 17,000 Atlantic white cedar (AWC) trees, and re-establishment of rare wetland communities. Sawmill Pond Dam site has been re-configured to allow fish passage, and a restored river channel and floodplain has been reconstructed in the existing impoundment.

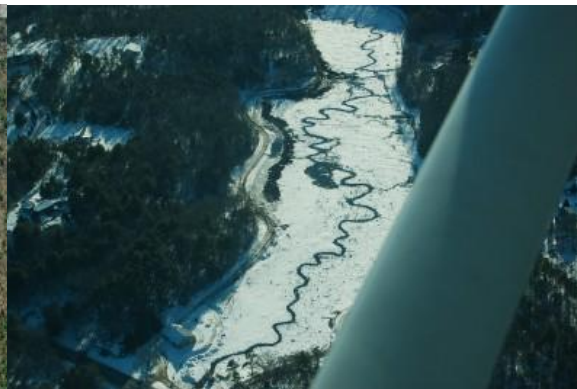
***(Post-restoration channel)***

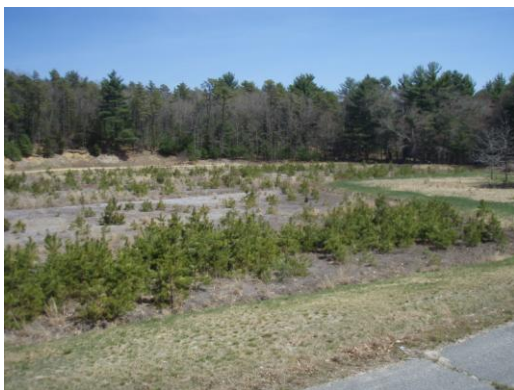
***(Bog 1 pre-restoration)***

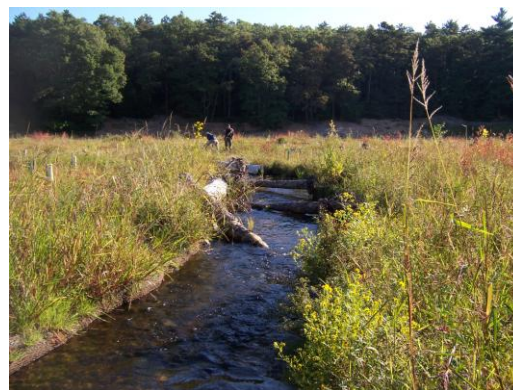
***(Bog 1 post-restoration)***

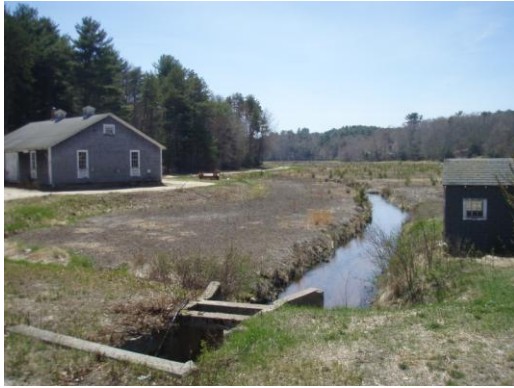
*(Bog 2 pre-restoration)*

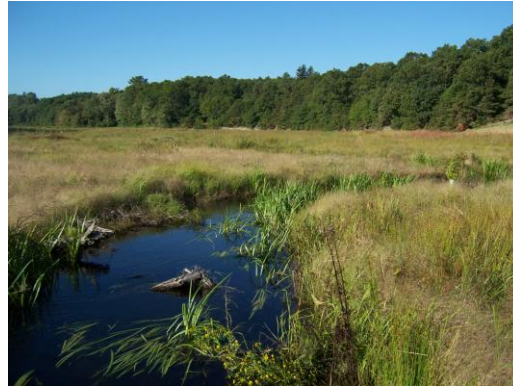
*(Bog 2 post-restoration)*
