Town of Plymouth, MA
Department of Marine & Environmental Affairs

Nutrient Management Data Report
Operational Monitoring Program
Data Report for 2018

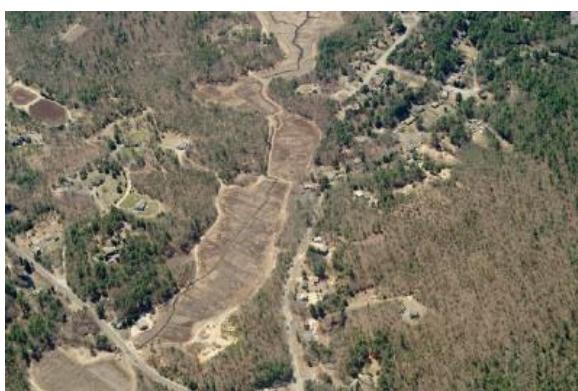
(Pre-restoration channel)

In October of 2010 the Town of Plymouth, with the assistance of State & Federal Project Partner Agencies, have completed river and wetland restoration activities in the headwaters of the Eel River, the small spring-fed system which drains into historic Plymouth Harbor. This State & Federal Listed Priority Project included dredging to construct a sinuous stream channel 1.7 miles in length to reestablish natural conditions and enhance river continuity, filling of former artificial side channels, reconstruction of a re-connected floodplain, removal of dikes and water control structures, replacement of undersized culverts at Long Pond Road and a driveway to enhance fish passage, extensive wetland plantings including 17,000 Atlantic white cedar (AWC) trees, and re-establishment of rare wetland communities. Sawmill Pond Dam site has been re-configured to allow fish passage, and a restored river channel and floodplain has been reconstructed in the existing impoundment.

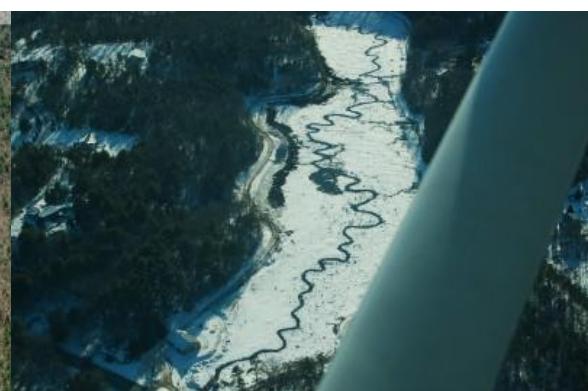
(Post-restoration channel)
