Town of Plymouth, MA  
Department of Marine & Environmental Affairs

Nutrient Management Data Report  
Operational Monitoring Program  
Data Report for 2020

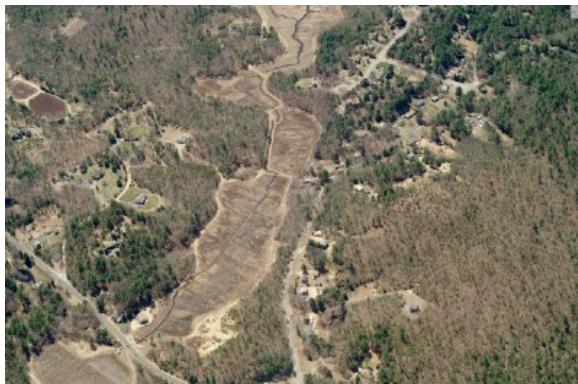
In October of 2010 the Town of Plymouth, with the assistance of State & Federal Project Partner Agencies, have completed river and wetland restoration activities in the headwaters of the Eel River, the small spring-fed system which drains into historic Plymouth Harbor. This State & Federal Listed Priority Project included dredging to construct a sinuous stream channel 1.7 miles in length to reestablish natural conditions and enhance river continuity, filling of former artificial side channels, reconstruction of a re-connected floodplain, removal of dikes and water control structures, replacement of undersized culverts at Long Pond Road and a driveway to enhance fish passage, extensive wetland plantings including 17,000 Atlantic white cedar (AWC) trees, and re-establishment of rare wetland communities. Sawmill Pond Dam site has been re-configured to allow fish passage, and a restored river channel and floodplain has been reconstructed in the existing impoundment.

*(Pre-restoration channel)*

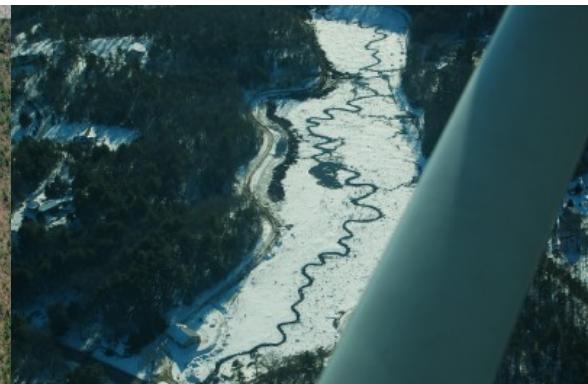
*(Post-restoration channel)*

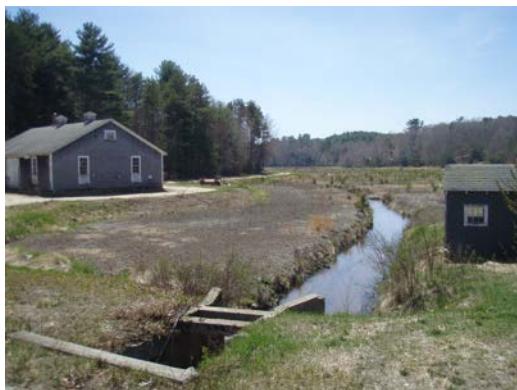
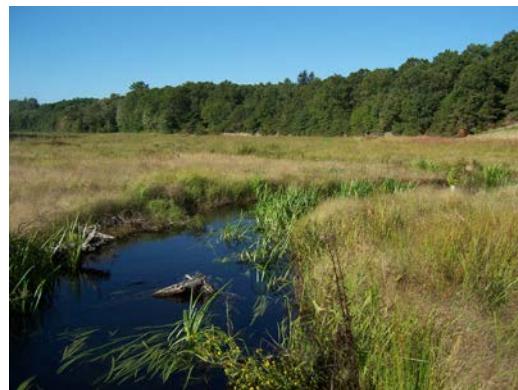
*(Bog 1 post-restoration)*

*(Bog 2 post-restoration)*
