Town of Plymouth, MA  
Department of Energy and Environment

Nutrient Management Data Report  
Operational Monitoring Program  
Data Report for 2024

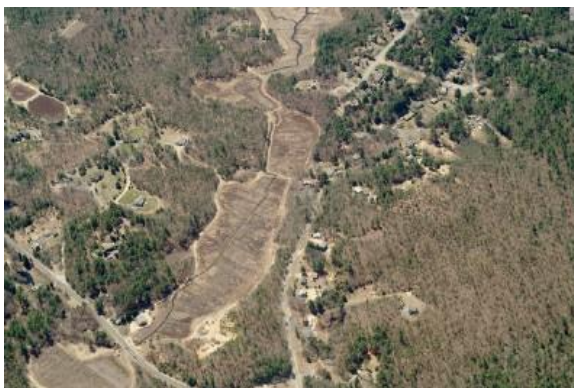
***(Pre-restoration channel)***

In October of 2010 the Town of Plymouth, with the assistance of State & Federal Project Partner Agencies, have completed river and wetland restoration activities in the headwaters of the Eel River, the small spring-fed system which drains into historic Plymouth Harbor. This State & Federal Listed Priority Project included dredging to construct a sinuous stream channel 1.7 miles in length to reestablish natural conditions and enhance river continuity, filling of former artificial side channels, reconstruction of a re-connected floodplain, removal of dikes and water control structures, replacement of undersized culverts at Long Pond Road and a driveway to enhance fish passage, extensive wetland plantings including 17,000 Atlantic white cedar (AWC) trees, and re-establishment of rare wetland communities. Sawmill Pond Dam site has been re-configured to allow fish passage, and a restored river channel and floodplain has been reconstructed in the existing impoundment.
