Plymouth Foundry

Safe Harbor Marinas
Plymouth, Massachusetts

Exterior Conditions and Treatment Recommendations

September 8, 2022

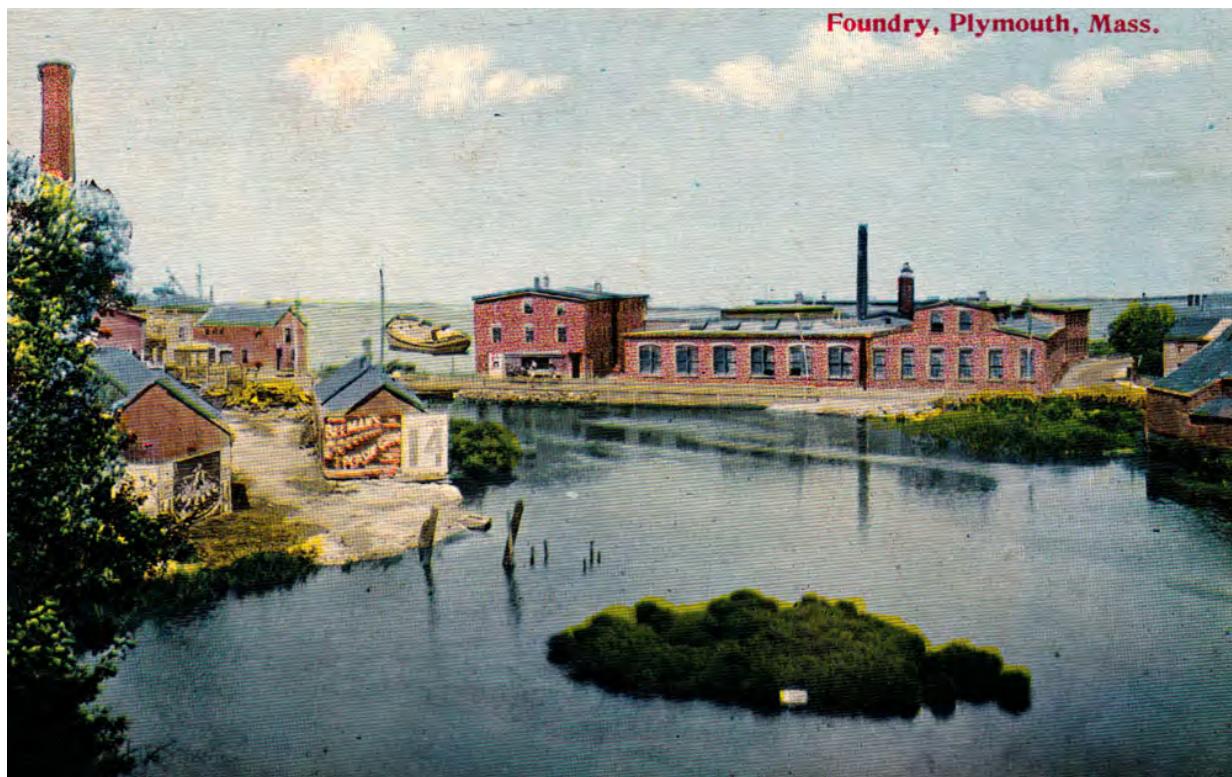
With the exception of the original wood windows mentioned above, all windows are aluminum replacement that somewhat replicate the original windows in configuration. One original wood window remains on the second bay in on the north elevation (Figure 17). This window is in restorable condition. Interestingly, peeling paint on the wood reveals the possibility of an earlier paint scheme, prior to the 1940's and potentially dates to 1900; the arched infill above the window sash shows as dark red and the window sash is dark green. This dark green sash is depicted in an early illustration of the building prior to the 1940's work (Figure 18).

Figure 18: Illustration of foundry, date unknown, pre-1940's reconfiguration. Note dark color of window sash. Date, source; unknown.

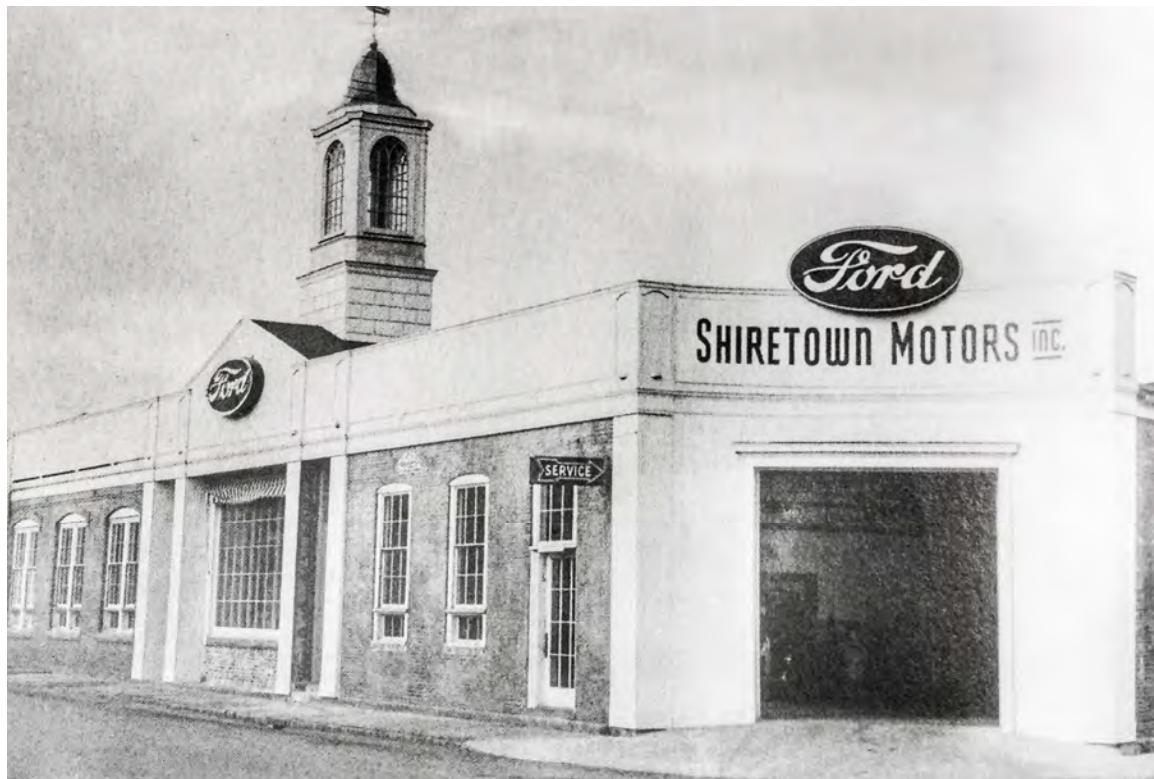
Figure 21: Car dealership photograph, circa 1940's. Source unknown.
