**EXECUTIVE OFFICE OF ENERGY AND ENVIRONMENTAL AFFAIRS
DAM, LEVEE AND SEAWALL REPAIR AND REMOVAL**

PROJECT TITLE:	Design and Permitting for Long Beach Seawall	STATE ID #	#057-039-000-010B-100	
LOCATION COORDINATES:	Latitude	42° 56' 36"	Longitude	-70° 37' 07"

**EXECUTIVE OFFICE OF ENERGY AND ENVIRONMENTAL AFFAIRS
DAM, LEVEE AND SEAWALL REPAIR AND REMOVAL:
APPLICATION FOR FUNDING – DESIGN AND PERMIT
RESPONSE PROPOSAL**

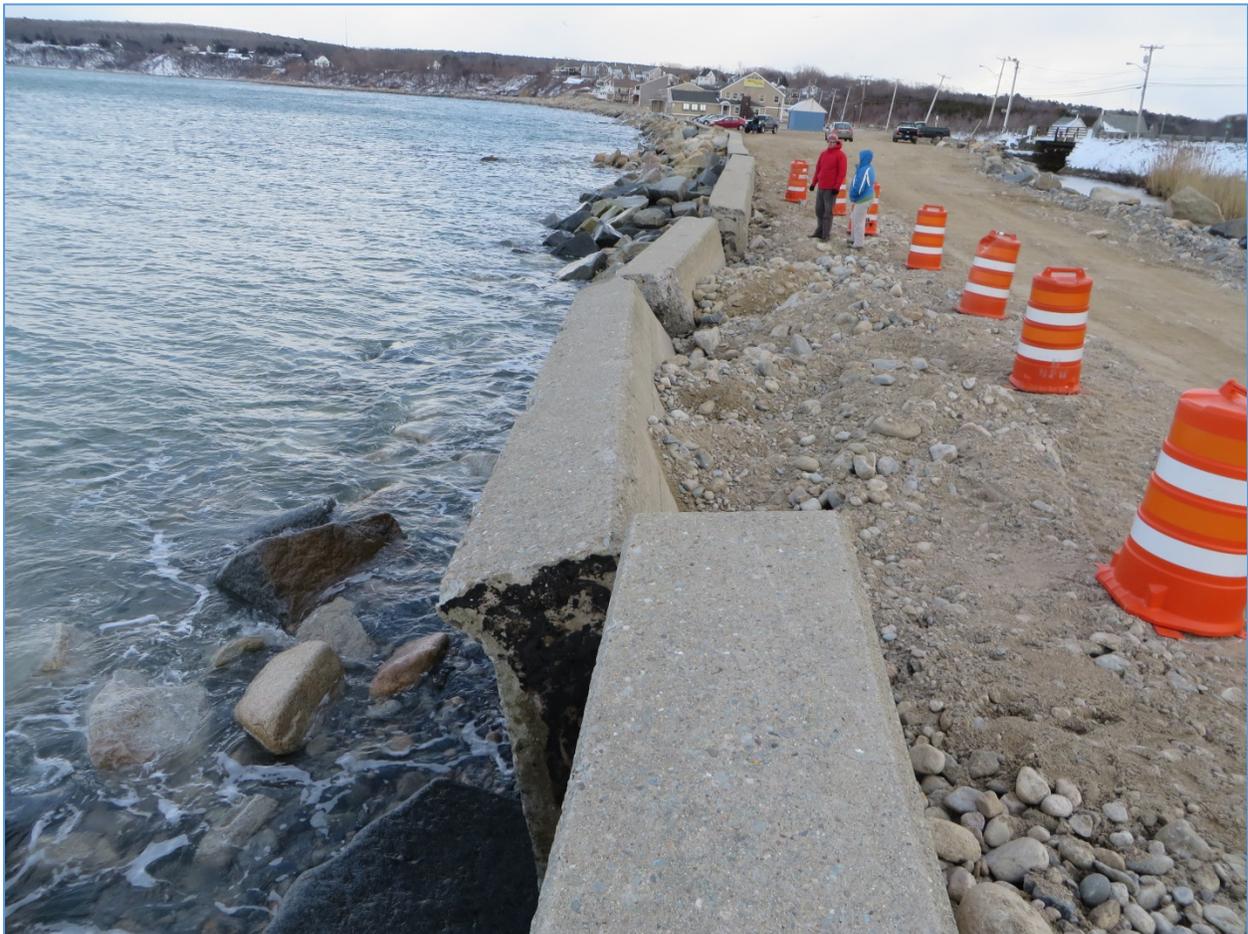
Figure 2. Failed section of seawall following a moderate nor'easter in February 2016 (view towards the south).

The low lying landform at the south end of Plymouth Beach has experienced wave overtopping during severe storm events. Recently, the series of severe northeast storms over the 2012-2013 winter season. Damage during a Nor'easter in January 2013 is typical of problems at Plymouth Beach after storms. During this event Route 3A had to be closed due to flooding and waves overtopping the seawall washed sand and gravel into the Eel River. It took five days to dredge out the river with a large backhoe. The dredged material is typically put back on the parking lot area and used in reconstruction of the parking area. Dredging is done under emergency permits. Storm damage and the failure of an approximate 200-foot length of seawall after a February 2015 nor'easter is documented in Figures 2 and 3.

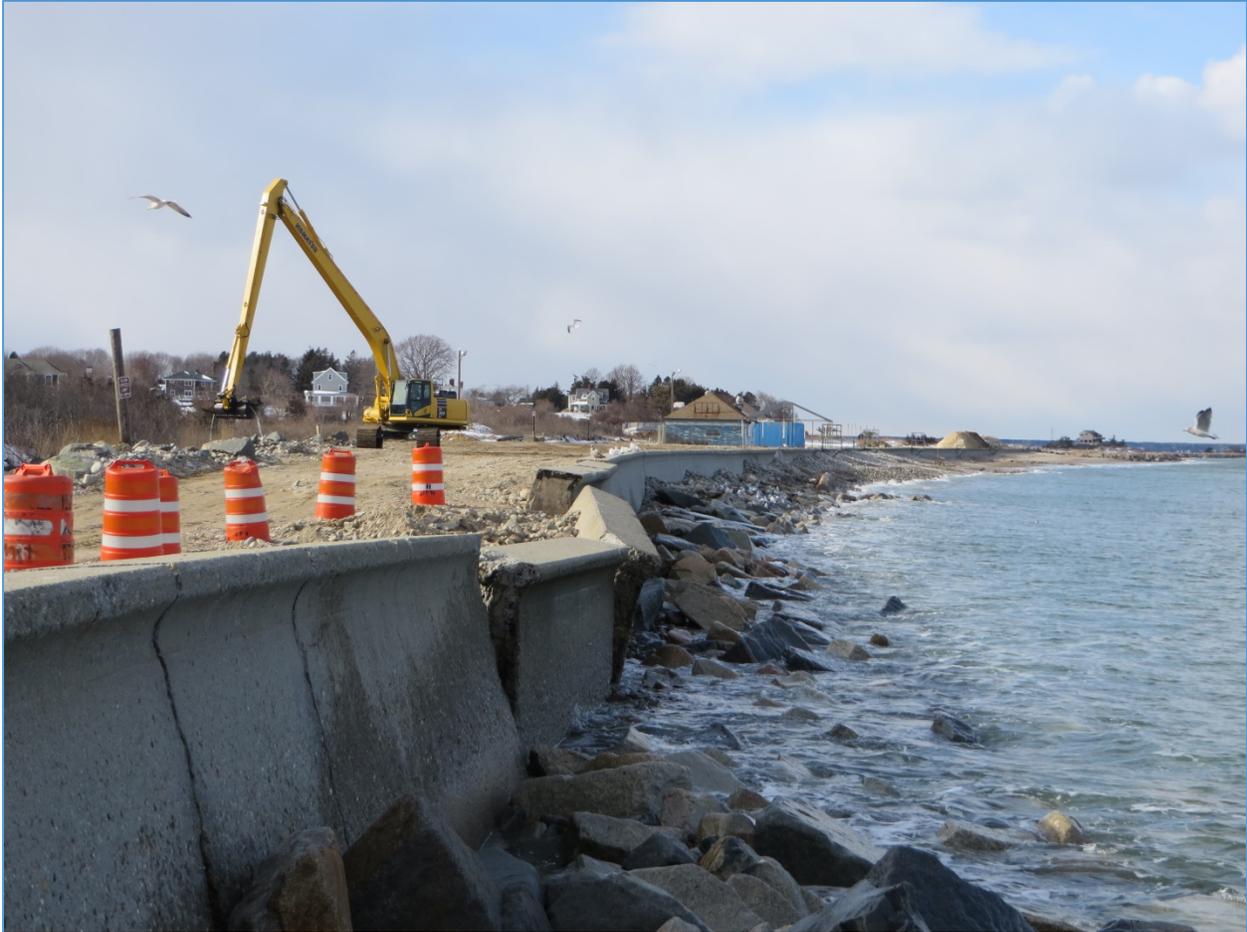
Figure 3. Failed section of seawall following a moderate nor'easter in February 2016 (view towards the north). Excavation equipment is shown in the background performing emergency dredging of the Eel River blockage.

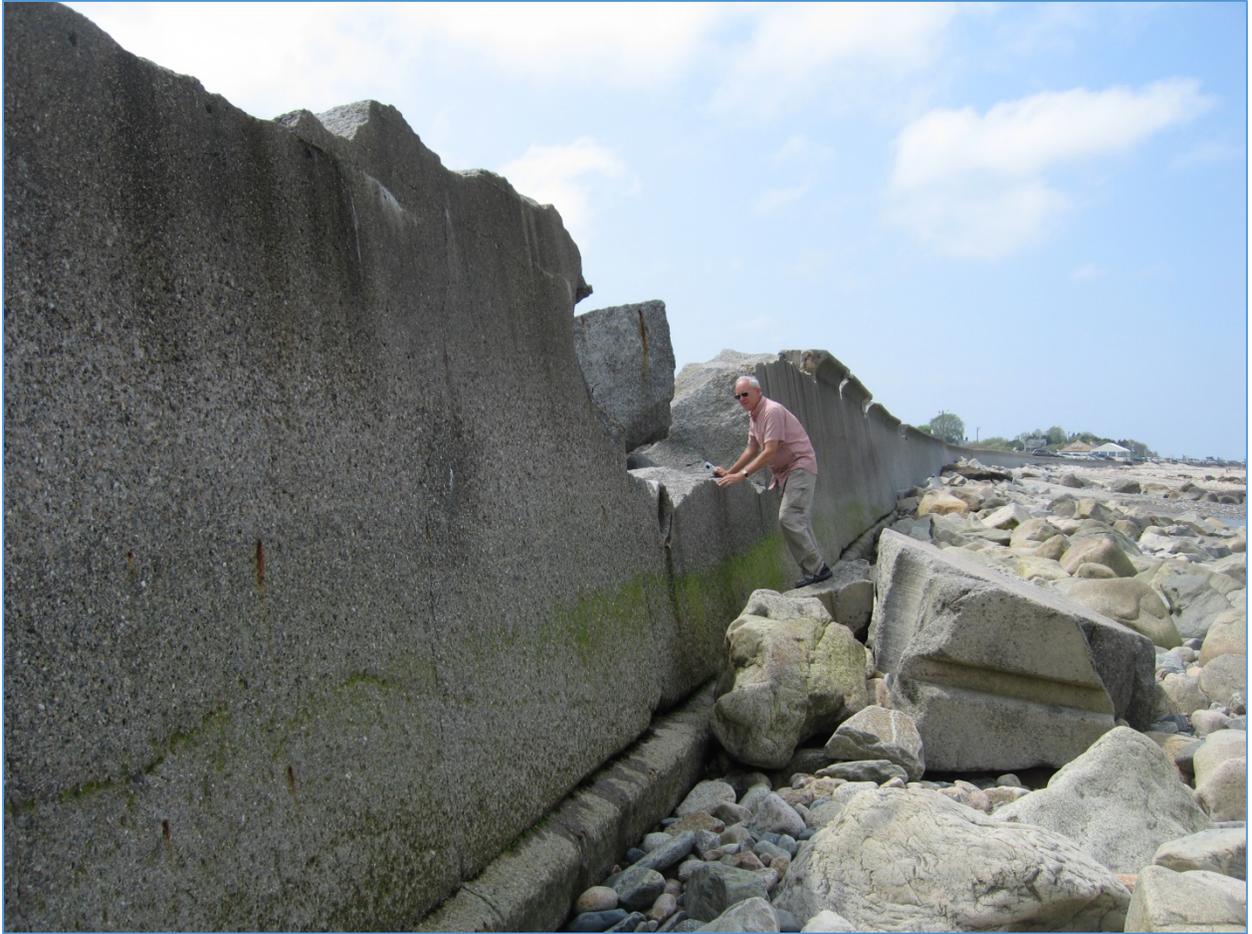
Figure 4. Failed section of seawall following a moderate nor'easter in early 2011 showing area that had been sheared off from the top of the seawall. This portion of seawall had the cap re-cast in late 2011, as part of emergency repairs.

Although much of the 900-foot seawall section that is the subject of this proposal has remained intact, numerous repairs to both the fronting revetment and seawall have been required over the past 10 years, including re-casting portions of the wall that have sheared off (see Figure 4), placement of flowable fill and revetment construction to prevent wall undermining/failure (see Figure 5), and emergency placement of boulders against failed sections of the seawall to prevent collapse.

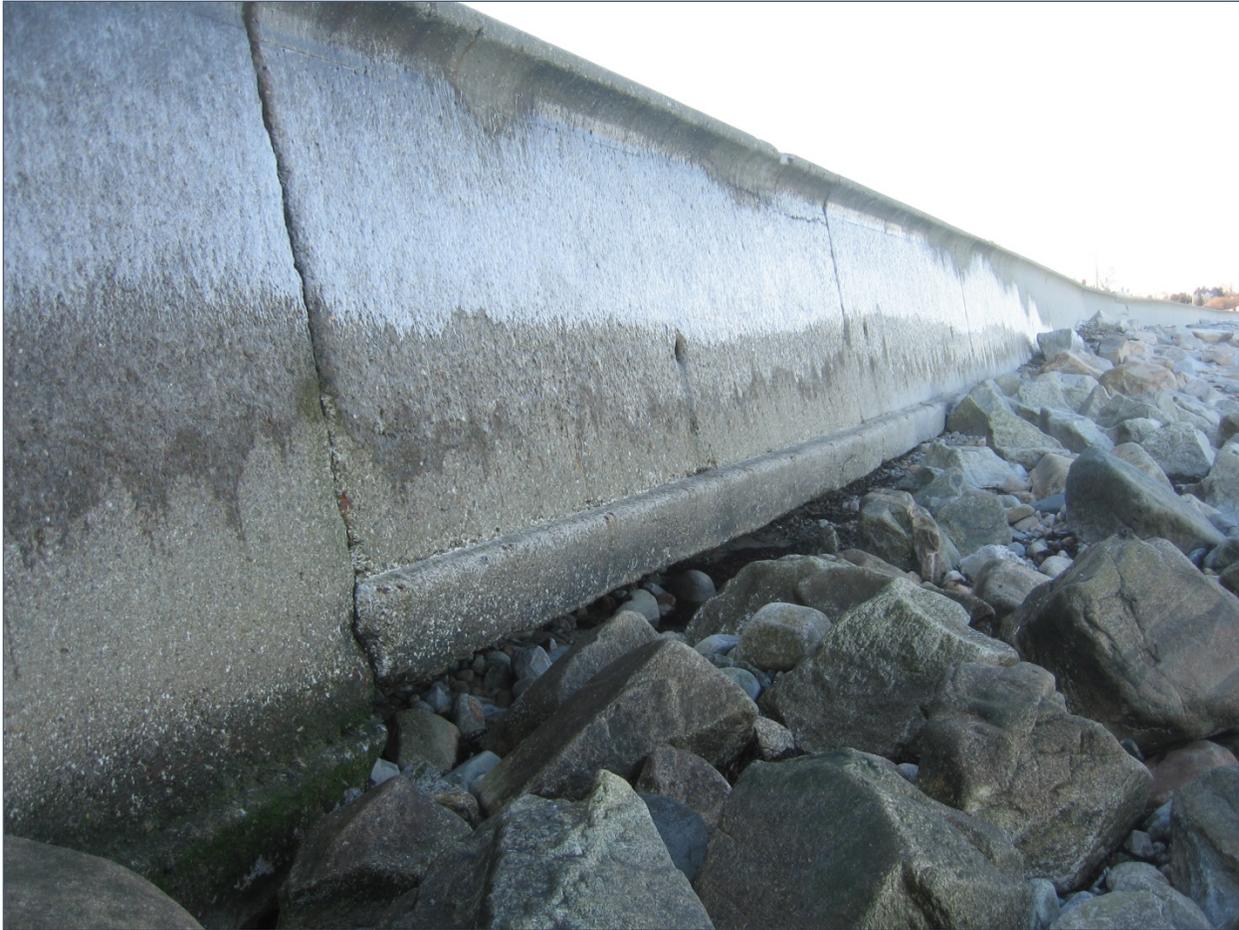
Figure 5. Undermining of seawall as beach erosion causes lowering of the seaward beach profile and exposing the foundation. This undermining required emergency repairs in 2009.

Due to the condition of the seawall and the demonstrated structural failures over the past decade, it is clear that the structure has exceeded its serviceable life. Emergency work in 2009 was performed to prevent undermining of the seawall. In 2011, the Town of Plymouth performed emergency repairs to the upper half of the seawall and reconstructed the revetment along an approximate 100-foot section near the southern limits of the proposed project. However, based on more recent failures, the structural integrity of the seawall along this entire ±900-foot section is compromised and requires replacement.
