SIMES HOUSE – RECOMMENDED TREATMENT STANDARDS

HISTORIC STRUCTURE REPORT & LANDSCAPE PRESERVATION PLAN

Agricola Corp.
Red Hawk Studio Architects, Inc.
Martha Lyon Landscape Architecture, LLC

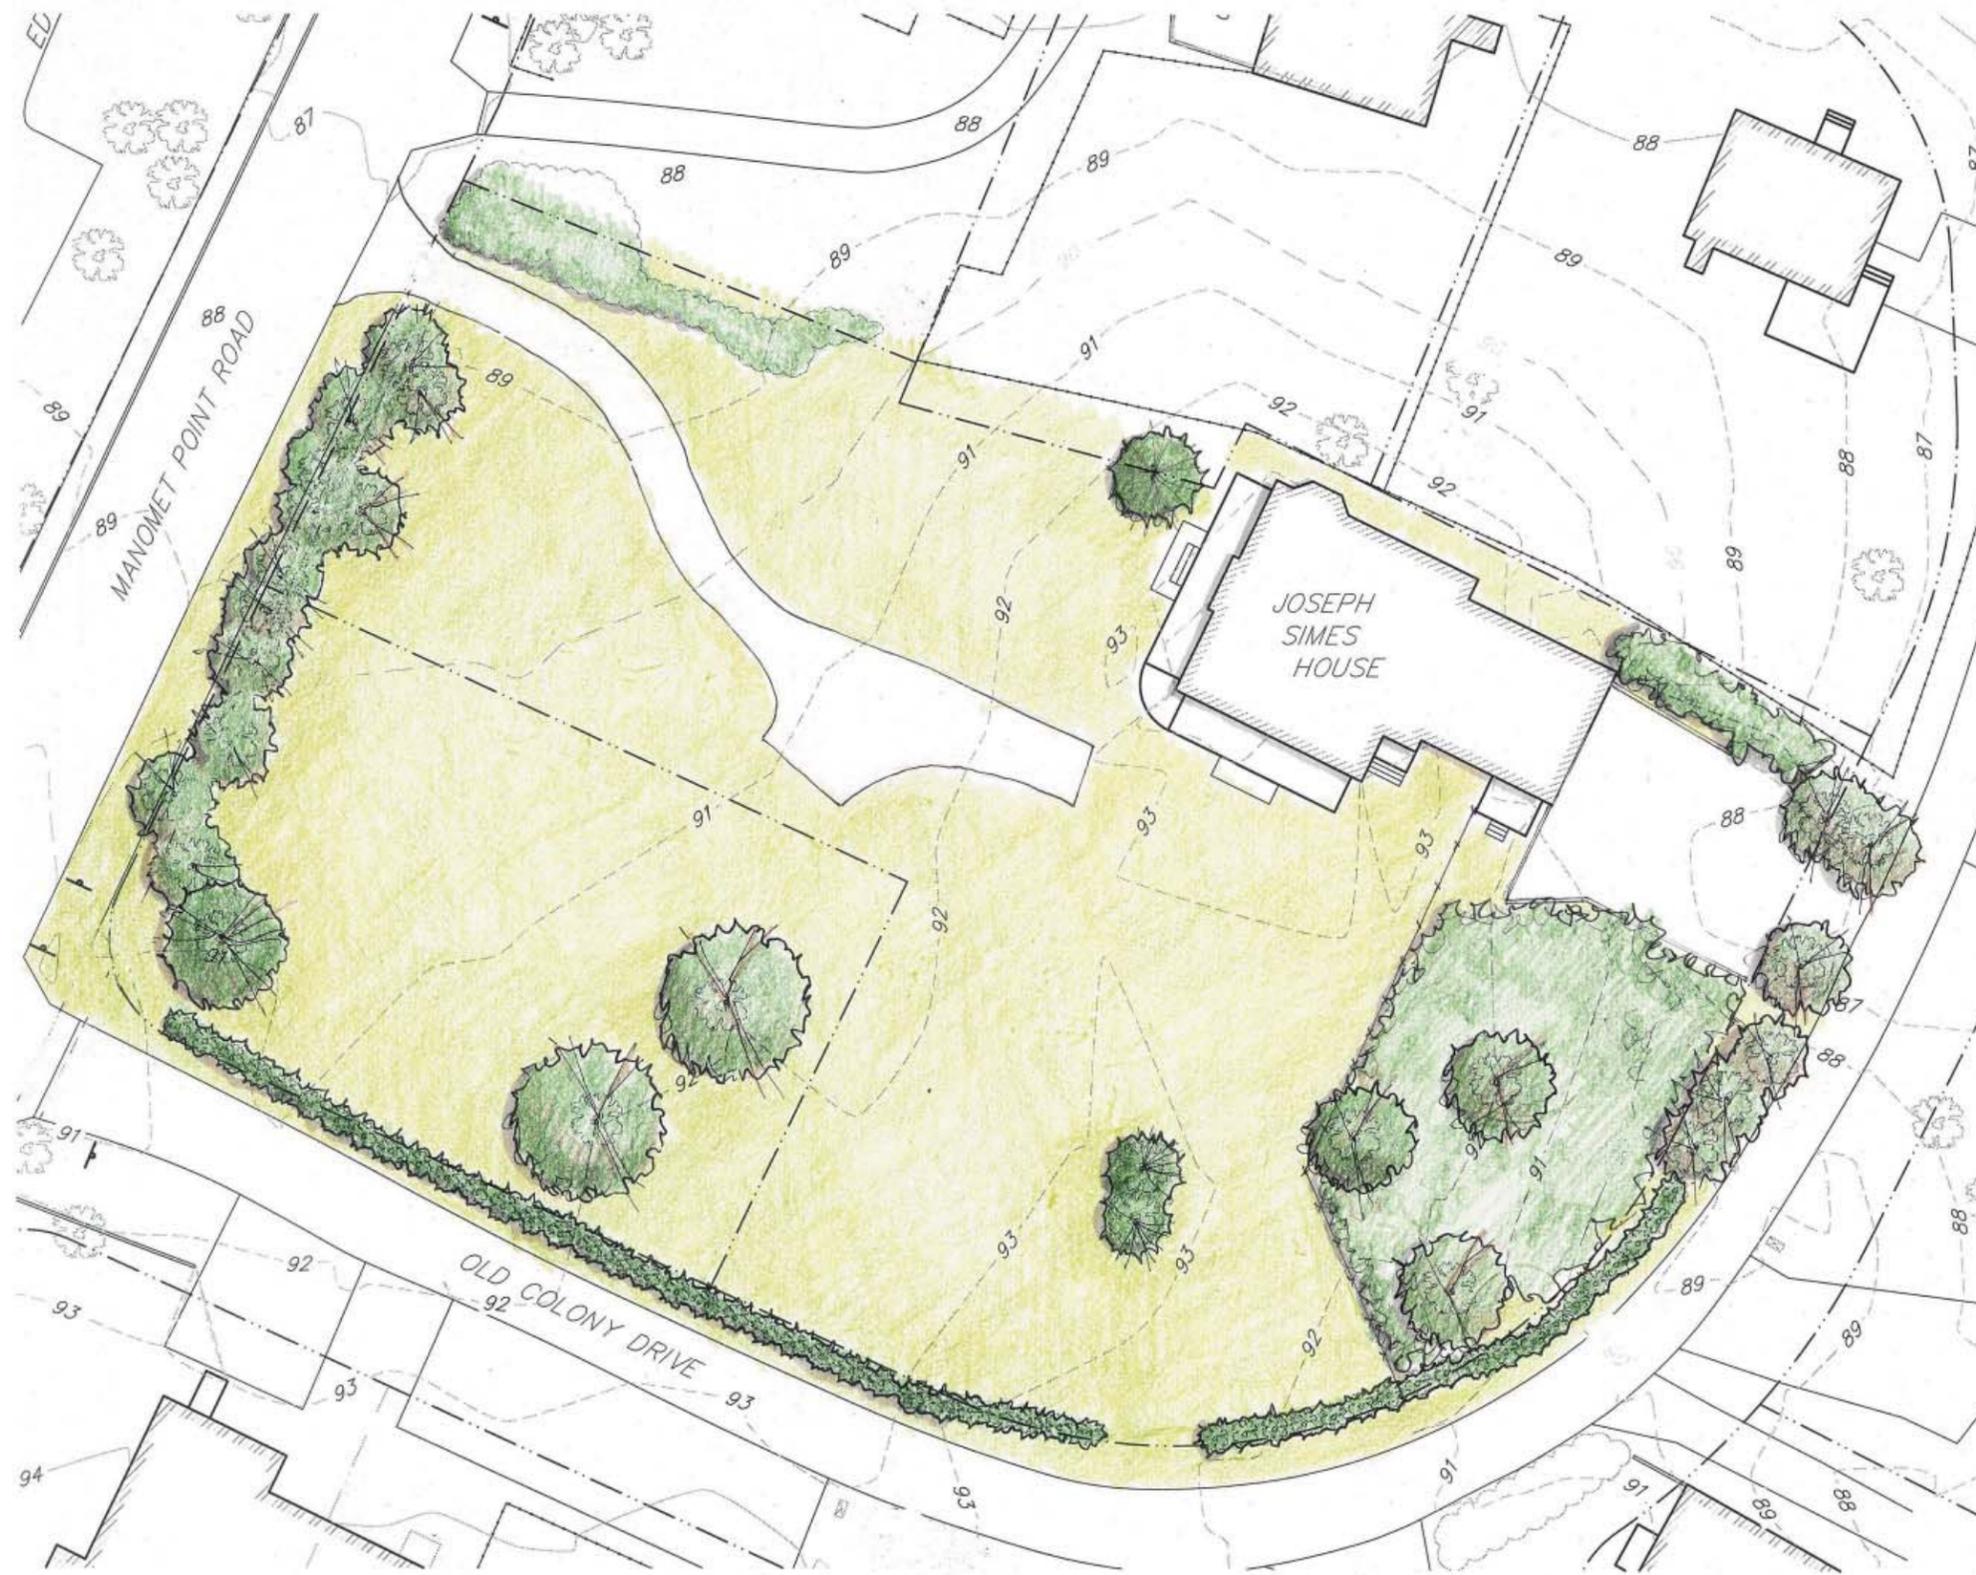
Existing conditions information derived from "EXISTING CONDITIONS PLAN IN PLYMOUTH, MA," prepared on January 19, 2012 by Bracken Engineering, 49 Herring Point Road, Buzzards Bay, MA. Martha Lyon Landscape Architecture, LLC makes no claim to the accuracy of the data found on this plan.

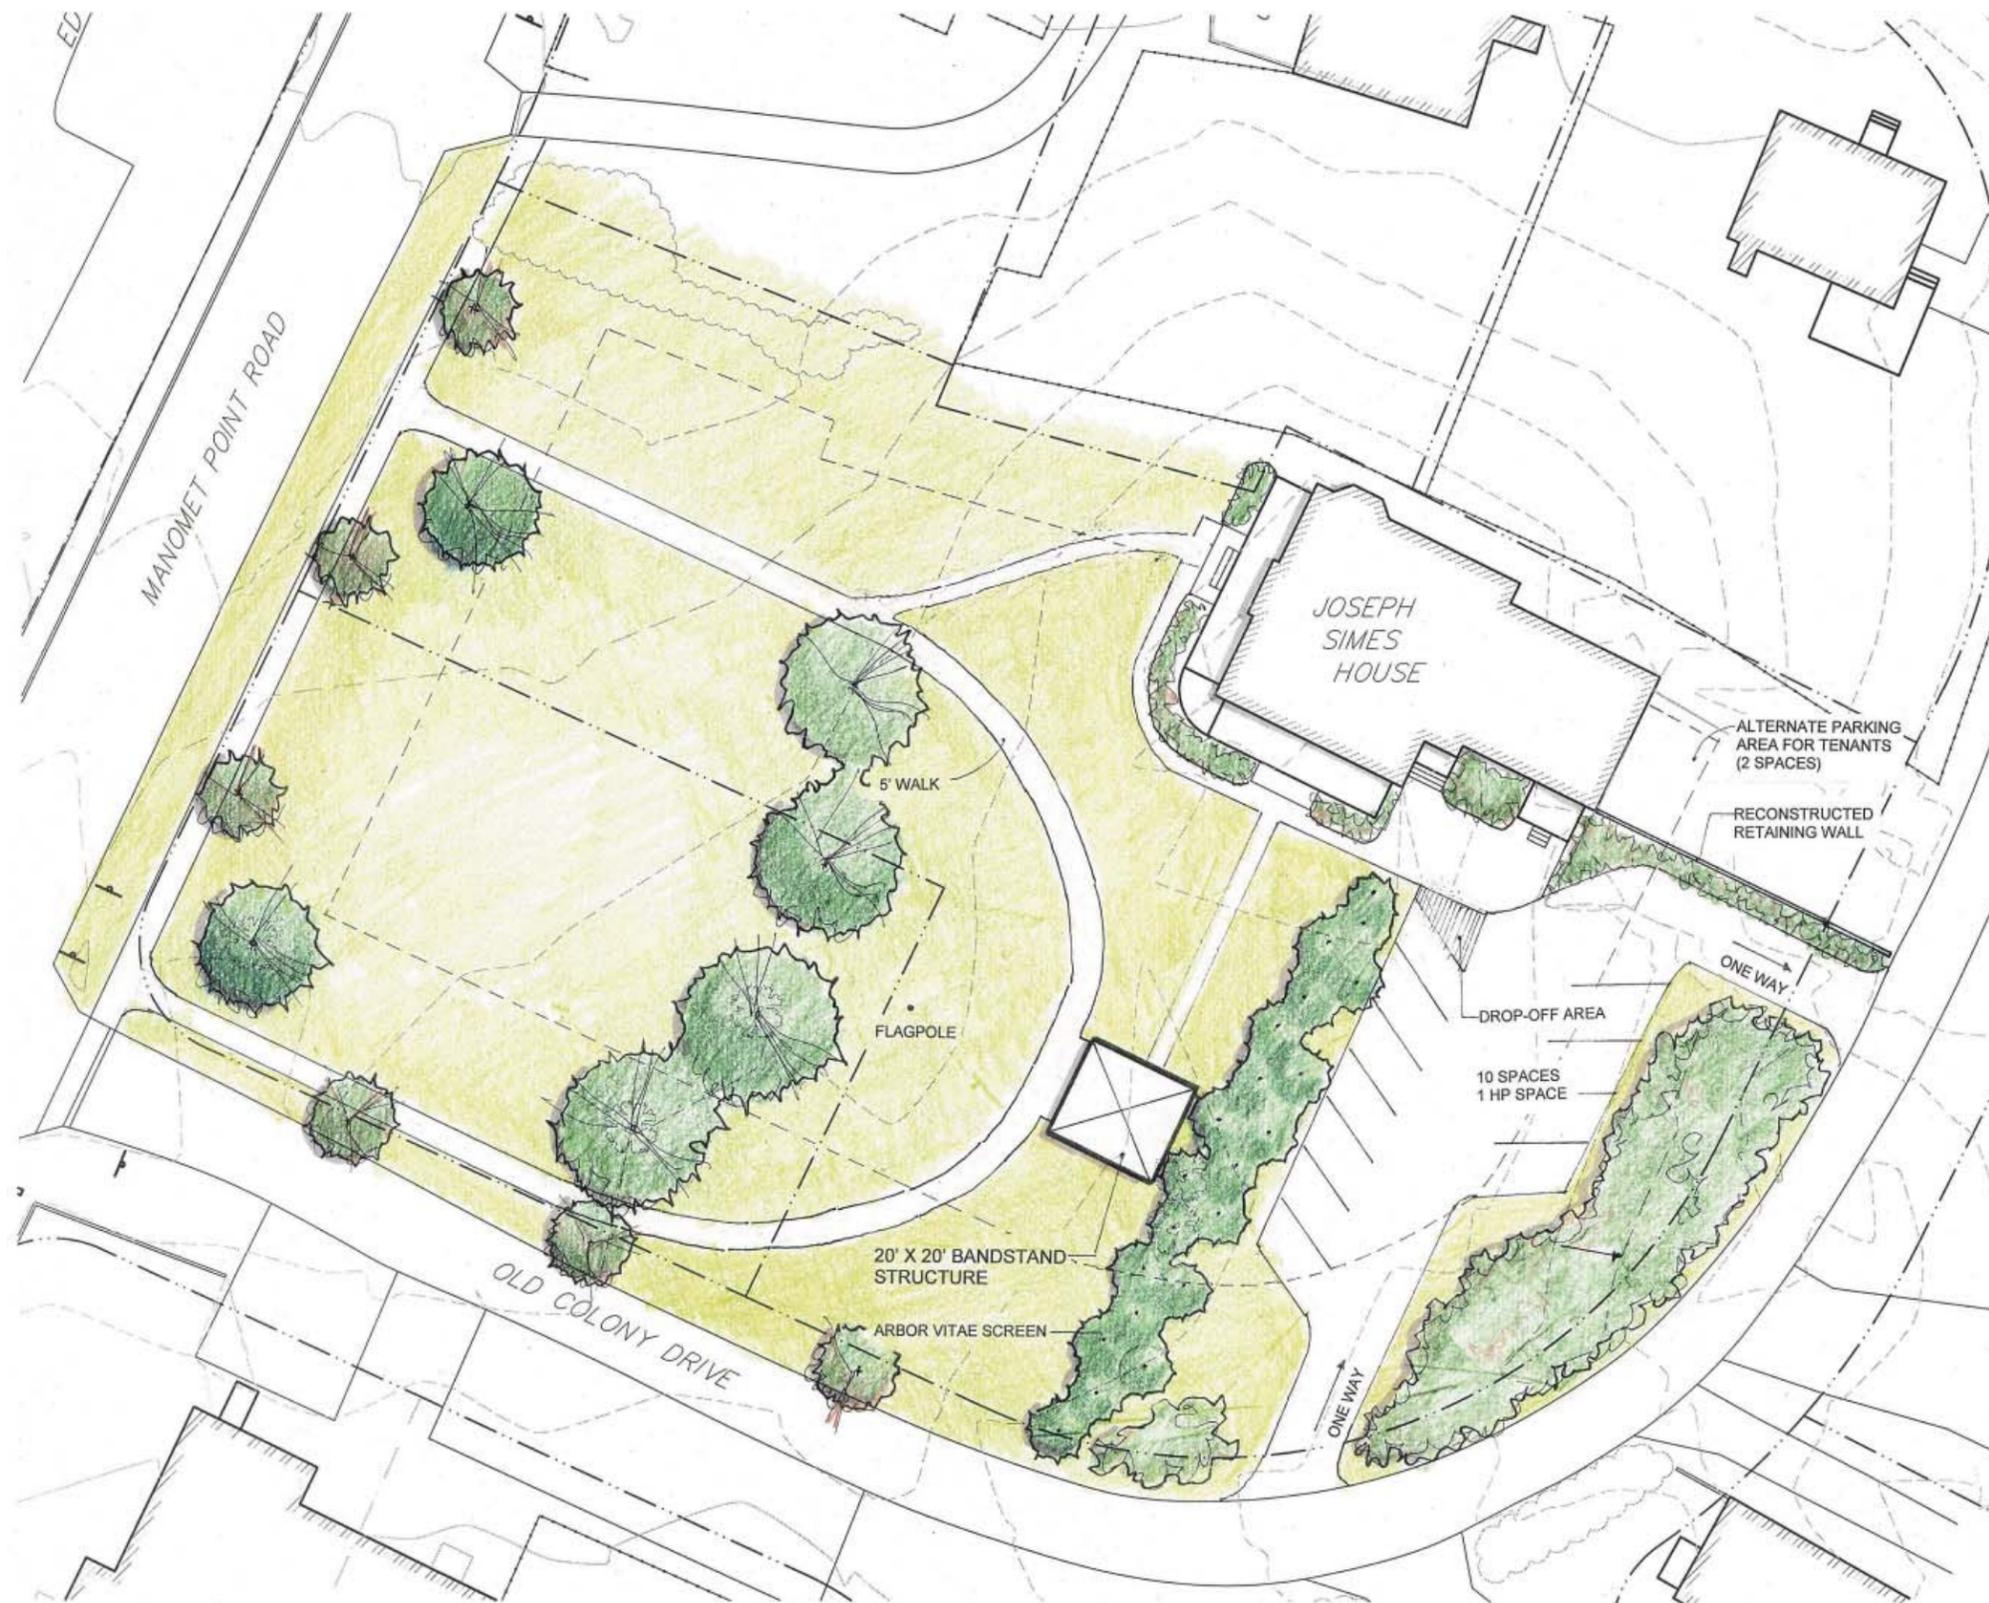
Existing conditions information derived from "EXISTING CONDITIONS PLAN IN PLYMOUTH, MA," prepared on January 19, 2012 by Bracken Engineering, 49 Herring Point Road, Buzzards Bay, MA. Martha Lyon Landscape Architecture, LLC makes no claim to the accuracy of the data found on this plan.

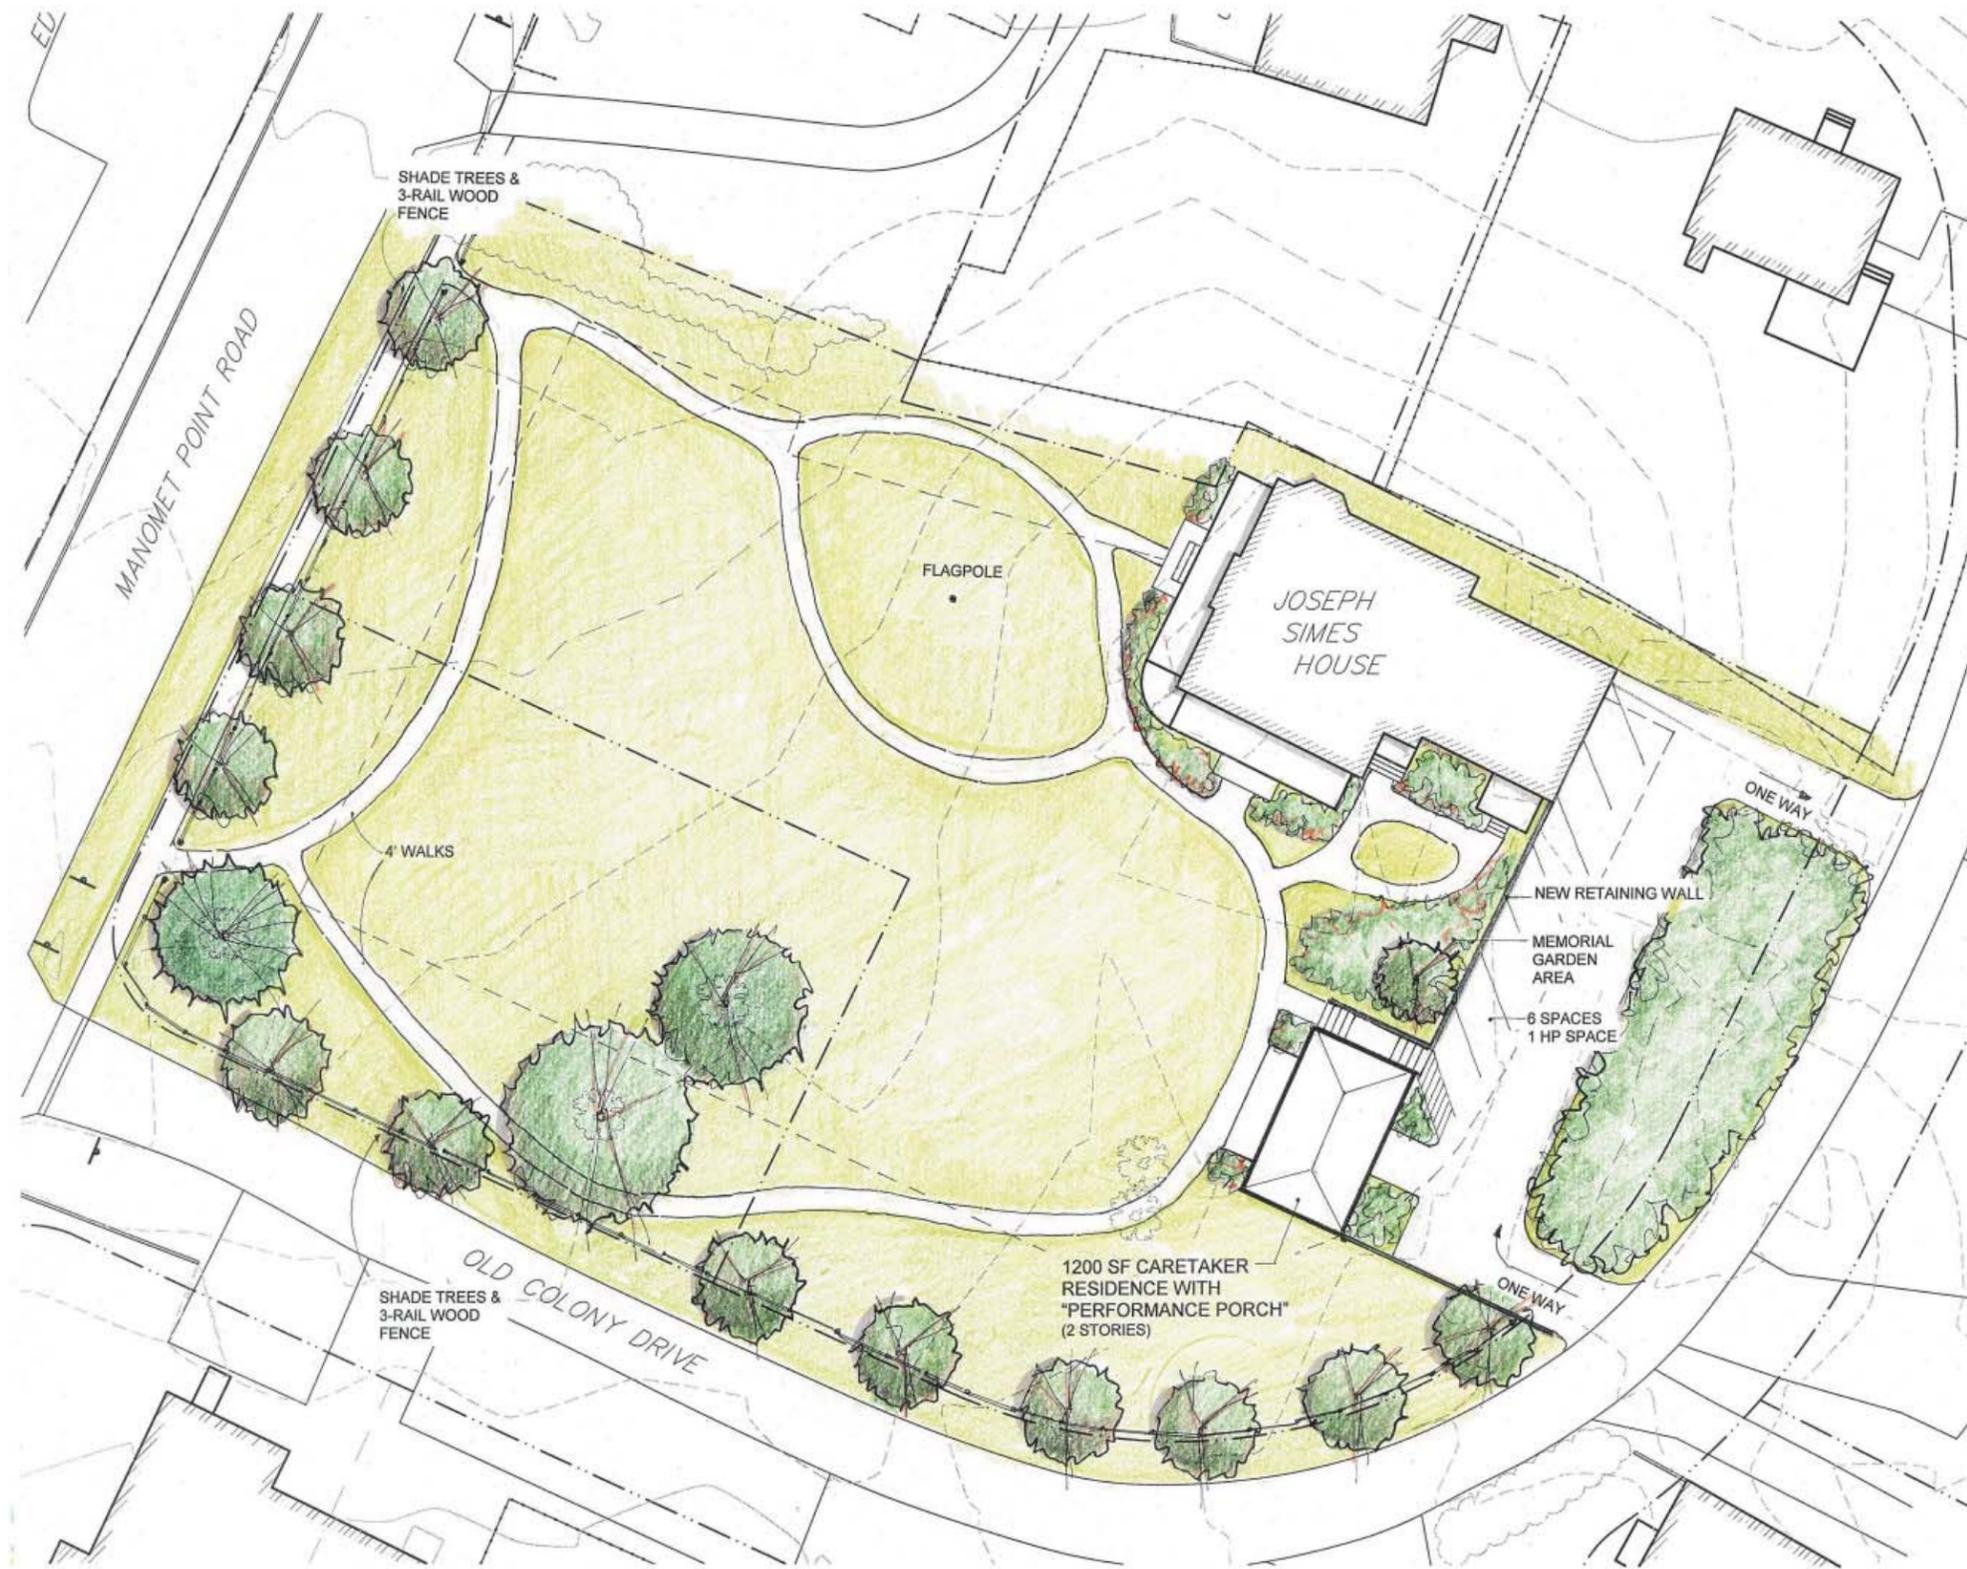
Existing conditions information derived from "EXISTING CONDITIONS PLAN IN PLYMOUTH, MA," prepared on January 19, 2012 by Bracken Engineering, 49 Herring Point Road, Buzzards Bay, MA. Martha Lyon Landscape Architecture, LLC makes no claim to the accuracy of the data found on this plan.

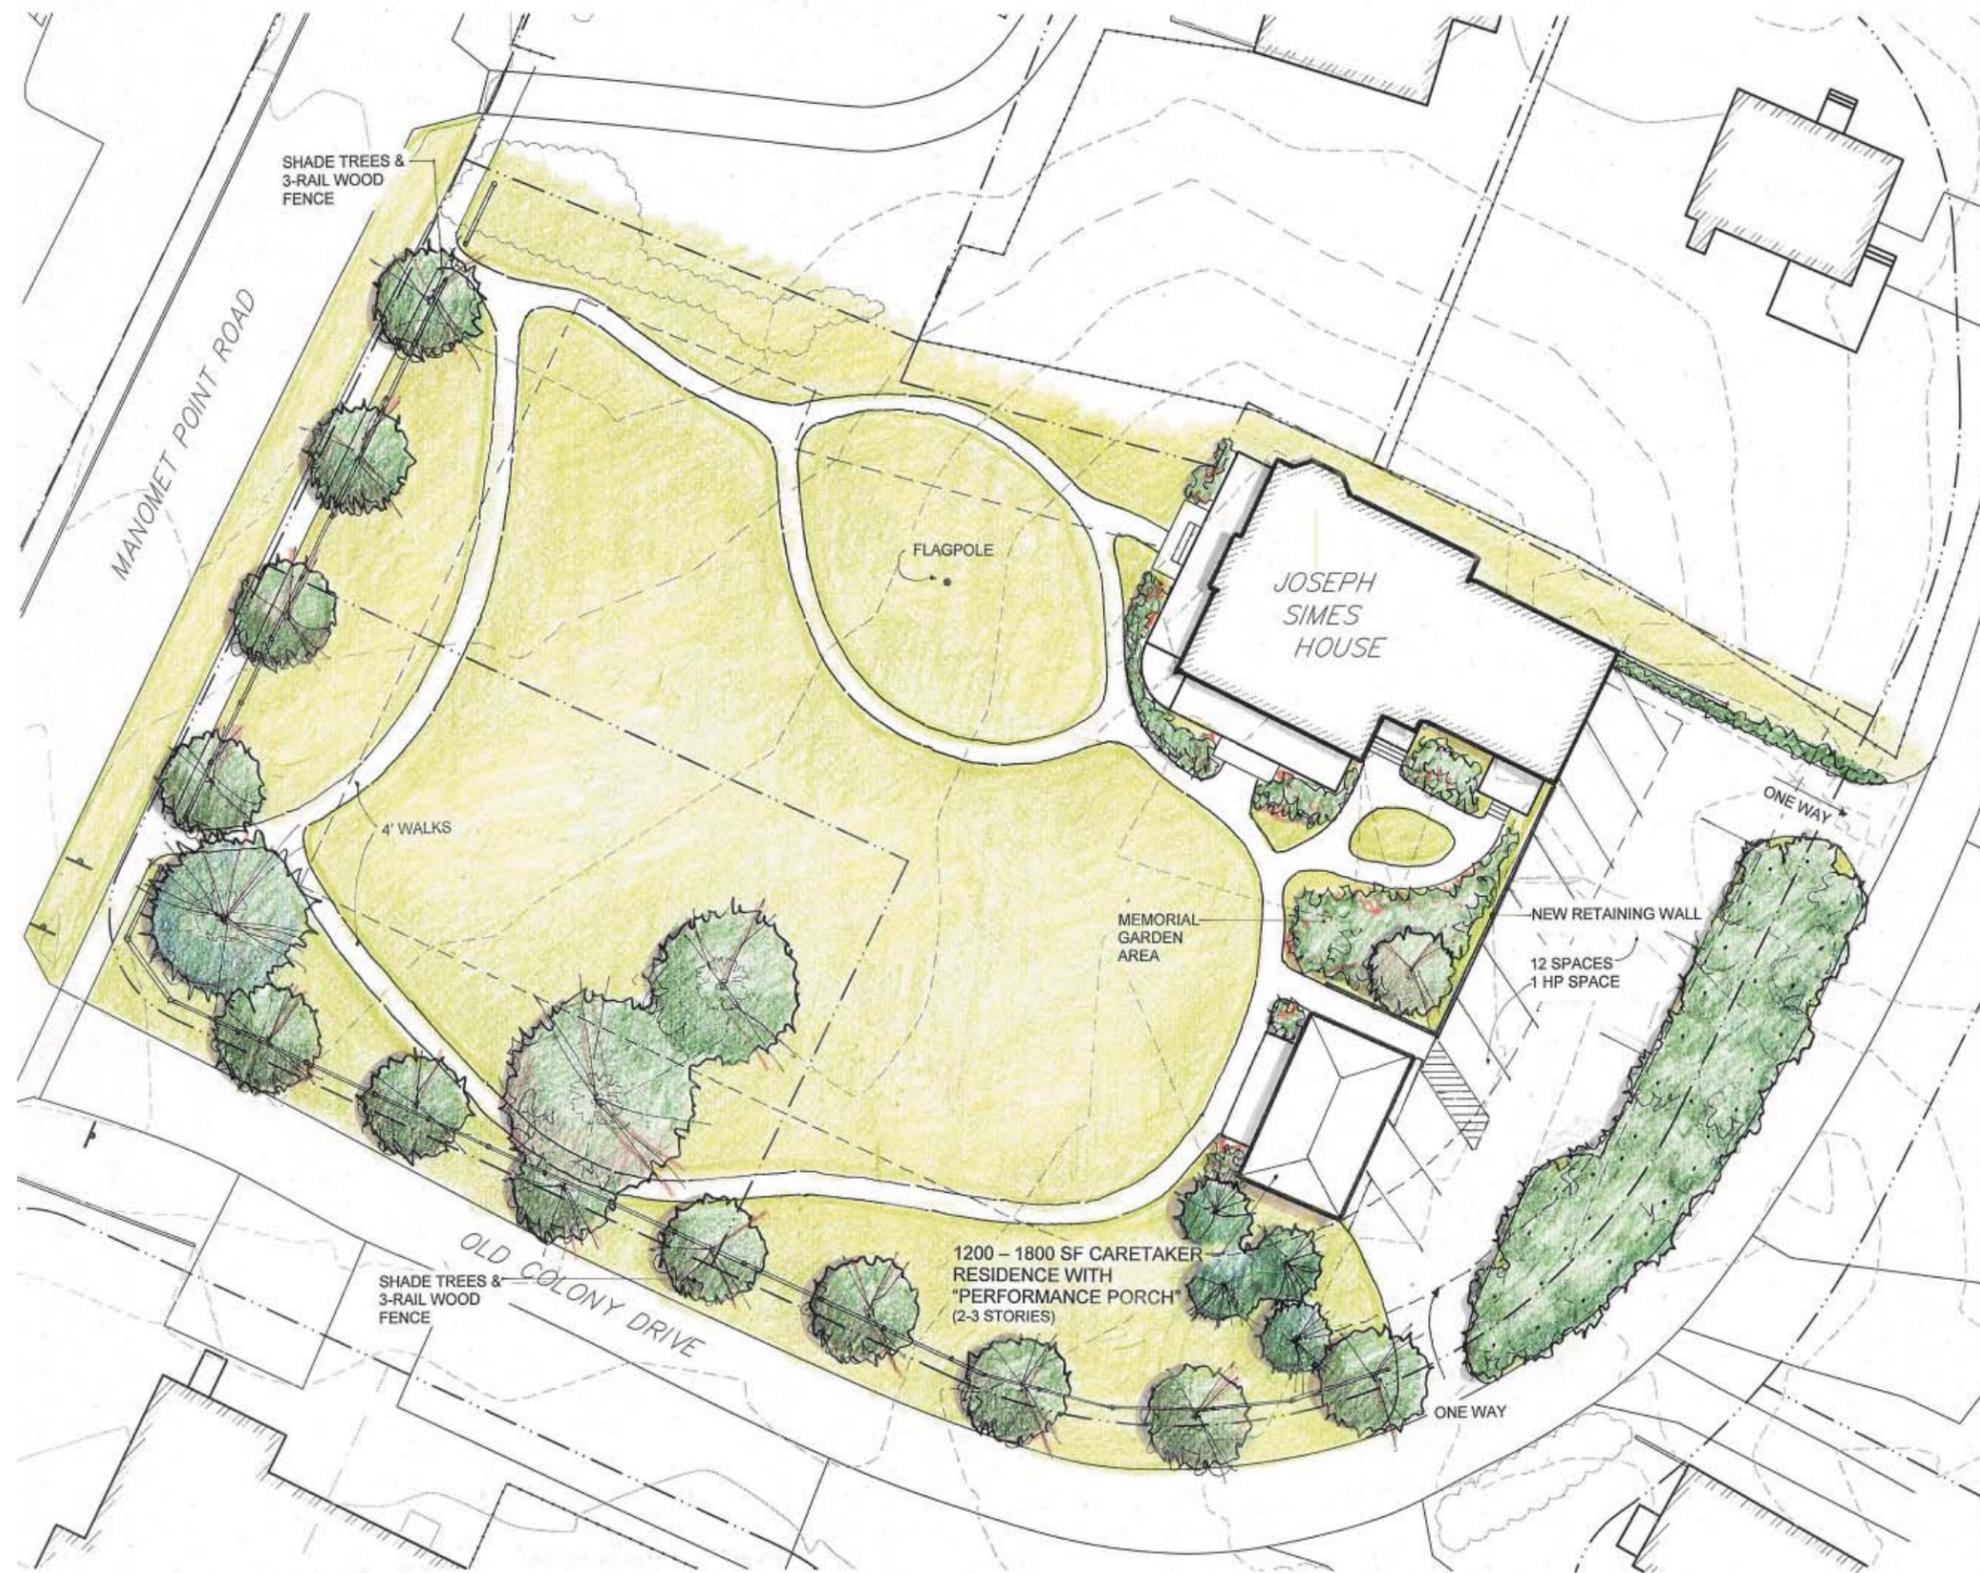
Existing conditions information derived from "EXISTING CONDITIONS PLAN IN PLYMOUTH, MA," prepared on January 19, 2012 by Bracken Engineering, 49 Herring Point Road, Buzzards Bay, MA. Martha Lyon Landscape Architecture, LLC makes no claim to the accuracy of the data found on this plan.
