**TOWN OF PLYMOUTH CAPITAL IMPROVEMENT PLAN REQUEST FORM
FY24 SPRING ANNUAL TOWN MEETING REQUEST FORM**

Department: Facilities Services - PPS	Priority #:	3
Project Title and Description: MES Brick and Window Seal Repair	Total Project Cost:	\$97,027.35

PROPOSAL: Manomet Elementary School

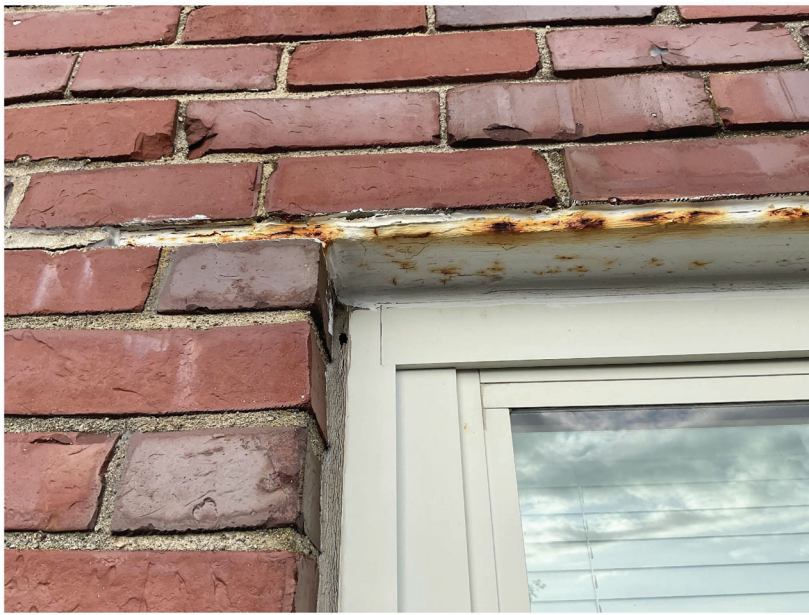
Example of damage due to no weep holes or other arrangement for water to drain. Typical around building

- E) Saw out and replace 60 misc brick do to Spaulding cracked or missing.
- F) Drill in above header of windows where mortar and caulking have been used allowing water to stay trapped and run back into building . We will drill clean and install weeps .to allow water to run out freely as it should .

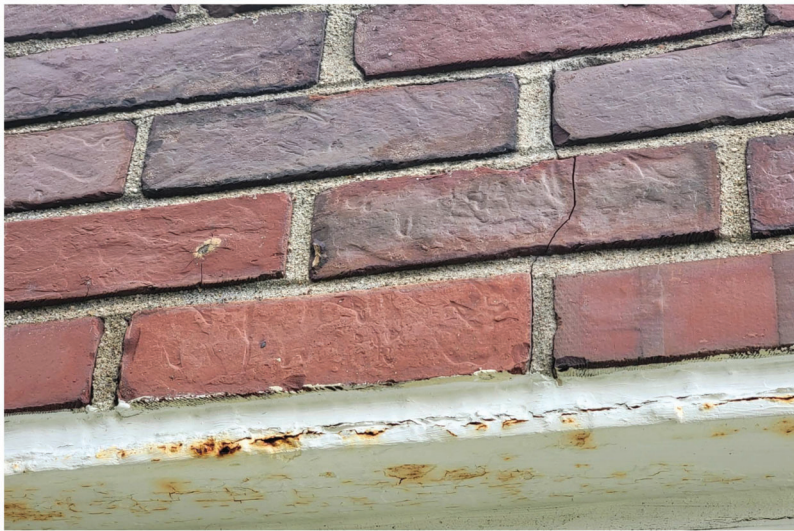
Examples of damage.

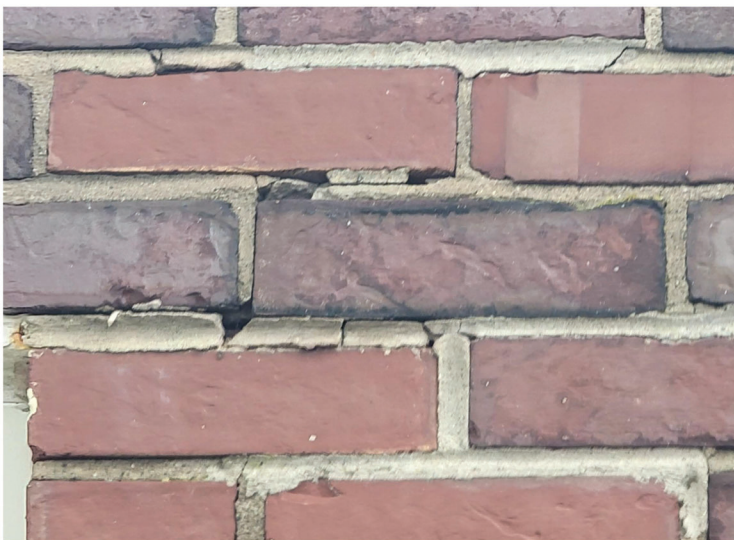
Cracks expanding from water damage

- A) Saw out clean prime and recaulk 2920 If this covers all windows ,doors and vents as well as all control joints and roof top windows.
- B) Saw out and repoint 825 sq feet of cracked ,deteriorated and missing mortar joints.

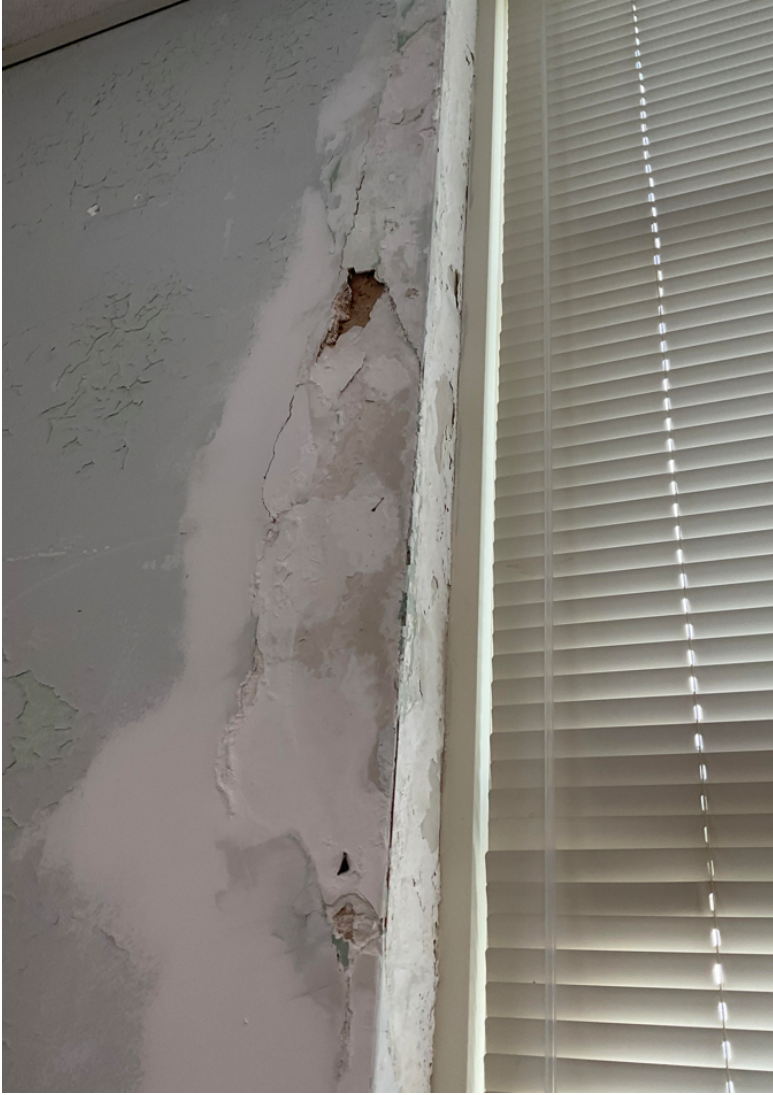
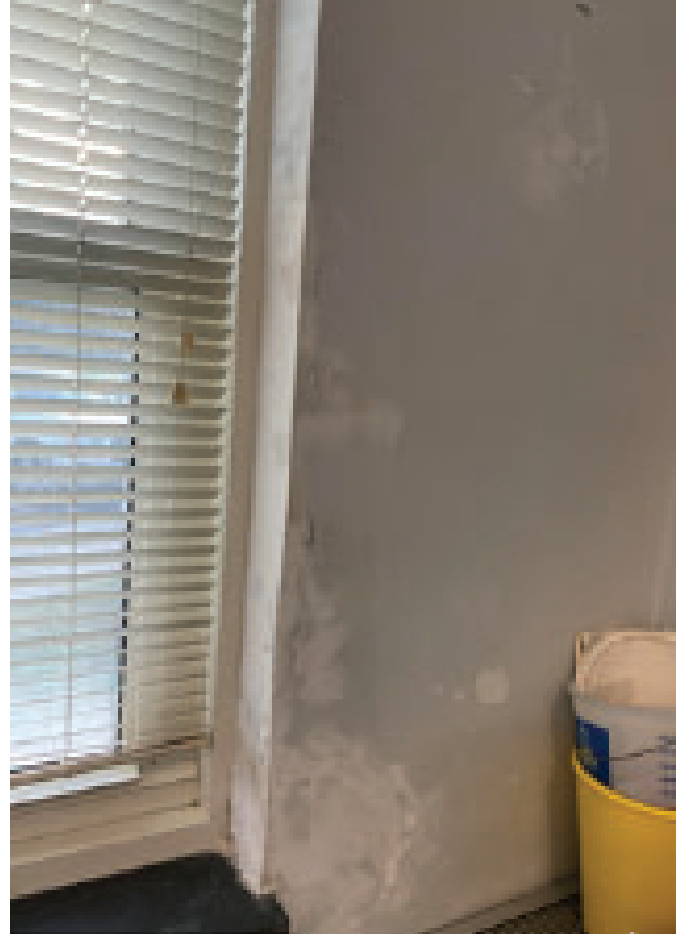
Samples of internal building damage due to water taking the path of least resistance to inside the walls.
