**TOWN OF PLYMOUTH CAPITAL IMPROVEMENT PLAN REQUEST
FY24 FALL ANNUAL TOWN MEETING**

Department: Schools Facilities	Priority #:	5 ⁸
Project Title and Description: Manomet Ele rubber roof replacement 6300 s.f.	Total Project Cost:	\$388,500.00

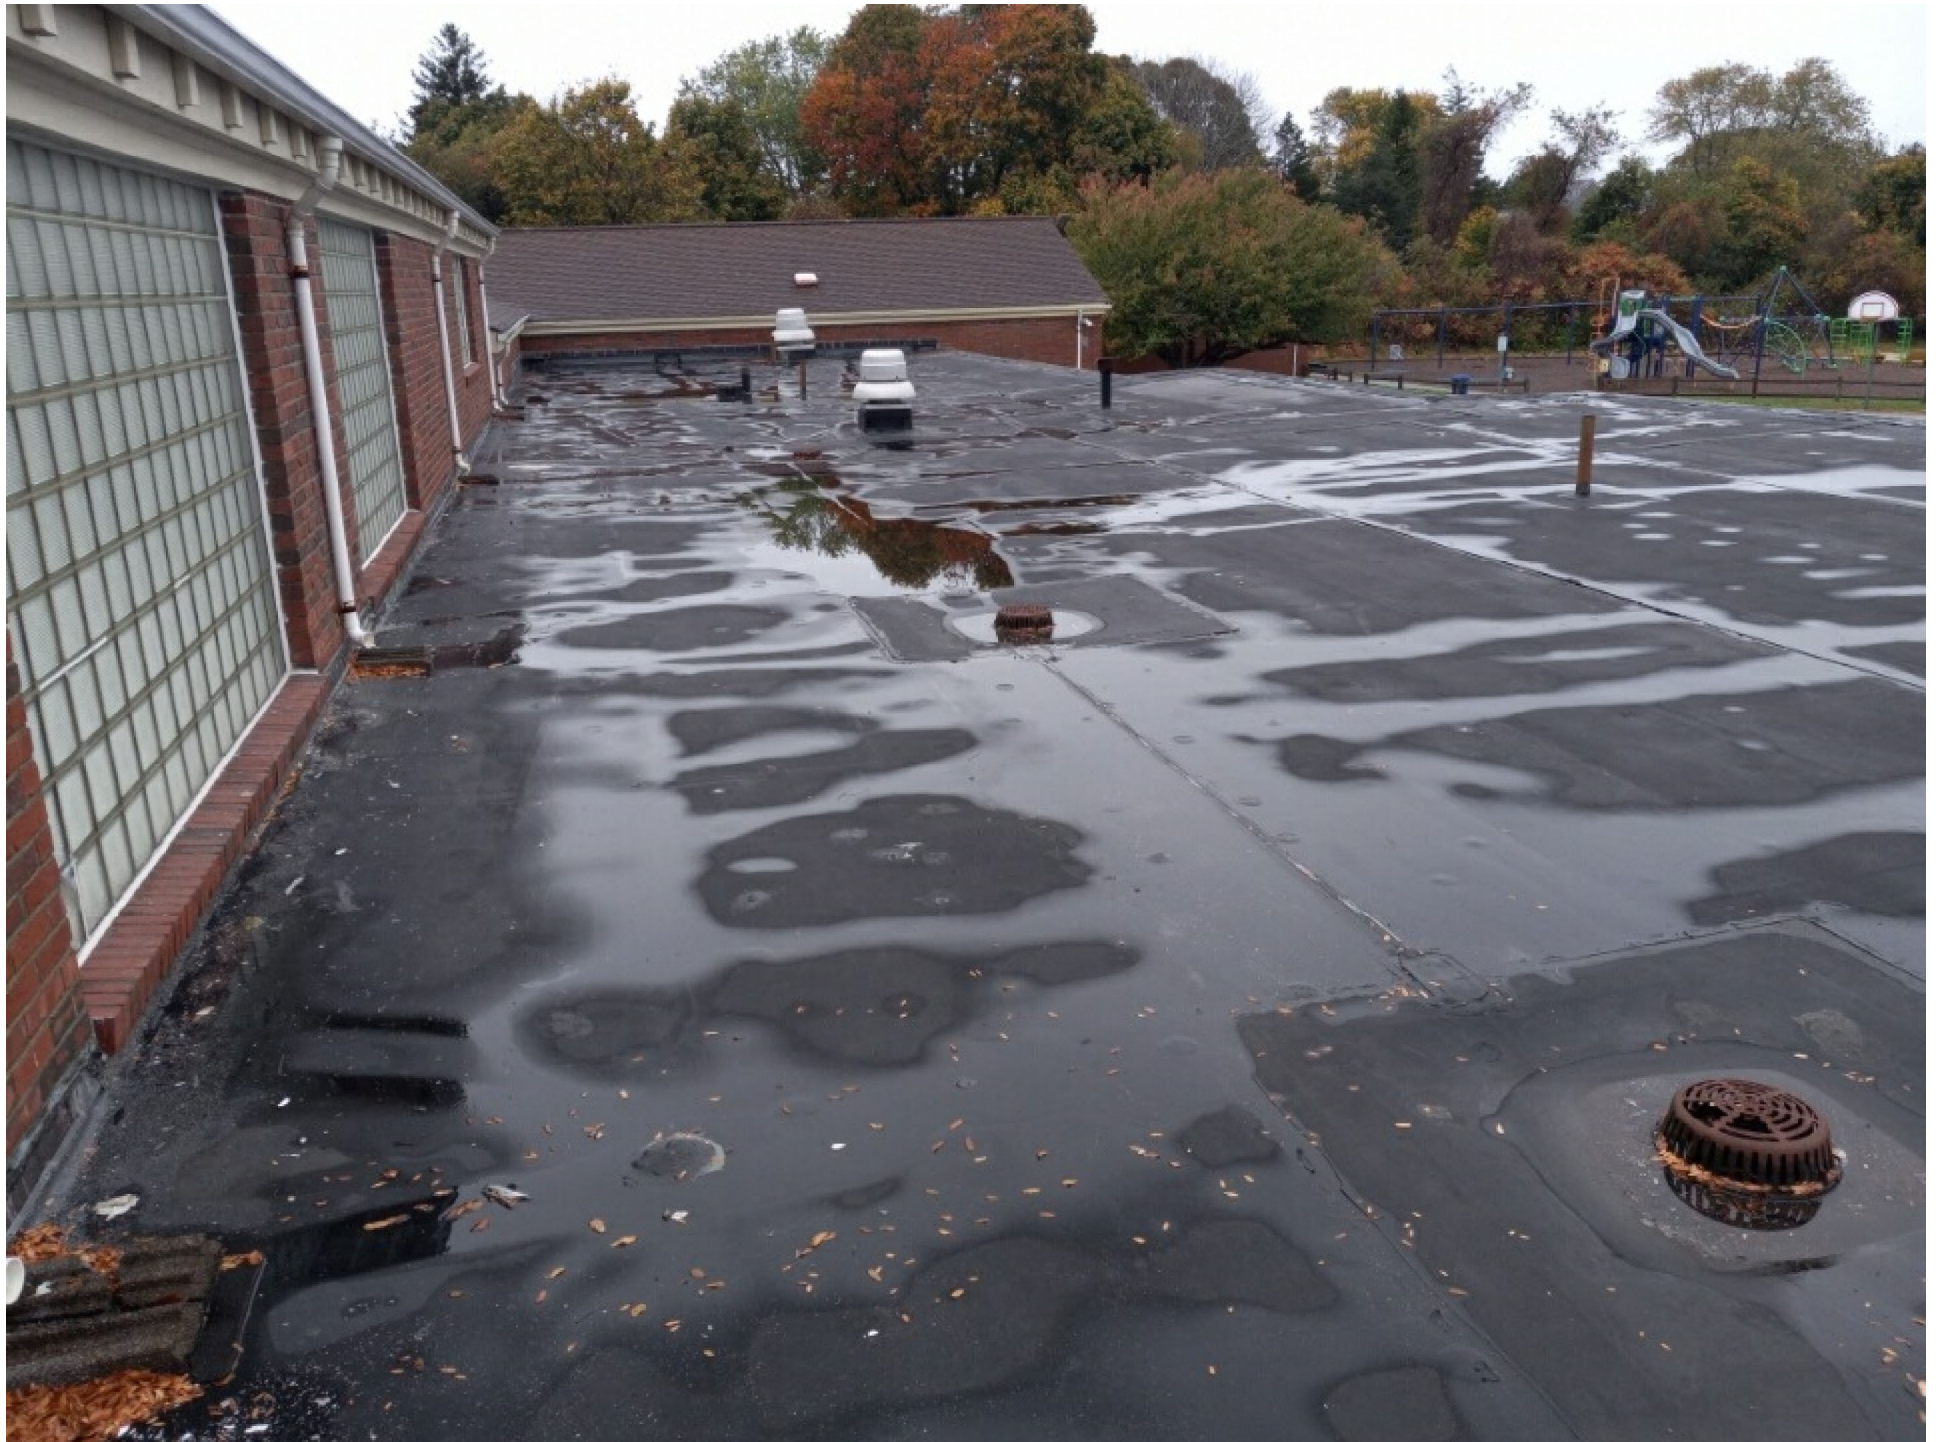
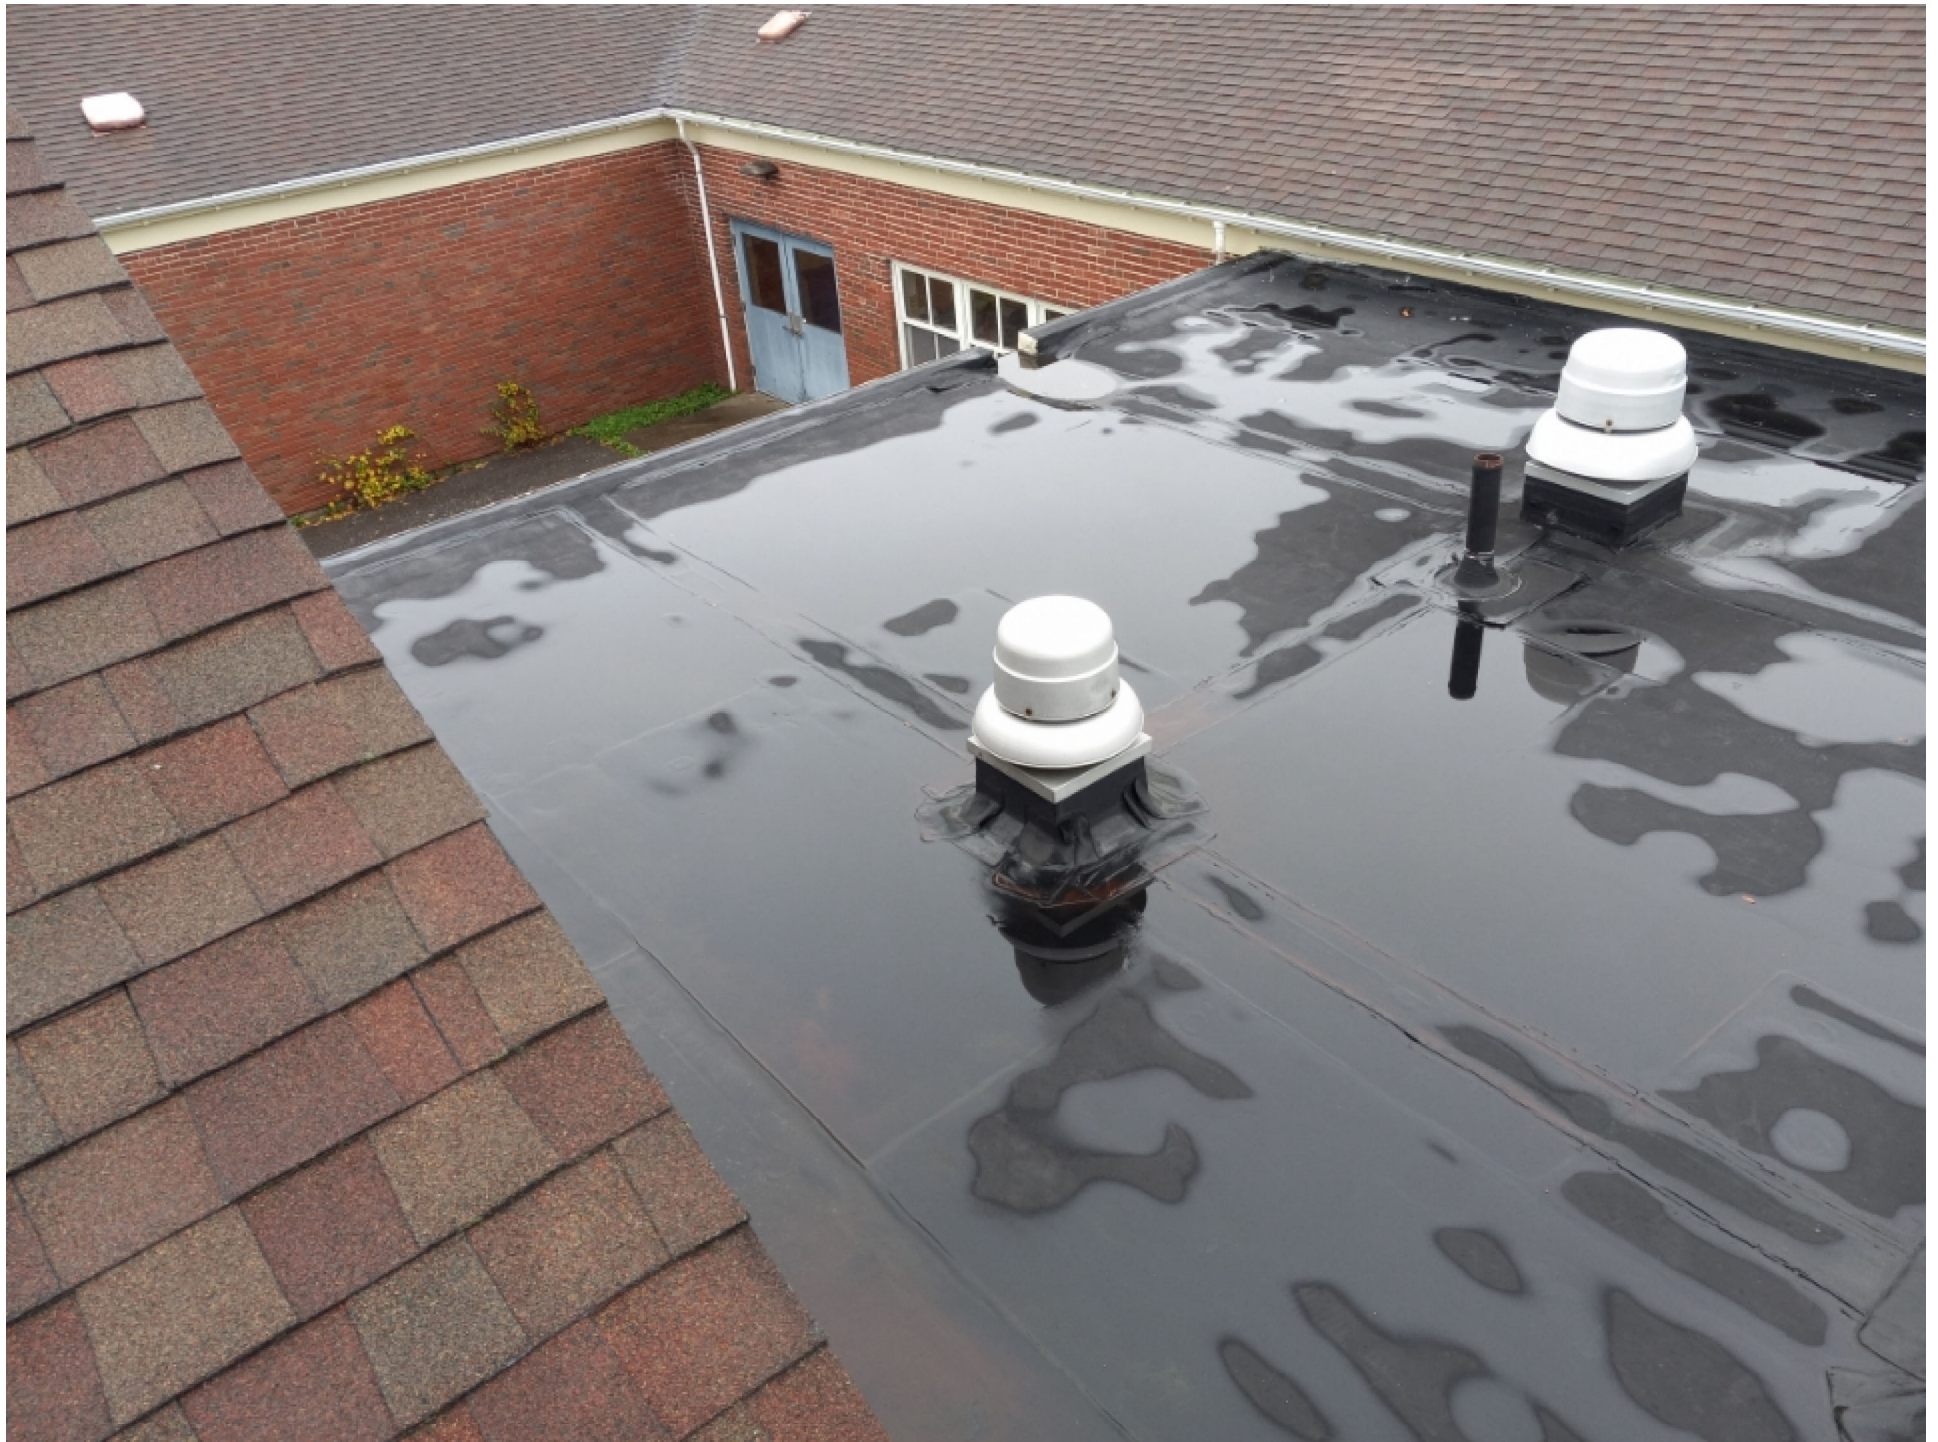
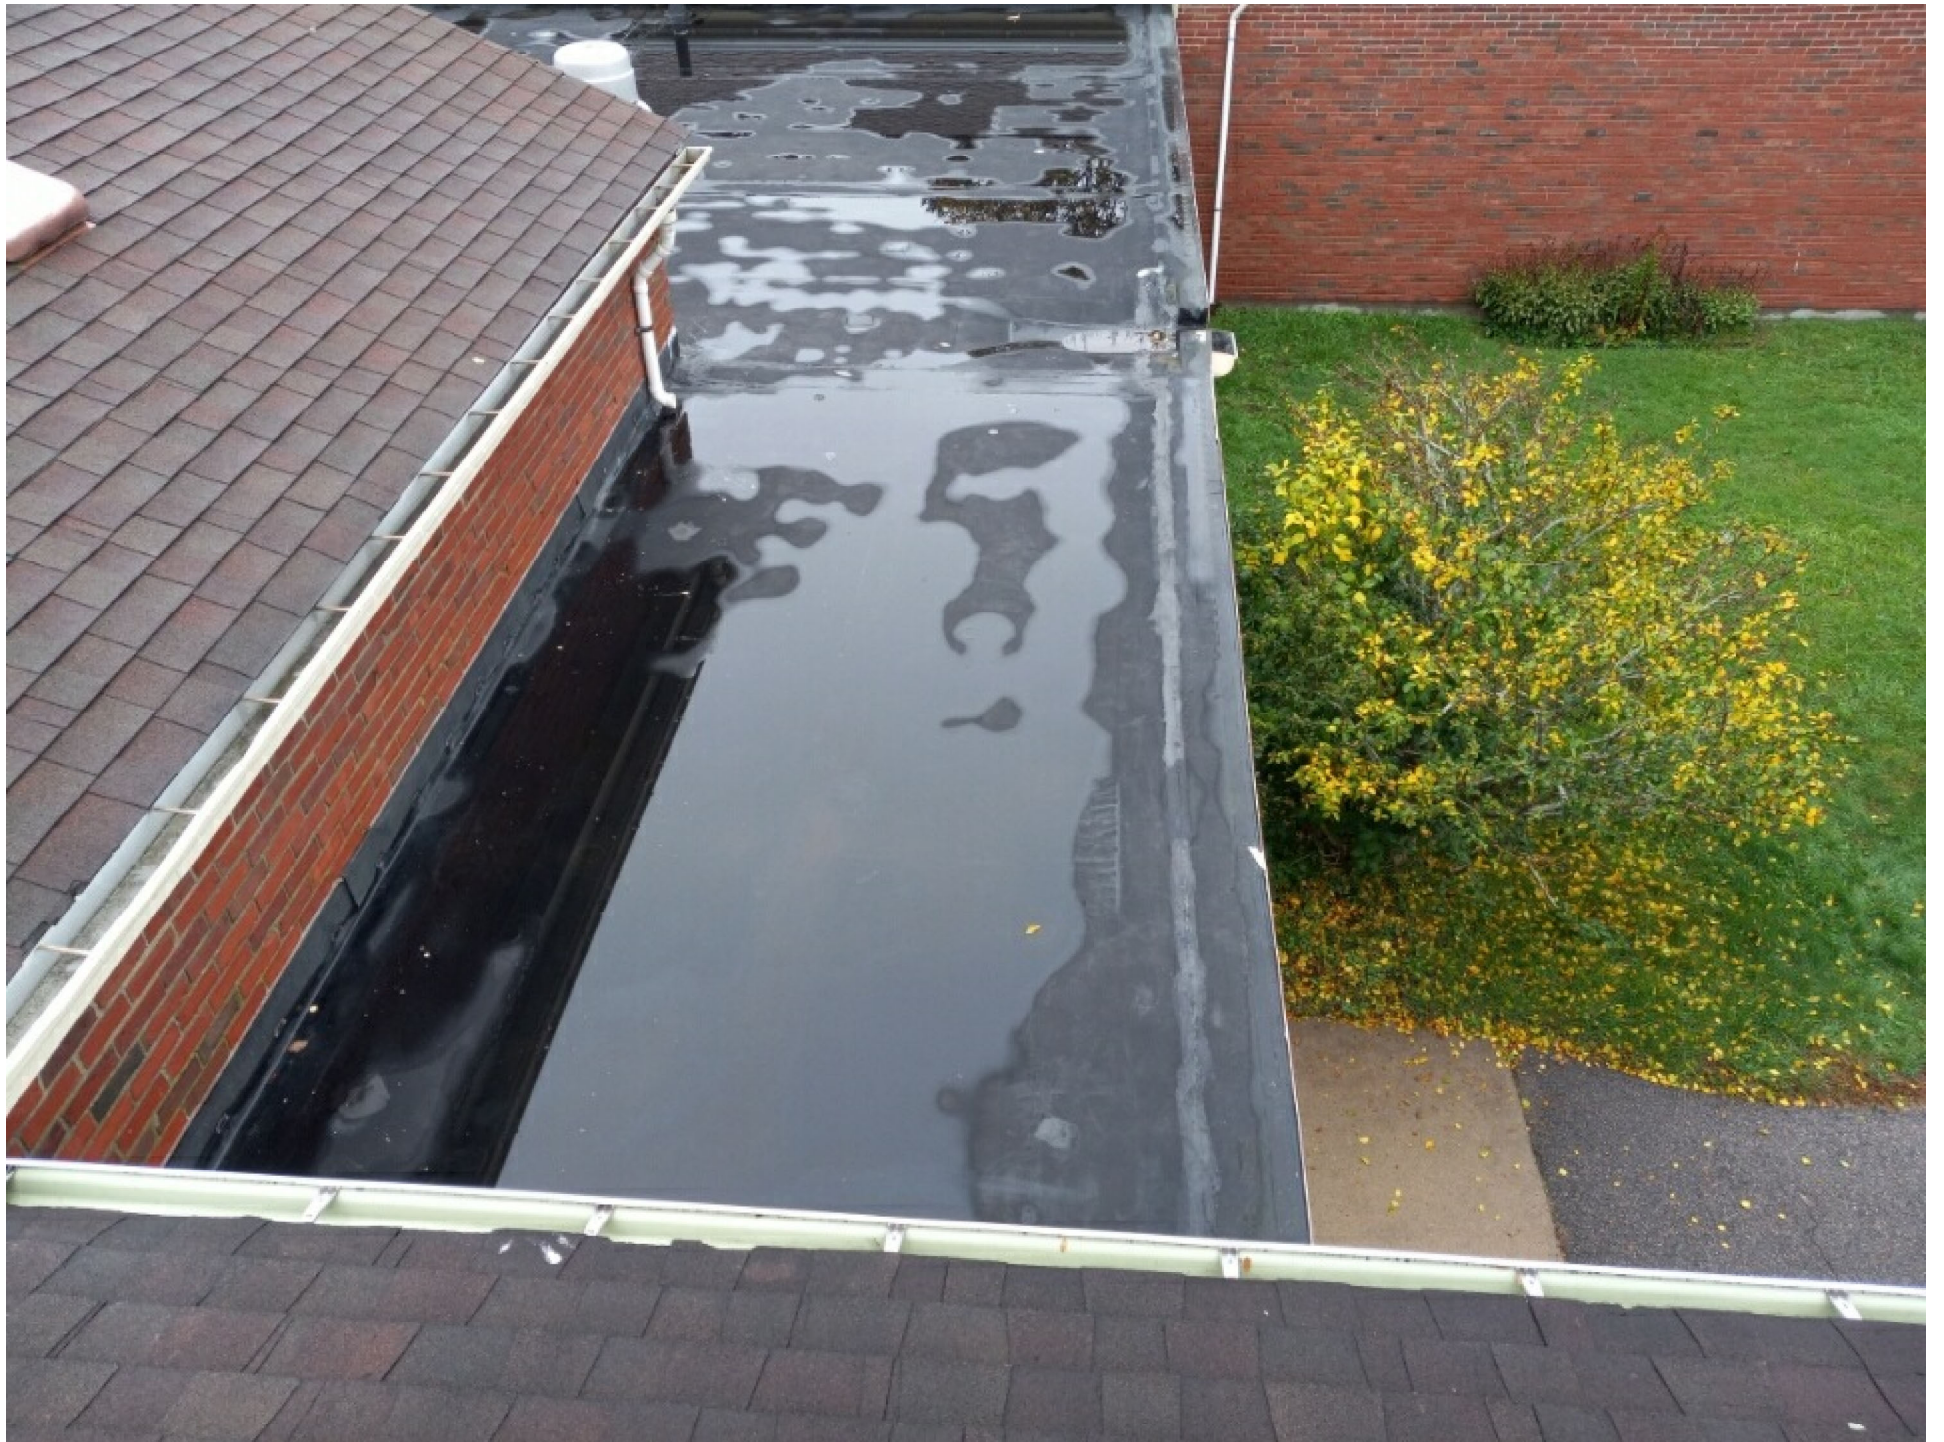
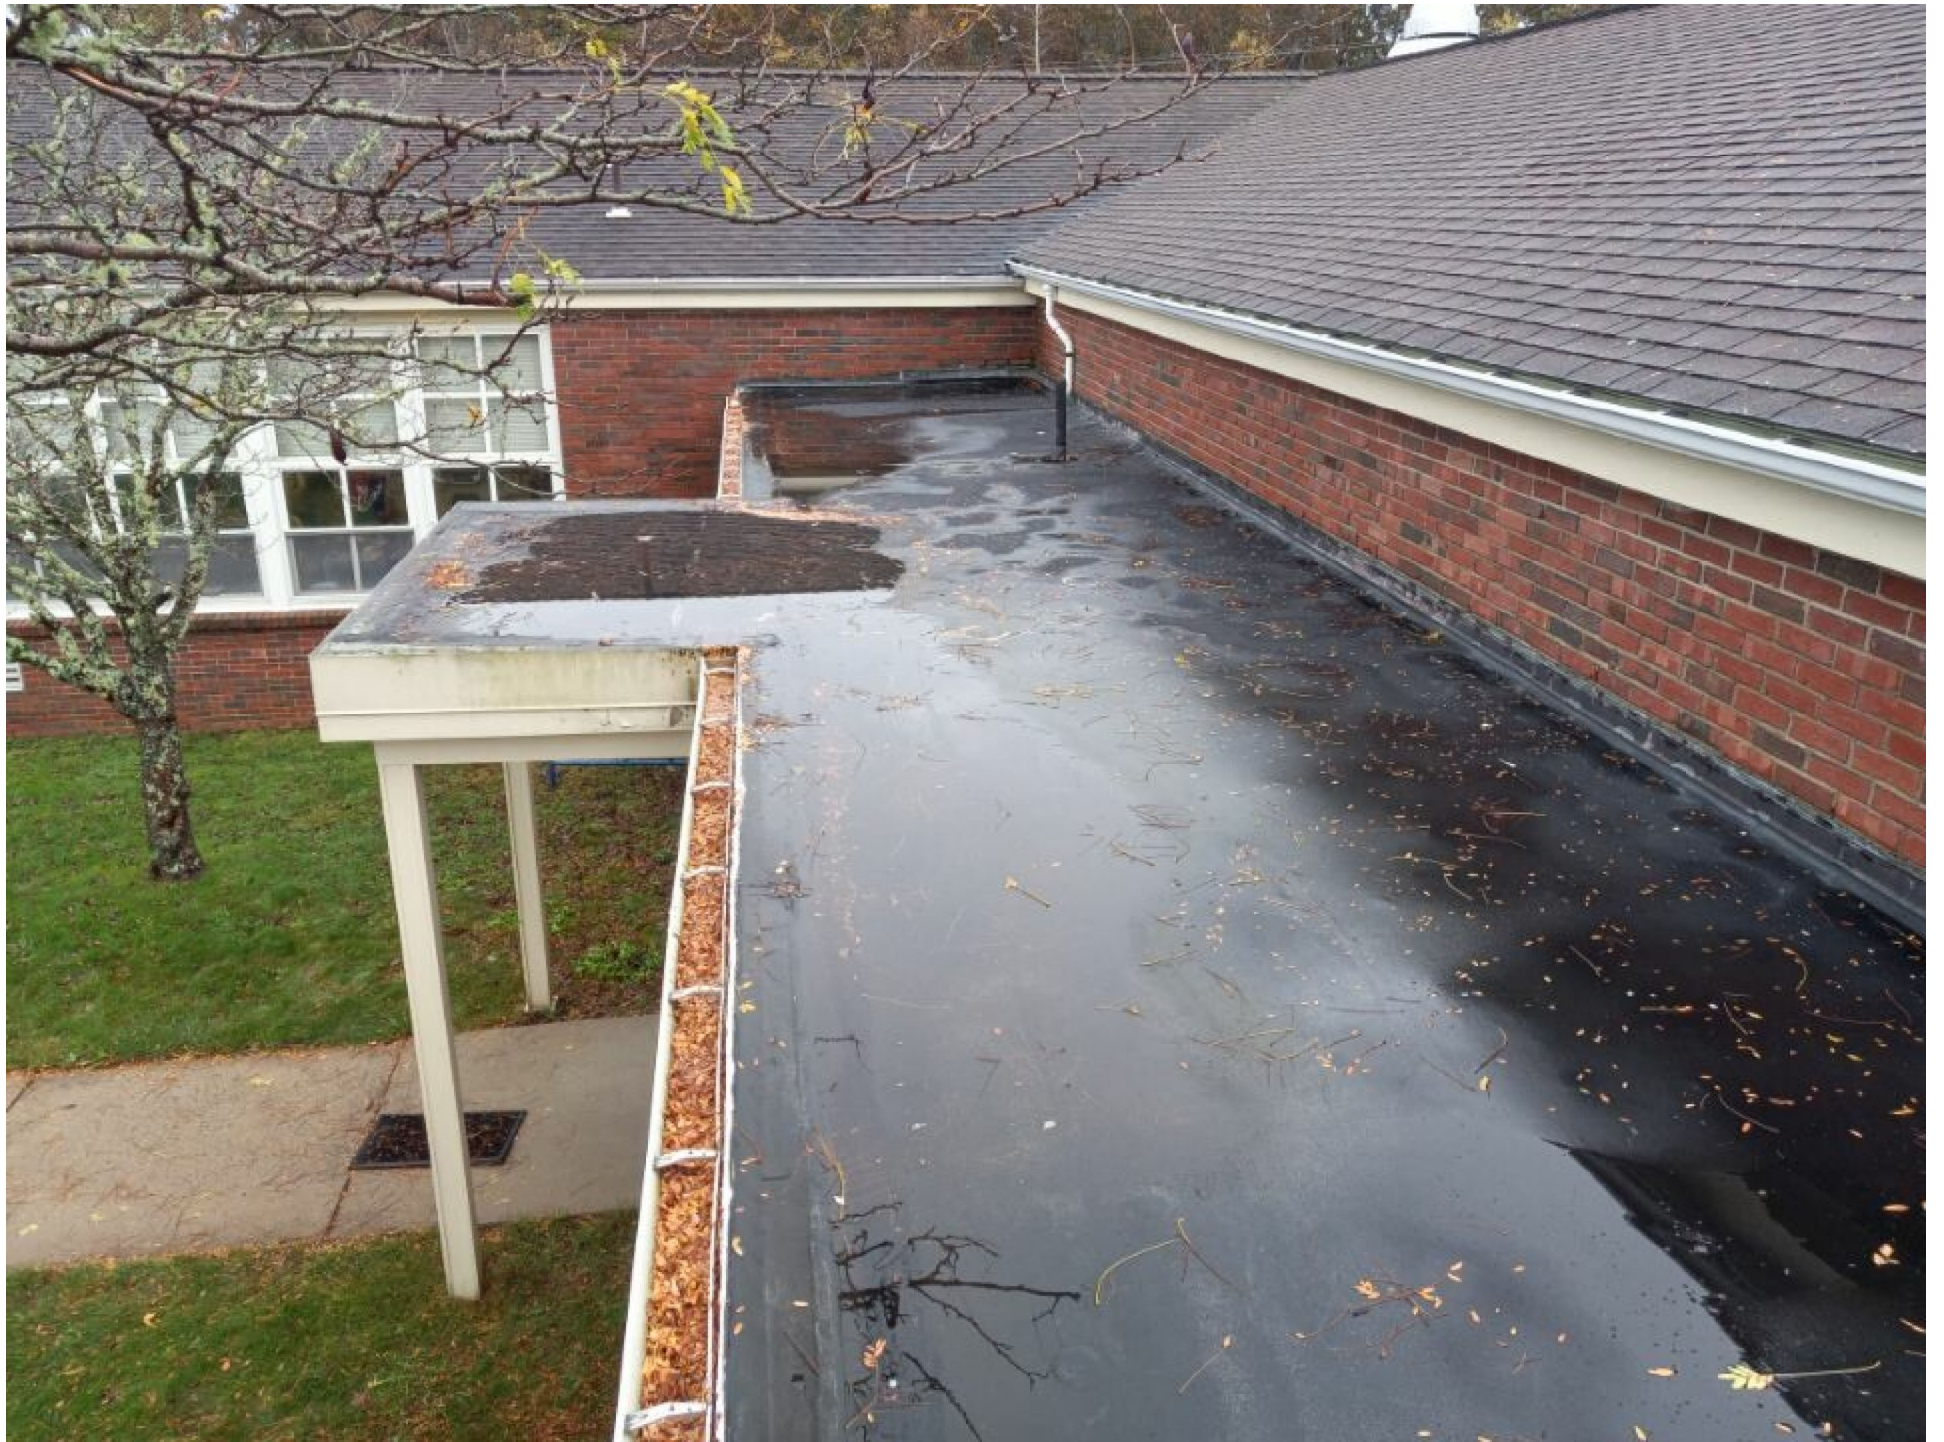
Project Justification and Objective: The rubber roof is breaking down at all seam and needs to be replaced to prevent any more interior building leaks

*Issues with project include no manufacturer jobsite observations, poor to negative slope resulting in ponding water, flashing heights not raised, low performance low cost rubber membrane roof will result in high life cycle costs.
